**Title: Foreign pipeline Interference and Detection of third party coating defect by ACVG A-frame survey - A Case Study**

GAIL (India) Ltd, Chittorgarh, INDIA

**NIGIS \* CORCON 2017 \* 17-20 September \* Mumbai, India**

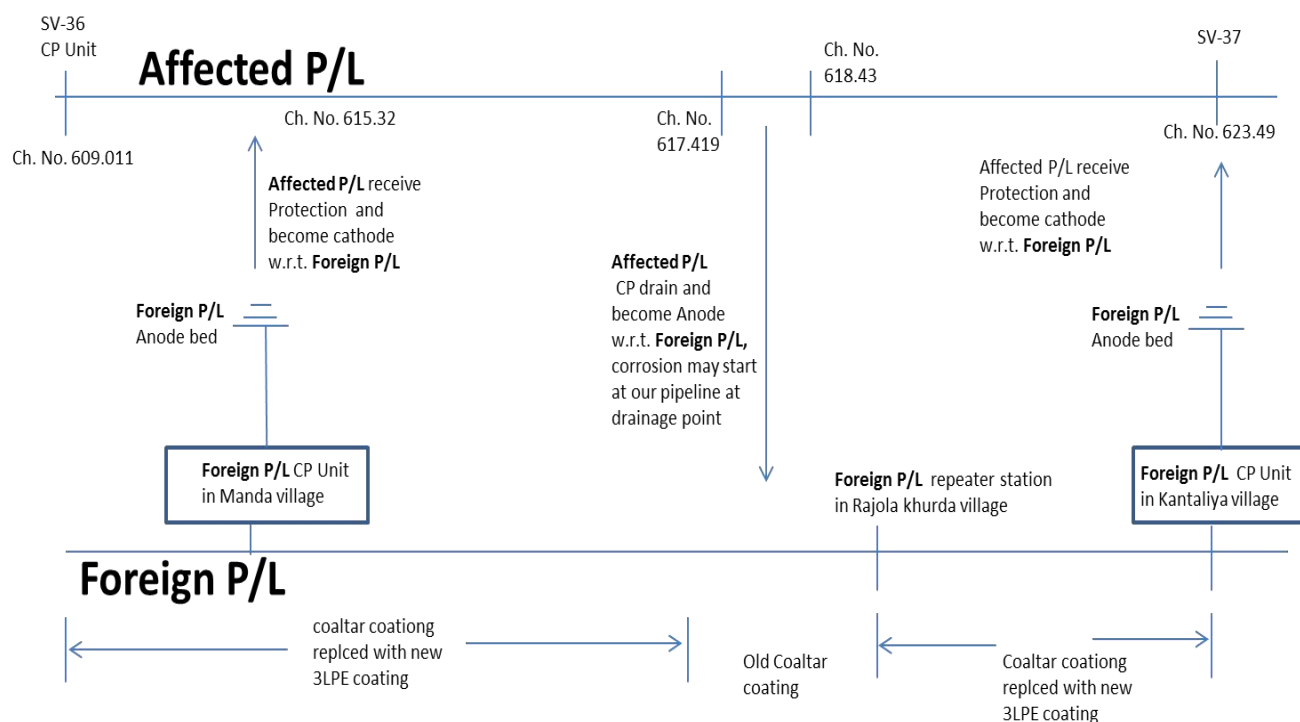
**Fig.-1 Interference of Foreign pipeline with affected pipeline at Ch. No. 617-618**

Below schematic shows the location of CP unit foreign line w.r.t. affected pipeline. Two anode beds of foreign pipeline are laid towards affected pipeline.

The results clearly suggested that Company-A P/L is suffered with foreign pipeline interference. Affected pipeline receives current from two anode bed of foreign P/L and the discharge current at chainage No. 617.419. Due to the discharge of current PSP is observed less electronegative than - 850 mV. If the source of interference i.e. foreign pipeline CP unit is switched-off affected P/LPSP is improved by 270mV.

Further discussion with foreign P/L CP engineer, it is observed that they are replacing the old coal-tar coating with 3LPE coating in phase wise manner. It is also observed that foreign P/L having old coal-tar coating at affected location at Chainage No. 617.419.

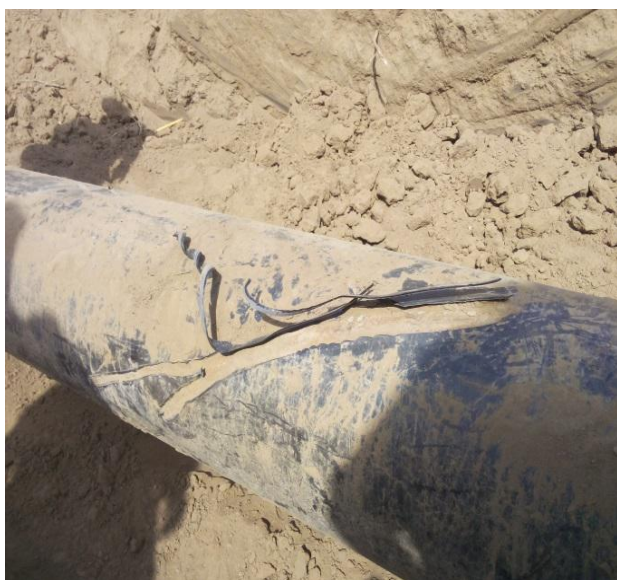
**Step-2:** Excavation was carried out at the locations identified in ACVG A-frame survey. Coating defect was found at two locations as per survey reports. Pipeline & coating was suspected to be damaged by third party activities also damage by third party.

**Fig.- 4 Coating & pipe damage at Ch. 617.550    Fig.-5 Coating & pipe damage at Ch. 617.600**

It was suspected that during the operation of the excavator by the third party, the pipe also got damaged along with the coating at both the locations at Ch.617.550 and 617.600Km. Both the locations were excavated and coating was removed on the pipeline up to the extent of the coating damage. At first location Ch.617.550Km, it was observed that the excavator pressed a penetration tooth down on the pipe until the front of its tracks lifted off the ground then dragged the tooth along. Due to this, two numbers gouge were created with axial groove from 12'O clock position towards 3'O clock position (in Fig.6). At second location, the excavator bucket was wedged against the back wall / inside of the excavation and levered against the pipe(Fig-7).

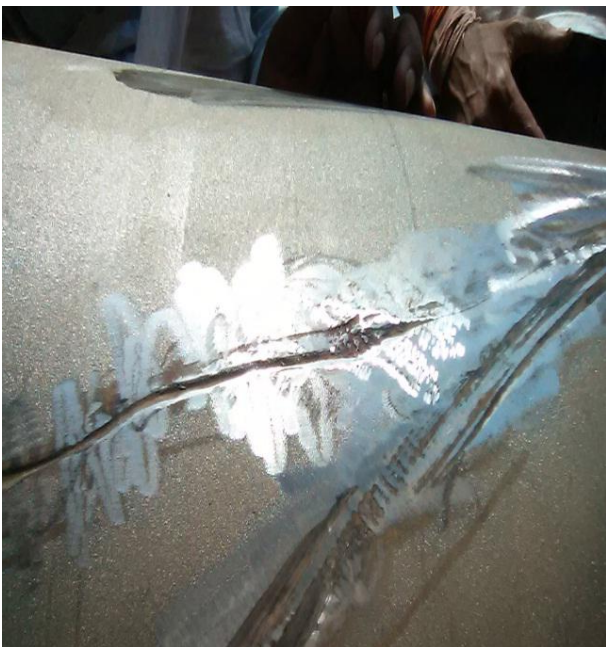
Fig. -6 At Ch.716.550Km – Location 1

Pipelines are designed to withstand internal pressures well above their operating pressure. This 'design pressure' is one factor that determines the wall thickness of the pipe. As the pipe wall thickness decreases and so does the pressure rating of the pipeline. It requires determining of safe operating pressure and ERF (Estimated Repair Factor). The following NDT tests were done on the first location. DPT test, MPT test and UT test were applied for detecting surface and sub-surface cracks and other anomalies if any. The maximum depth found on the first location is 28% and it was within the maximum allowable length i.e.80mm.At second location, visual inspection and thickness test was done around the defect and the maximum depth is below 10%.It was confirmed all parameters were within the limit.
