STUDY ON TROUBLE SHOOTING IN ICCP PROTECTED UNDERGROUND PIPELINE FOR LOW INSTANT OFF PSP VALUES.

GAIL (India) Ltd

6 Inch Dia, 24 KM length P/L spreads from Dispatch Terminal at location A to another Dispatch Terminal at location B. This P/L is ICCP protected having TR Units at Location A and Location B. During routine ON-OFF PSP monitoring, it was observed that the value of OFF PSP of 6 inch Dia, 24 Km pipeline was less electronegative than -850mV w.r.t. copper/copper Sulphate reference electrode across the majority length of pipeline towards Dispatch terminal A. The CP system of the pipeline was investigated to identify the problem in following manner:

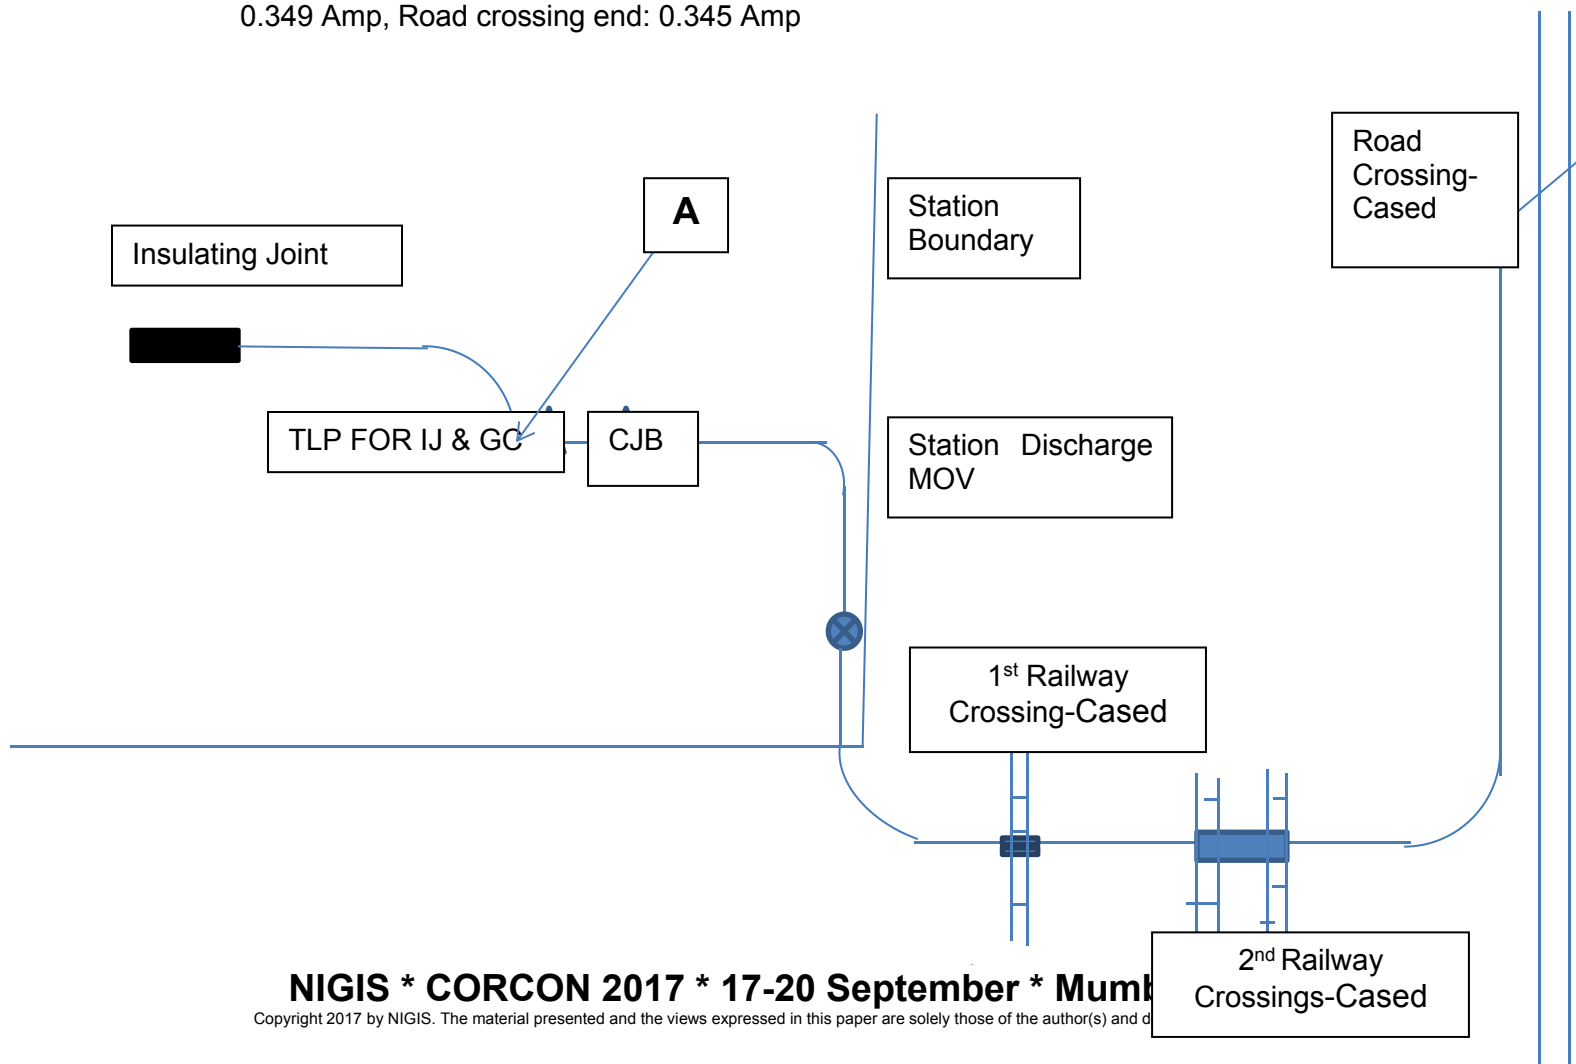
Figure 1: Sketch of pipeline for which CAT survey carried out

After conducting CAT survey it was observed that overall current loss in coating inside and near IJ in Dispatch Terminal A was much higher as compared to other spans of pipeline. Therefore it was suspected that grounding of pipeline is inside the terminal itself. After all the findings it was suspected for possibility of grounding through above ground pipeline across insulation joint. It was suspected that current was grounded through earthing system at above ground piping. For further investigation it was decided to carry out IJ checking.

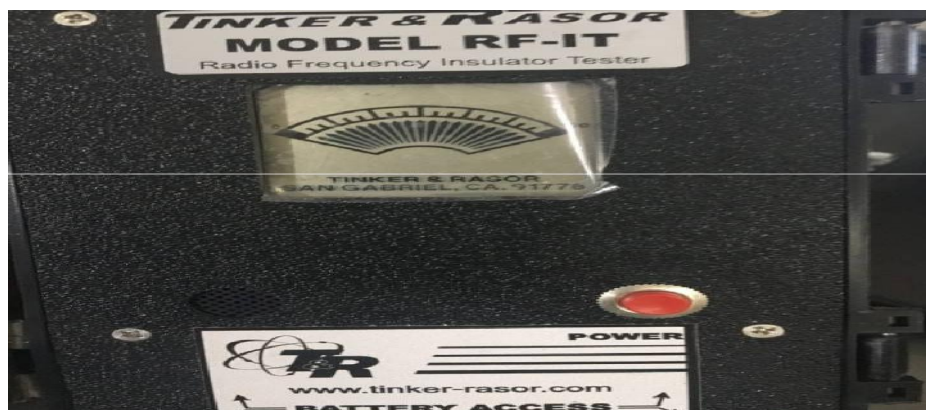
At Dispatch Terminal B IJ was found ok with RF-IT however IJ at Dispatch Terminal A was found partially conducting. Ref photographs of both IJs with RF-IT

Figure 2: RF-IT shows IJ at Dispatch terminal B was Isolated and Healthy

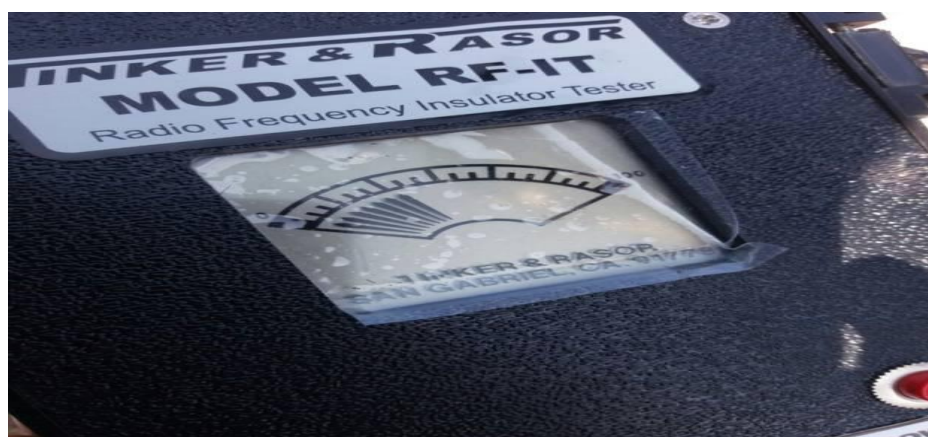
Figure 3: RF-IT shows IJ at Dispatch terminal A was partially short and conducting.

After conducting all relevant surveys, it was almost ascertained that the existing IJ itself was not completely providing electrical isolation between unprotected and protected side of the pipeline at Dispatch Terminal A.

INSTALLATION OF FLANGE INSULATION GASKETS: The possibility for installing the insulating gaskets in flanges was explored. Total 05 Nos. flanges were identified in which insulating gaskets were to be installed. All insulating gaskets were to be protected against surges by installing Surge Diverters

Replacement of IJ was not feasible without shut down of Dispatch Terminal A and evacuation of product from Pipeline Section from Dispatch Terminal to Battery Limit Valve. Therefore it was decided to install insulation gaskets at identified flanges. All the existing gaskets in identified flanges were replaced with insulation gaskets. This exercise was successful and provided the required electrical isolation of CP system. Immediately after this exercise the ON-OFF PSP was observed inside Dispatch Terminal A. Instant OFF PSP was more electronegative than 1000 mV (with respect to a saturated Copper/Copper Sulphate Reference Electrode). But isolation provided by these insulation gaskets lasted only for one day. After checking of these insulation gaskets it was found that there were shorting at many nut bolts of installed insulation gaskets. Therefore it is now decided to replace the IJ itself with new healthy IJ. This process is under progress.
