CASE STUDY ON PIPELINE UNDER-PROTECTION ALONG WITH MITIGATION METHODS

Vipul Vilas Sawant

Mahanagar Gas Ltd, Mumbai, India
vsawant@mahanagargas.com

This paper deals with an issue of under-protection at two of our locations – Mantralaya and Andheri:

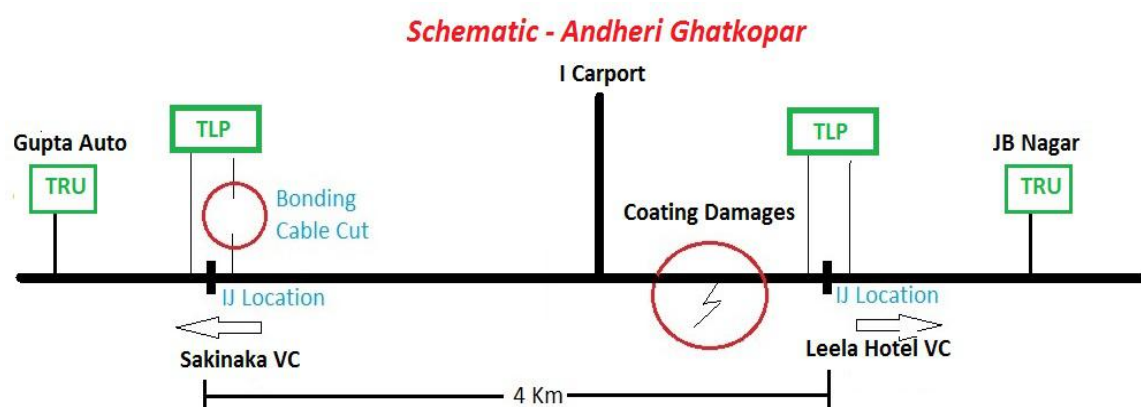
Figure 1: Schematic Diagram of Ghatkopar- Andheri Line

We have faced under-protection in this 4km of section due to coating damages and Bonding Cable Cuts.

Previously the said section was getting protection from Gupta TRU but due to cable cut at IJ location at Sakinaka VC the under protection was observed on pipeline. Then we have bonded the same stretch at Leela VC with JB TRU but again due to coating damage the CP current were getting drain at some locations due to which again the line was not getting adequate protection. The matter was further investigated. It was seen that the anode bed of JB Nagar TRU had failed and the resistance had gone upto 18 ohms. Rectification of coating damages and cable cut was not possible due to concretization of road.

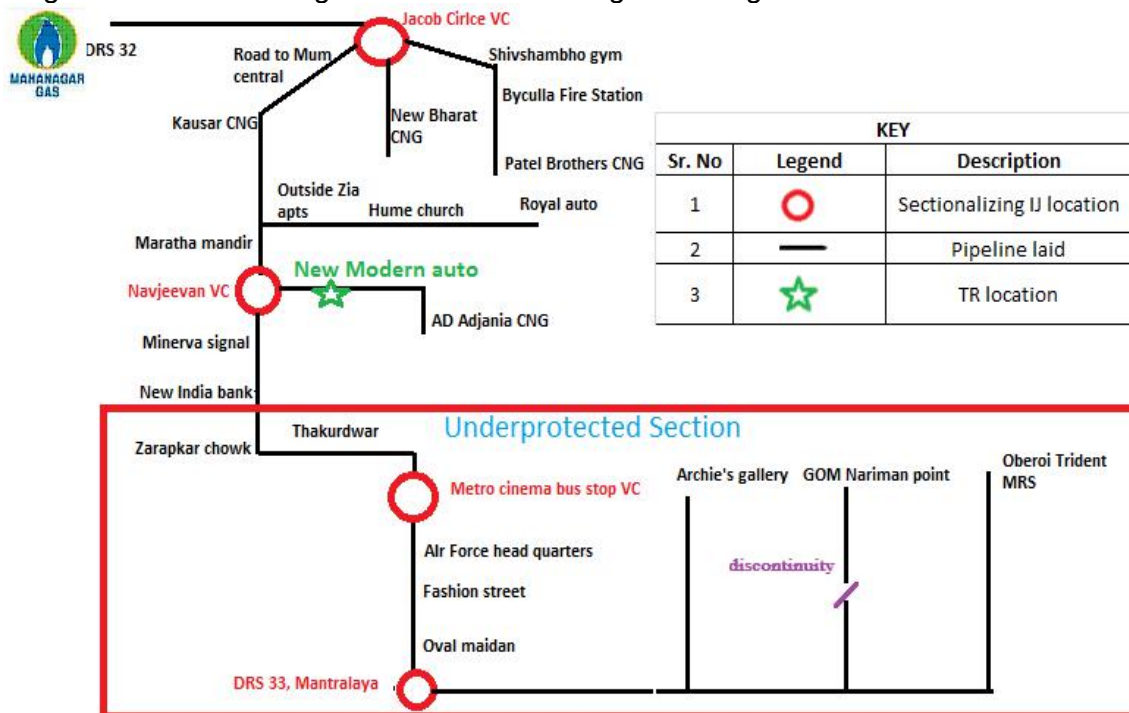
Figure 3: Schematic Diagram of Mantralaya Section

From the year 2012, we started observing under-protection issues from Mantralaya to Oberoi Trident. (4kms). We then installed temporary anodes at 4 locations (total number of 36 Mg anodes – 2.1 Kg each for 4kms). This improved the PSP for a few months after which again the values went down. Anode measurements were seen to be healthy. However the required current was not being dissipated.

The matter was investigated further. We initially carried out DCVG survey on the entire pipeline. 17 nos. of minor coating defects and 6 nos. of medium coating defects were recorded in the survey. These defects were in close proximity to each other and were spread out in a distance of 300mtrs. The under protection on 3.8km of line was not only due to addition of spur lines on main line but also due to lots of minor coating damages on line and contact with foreign water pipeline. Mostly minor faults does not contribute much to under-protection of pipeline but all 17 minor faults were on a stretch of 300mtrs contributed well in under-protection of section. All these damages were due third party excavations and during backfilling by third party after completion of work. Out of 17, 8 nos of coating damages observe due to hammering of Crowbar during third party excavation and remaining 9 were due to falling of stones/rocks during backfilling over line.

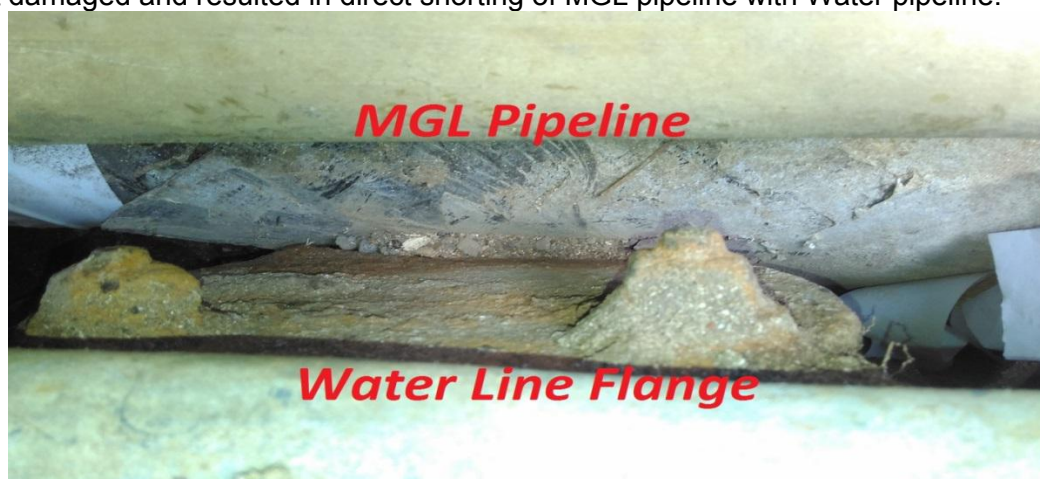
Figure 4: Shorting of MGL Gas Line and Water Line

Further, when we started rectification of remaining 6 locations, it has been observed that MGL pipeline is in contact with water pipeline flange. Due to deterioration of additional insulation sheet and pipeline factory coating at Flange location the flange came in contact with MGL pipeline. The CP current of MGL pipeline was getting drained in BMC Water pipeline, due to which the MGL pipeline was not getting adequate CP current. The bolts of Flanges were penetrating the coating with a high force which resulted in coating damage over a period of time. The insulation sheet was installed at the time of pipeline laying but after around 3 years the coating along with insulation sheet got damaged and resulted in direct shorting of MGL pipeline with Water pipeline.

To mitigate this we have inserted an insulator having life more than neoprene/ rubber sheets viz., Clock-spring. Pipeline cold wrap coating was not possible at such congested location due to inadequate space for rolling of coating rolls. To mitigate this contact we have inserted a clock-spring in between flange and pipe after application one coat of zinc based primer.

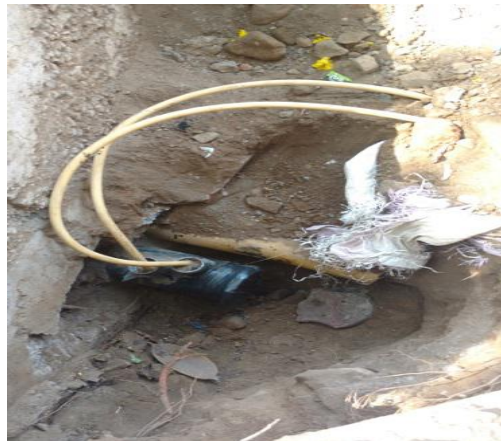
Figure 6: Schematic Diagram of Mantralaya Section

After carrying out application of Clock-spring, we have managed to obtain protection till Metro VC. Protection of whole section was not possible as the strength of anode bed degraded over a period of time as it was supplying current to BMC non-coated pipeline. Also, The cables used for the deep well anode bed were XLPE / PVC which is not resistant to chemical attack. Also due to road development, the anode bed was buried and hence there was no path for accumulated gas to escape. This may have damaged the cables over a period of time. In the present anode bed at new modern auto, only 3 anodes were seen to be conducting, out of 15 anodes that were installed. For the remaining section to brought under protection level we need to install a separate TRU but due to discontinuity of pipelines at many places it was not possible. Hence we decided to install cable jumper between pipeline to make them electrical continue and TRU installation can be made possible.

Hence we carry out current drain survey with the drain point at GoM Nariman point which is the mid-point of section considering future expansions of MGL Pipeline. After carrying out current drain survey, the requirement of section comes out to 3Amp for a section of 6km.
