CASE STUDY ON PIPELINE UNDER-PROTECTION ALONG WITH MITIGATION METHODS

Vipul Vilas Sawant

Mahanagar Gas Ltd, Mumbai, India
vsawant@mahanagargas.com

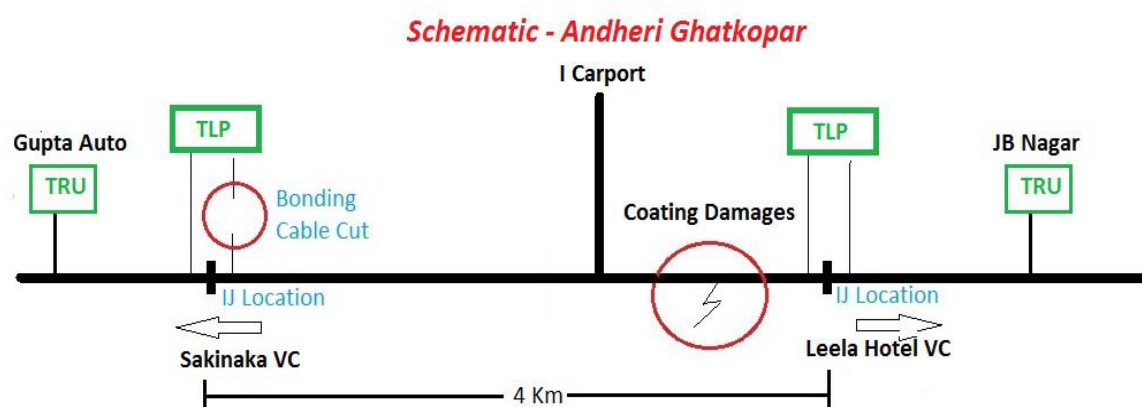
Figure 1: Schematic Diagram of Ghatkopar- Andheri Line

We have faced under-protection in this 4km of section due to coating damages and Bonding Cable Cuts.

Previously the said section was getting protection from Gupta TRU but due to cable cut at IJ location at Sakinaka VC the under protection was observed on pipeline. Then we have bonded the same stretch at Leela VC with JB TRU but again due to coating damage the CP current were getting drain at some locations due to which again the line was not getting adequate protection. The matter was further investigated. It was seen that the anode bed of JB Nagar TRU had failed and the resistance had gone upto 18 ohms. Rectification of coating damages and cable cut was not possible due to concretization of road.

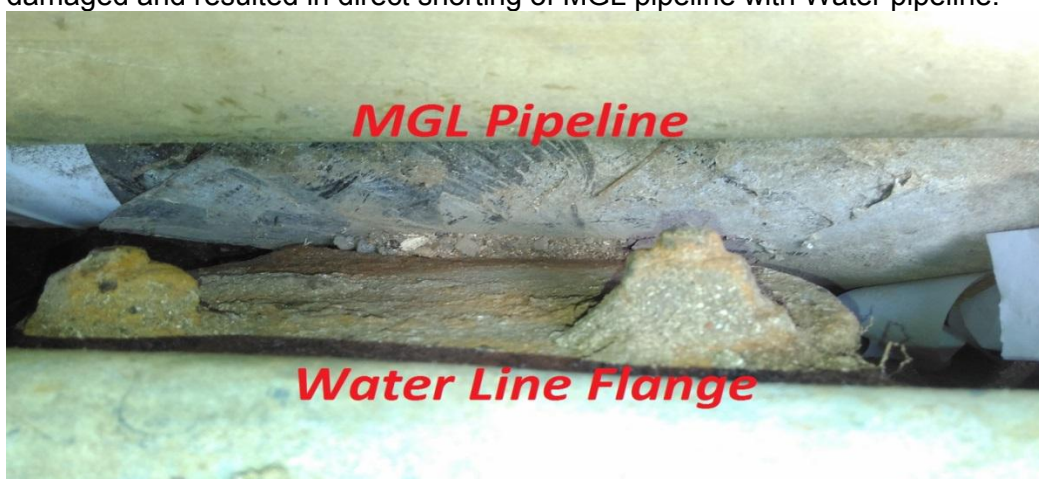
Figure 4: Shorting of MGL Gas Line and Water Line

Further, when we started rectification of remaining 6 locations, it has been observed that MGL pipeline is in contact with water pipeline flange. Due to deterioration of additional insulation sheet and pipeline factory coating at Flange location the flange came in contact with MGL pipeline. The CP current of MGL pipeline was getting drained in BMC Water pipeline, due to which the MGL pipeline was not getting adequate CP current. The bolts of Flanges were penetrating the coating with a high force which resulted in coating damage over a period of time. The insulation sheet was installed at the time of pipeline laying but after around 3 years the coating along with insulation sheet got damaged and resulted in direct shorting of MGL pipeline with Water pipeline.

To mitigate this we have inserted an insulator having life more than neoprene/ rubber sheets viz., Clock-spring. Pipeline cold wrap coating was not possible at such congested location due to inadequate space for rolling of coating rolls. To mitigate this contact we have inserted a clock-spring in between flange and pipe after application one coat of zinc based primer.

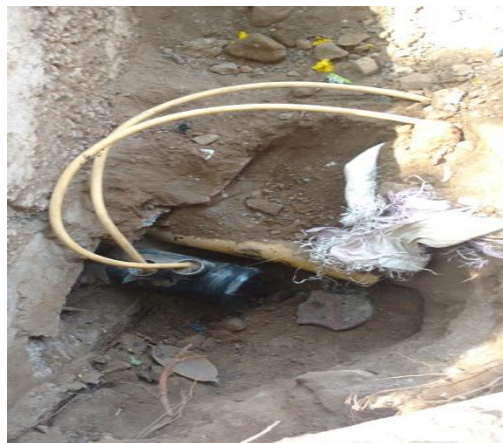
Figure 6: Schematic Diagram of Mantralaya Section

After carrying out application of Clock-spring, we have managed to obtain protection till Metro VC. Protection of whole section was not possible as the strength of anode bed degraded over a period of time as it was supplying current to BMC non-coated pipeline. Also, The cables used for the deep well anode bed were XLPE / PVC which is not resistant to chemical attack. Also due to road development, the anode bed was buried and hence there was no path for accumulated gas to escape. This may have damaged the cables over a period of time. In the present anode bed at new modern auto, only 3 anodes were seen to be conducting, out of 15 anodes that were installed. For the remaining section to brought under protection level we need to install a separate TRU but due to discontinuity of pipelines at many places it was not possible. Hence we decided to install cable jumper between pipeline to make them electrical continue and TRU installation can be made possible.

Hence we carry out current drain survey with the drain point at GoM Nariman point which is the mid-point of section considering future expansions of MGL Pipeline. After carrying out current drain survey, the requirement of section comes out to 3Amp for a section of 6km.
