CAP44

Interference & Corrosion due to HVAC power lines running parallel to cross country pipelines - Challenges in mitigation and way forward

ABSTRACT

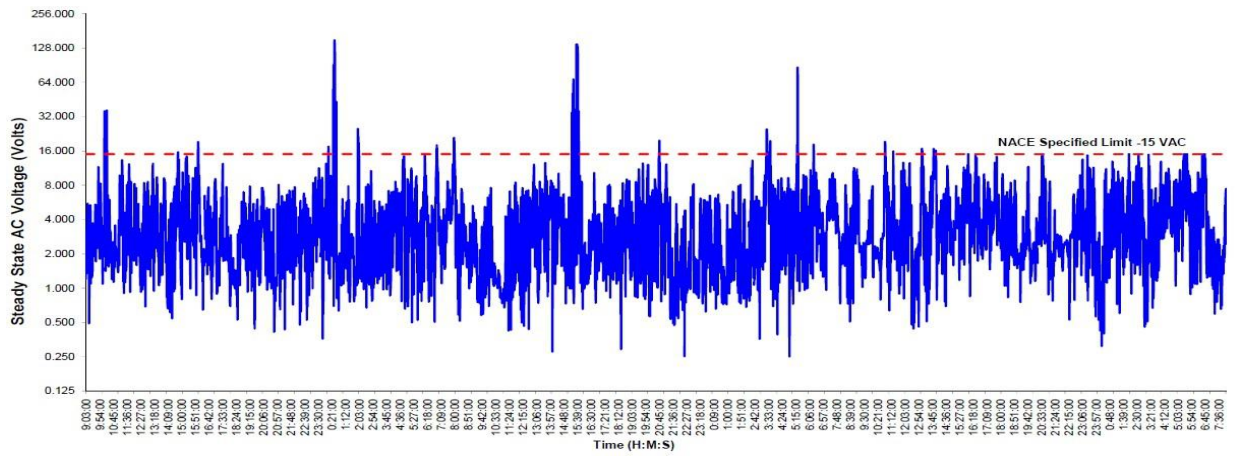
AC voltages of 159Vac and 91 Vac on pipeline was found during evening peak load hours for some chainages as given below graph.

AC voltages are also found on pipeline where the pipeline is running parallel to the HVAC transmission lines for around 75Kms

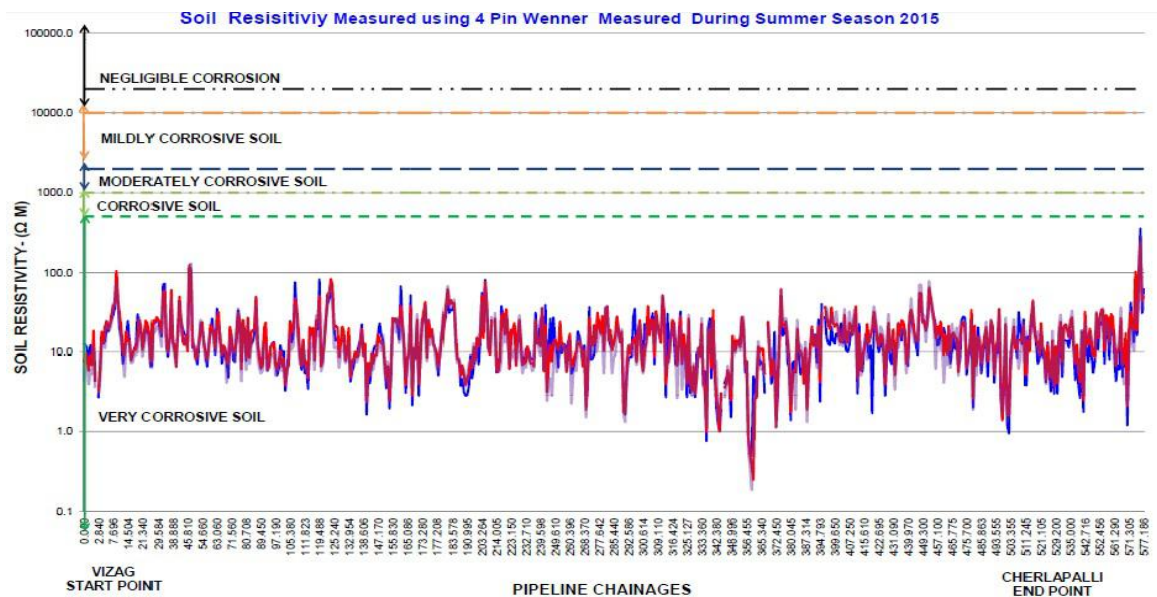
Soil resistivity in PL is very low & corrosive i.e. 100-1000 Ω -cm is shown below. Coating defects on pipeline are found of 1 to 3 cm² at time of digging at external corrosion locations.

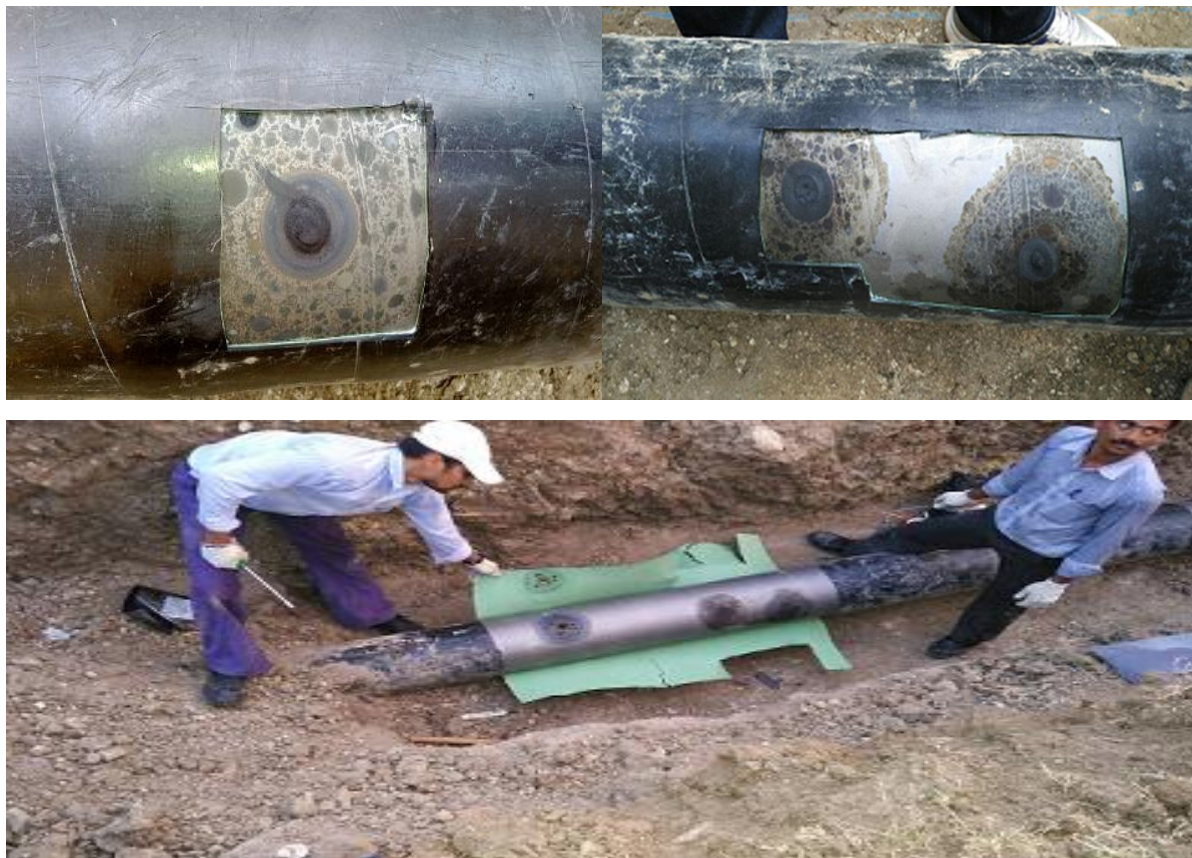
Corroded material analysis & soil sample analysis got done in lab as per recommendation of SME (Subject Matter Expert) during his site visit on 05.06.2015 & analyzed that these coating defects were due to damage during lowering of pipeline in construction period.

Figures shown below for the external defects, coatings

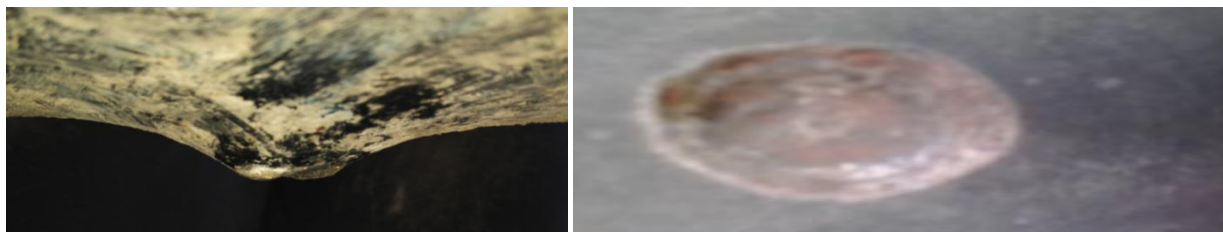
External defect of 52% metal loss

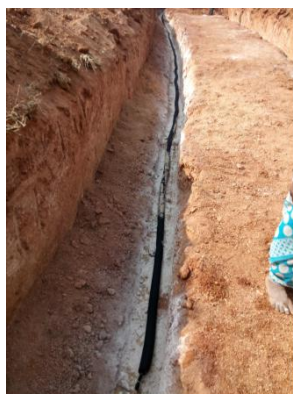
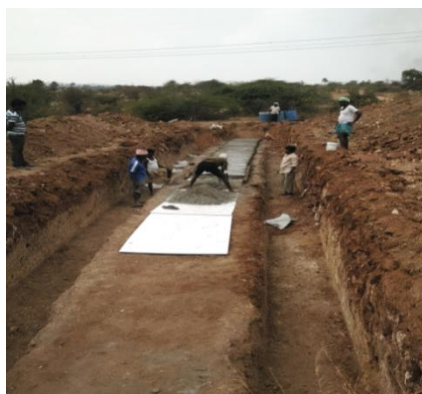
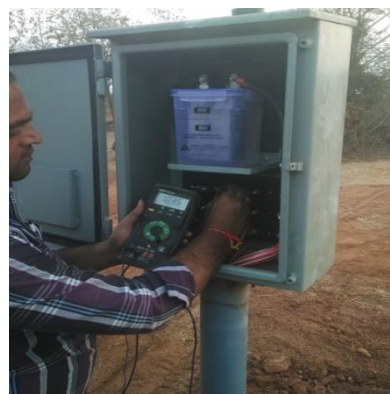
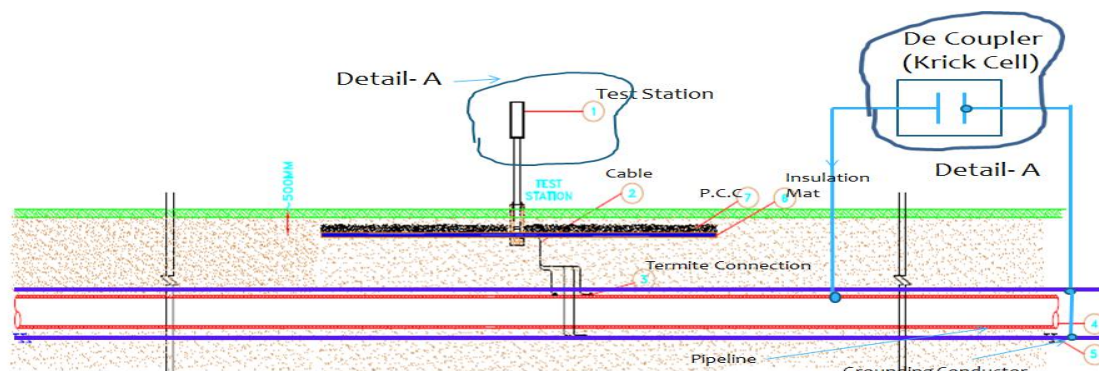
Schematic drawing shown above for mitigation of AC volates at HT crossing includes 1.Test station 2.Insulating case for grounding cable 3.cable connections on pipe 4.Pipeline 5.Grounding conductor 6.PVC mat 8mm thickness 7. PCC slab 80mm thickness

Grounding the AC voltages by installing of polarization cells in SV's with earth pits (constructing dedicated earth pits in SV's for polarization cells) and by installation of polarization cells at HT crossings with 8mm PVC mat, PCC slab with 80mm thickness and grounding conductors for reduction of inductive and conductive coupling interferences.

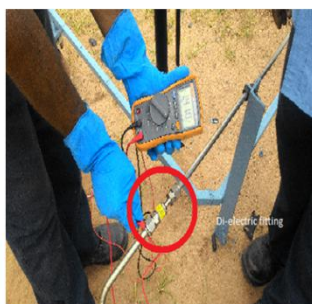
UP Stream Potential

There are PTs fitted with piping drawn out from underground pipeline to measure the pipeline pressure . As these PTs are electrically connected with Pipeline, there is a draining of CP currents from pipeline through PT body to cable armour to panel ground. Also there is a risk of availability of hazardous potentials with PT and chances of sparking at gaps.

Inorder to avoid draining of CP currents & the risk of hazardous voltages at PT during maintenance jobs by operators, dielectric fittings were installed that isolates electrical continuity from underground piping to PT.

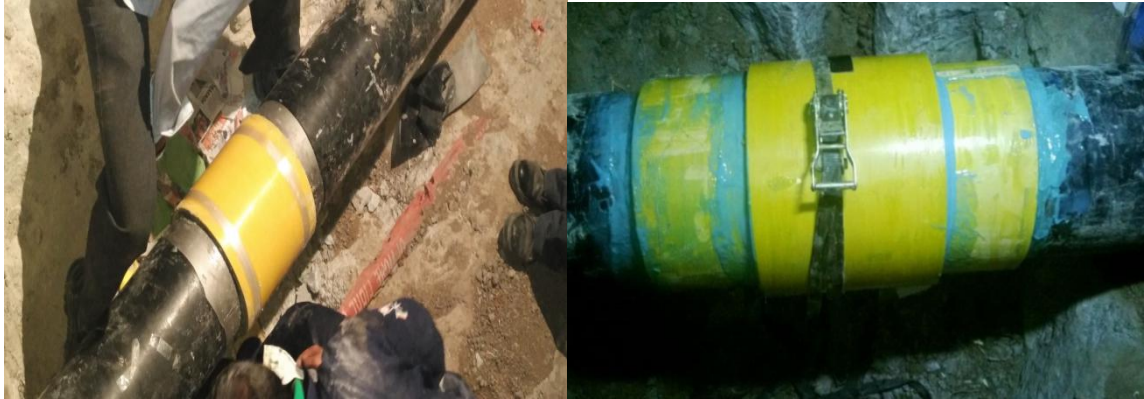
As a precautionary measure installation of composite sleeve for reinforcement and coating repairs for all major external corrosion were carried out, where the metal loss was higher than thirty percent.

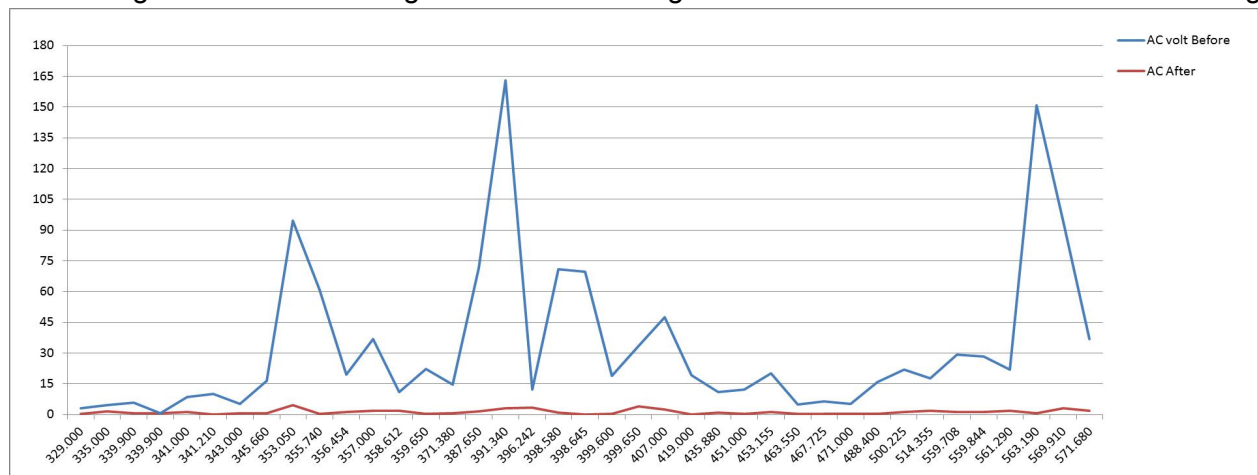
AC volatges data befor mitigation & after mitigation shown below for all HT crossing

As AC volatges has been mitigated at HT crossing and volatges after mitigation are <3 V AC.
