## **Avoid Weld Overlay Failures**

**Savio Rebello**

Reliance Industries Limited, Navi Mumbai, India  
Savio.rebello@ril.com

**NIGIS \* CORCON 2017 \* Sept. 17 – 20, 2017 \* Mumbai**

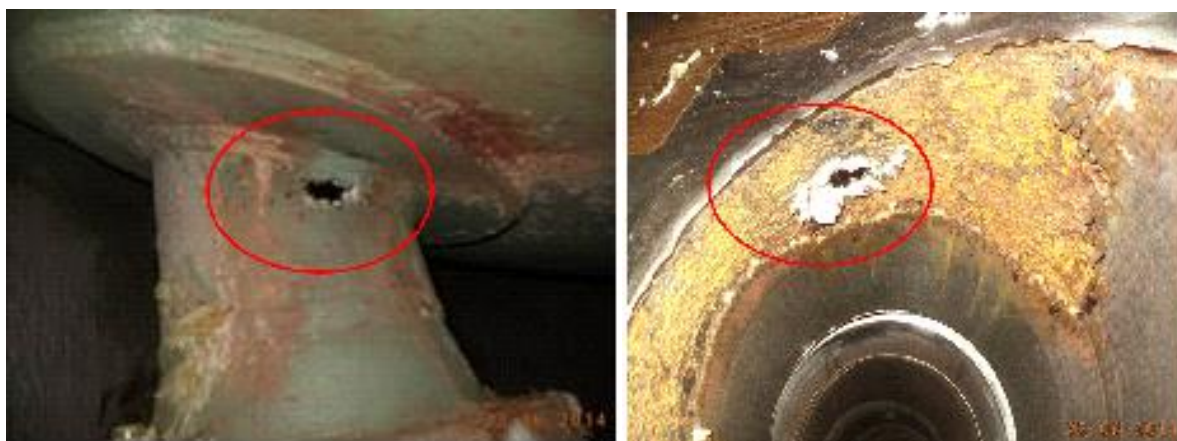
Leakage was observed from an 8” nozzle of a stripper vessel within less than two months of commissioning. Puncture was observed in the nozzle just below the weld to the bottom dish end. On internal inspection, the weld overlay of SS316L was found completely damaged for about 2/3<sup>rd</sup> of the circumference in the nozzle neck. The underlying base metal was observed to be significantly corroded.

**Figure 1: Failed nozzle: Left – view from Outer diameter; Right – view from Inner diameter**

welds. Complete inspection of the equipment was again carried out after the incident. Weld overlay damage was observed at the cut back areas of nozzle-shell attachment welds in nine nozzles with carbon steel base metal exposed. Corrosion grooving was observed at the nozzle-shell weld overlay in six nozzles and in the nozzle ID overlay in one nozzle.

Vessel cladding was unaffected. Welds in the connected piping to the vessel of the same SS316L metallurgy were internally inspected after the incident and found intact. Discoloration and rusting of the vessel overlay welds at a number of locations indicated corrosion due to inadequate weld composition.

The equipment drawing clearly stated the requirement for minimum 5 mm SS316L weld overlay to achieve min. 3 mm undiluted chemistry for nozzle neck / flange overlay, overlay at nozzle attachment cutback areas and main seam welds. However based on a later investigation, this requirement had been followed only for the overlay weld procedure qualification.

As per the procedure qualification record, total weld deposited was 7 mm in four layers. Positive Material Identification (PMI) was then carried out after grinding down to 3 mm remaining thickness and found acceptable. The welding procedure specification stated that 3 mm and above weld metal thickness was qualified. The actual overlay was flush with the 3 mm clad thickness or had reduced below the clad thickness after weld grinding and machining to achieve the local profile / dimensions. There was no recess provided in the base metal to accommodate higher overlay thickness.

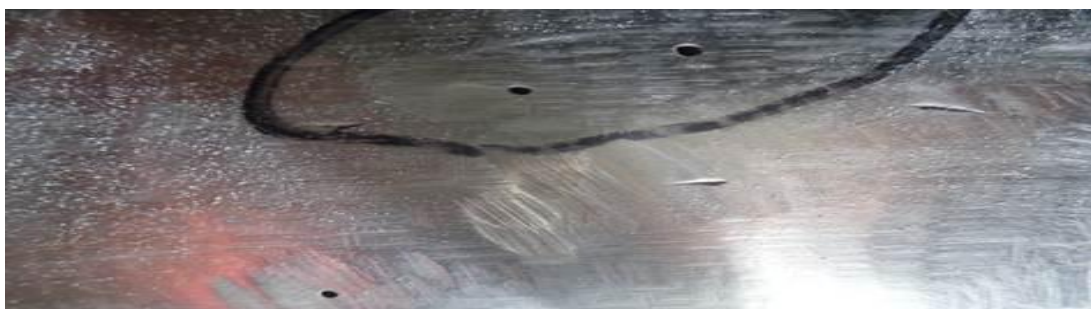
Visual inspection and DPT at the shell to top and bottom dish end joints revealed pits in the weld overlay. Weld overlay corrosion was also observed along the circumferential weld.

**Figure 2: Pits in the circumferential seam weld overlay**

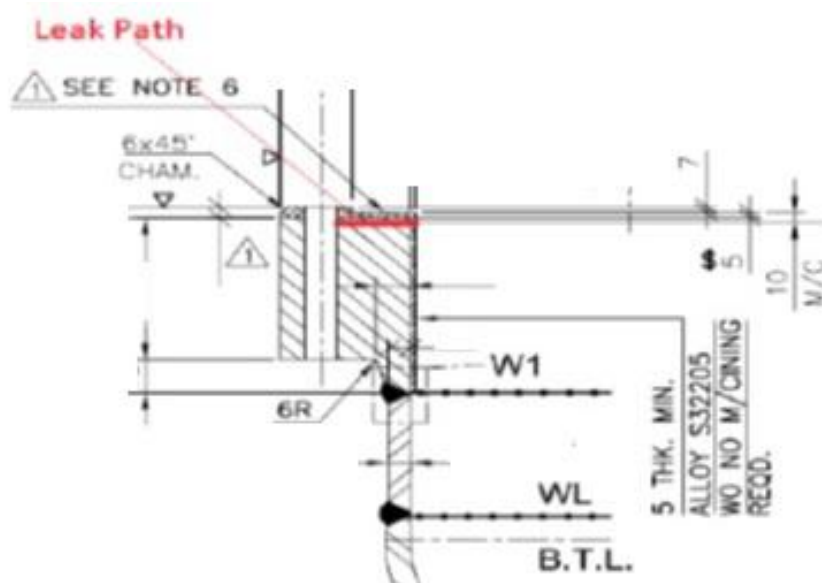
Leakage was observed from the body of the bottom channel girth flange (Figure 3) of a column re-boiler during normal plant operation. The new exchanger had been in service for less than nine months. The exchanger details were as follows:

Figure 3: Extract from exchanger drawing indicating the leak path (in red)

The exchanger drawing (Figure 3) clearly indicated minimum 5 mm thick duplex (SS2205) weld overlay on the inner diameter of the channel cover flange. The exchanger manufacturer may have complied with this requirement during fabrication of the channel cover.

However the inner diameter of the channel cover flange was later machined to enable final assembly with the mating tube-sheet flange on the shell / exchanger body. This machining was done without any reference to the client or the third party inspection agency. This significantly reduced the overlay thickness and brought the diluted weld composition in contact with the process fluid.

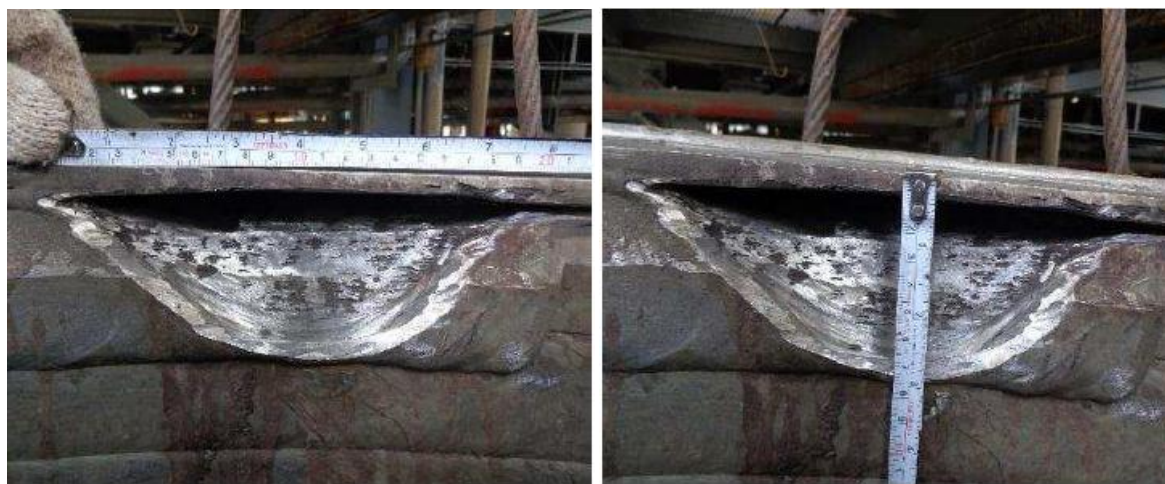
Internal inspection, after dropping the end cover, revealed corrosion damage in the weld overlay area at number of locations around the inner circumference of the channel cover just below the flange face. Corrosion had created a gap in the overlay at the leak location. Grinding of the overlay in this area revealed extensive metal loss of the underlying parent material (Figure 4). The affected

Longitudinal and circumferential seam welds in the solid duplex shell and dome of the channel cover were not affected. Similarly welds in the connected duplex piping to the vessel were inspected after failure and found intact. However the duplex weld overlay on the channel flange inner diameter, just below the gasket seating face, showed discoloration and corrosion. This clearly indicated inadequate weld chemical composition.

**Figure 4: Extent of metal loss in the underlying base material under the overlay**

area was repaired by weld build-up and duplex overlay as an immediate measure. The channel flanges were then replaced with solid duplex (SS2205) flanges at the next opportunity.

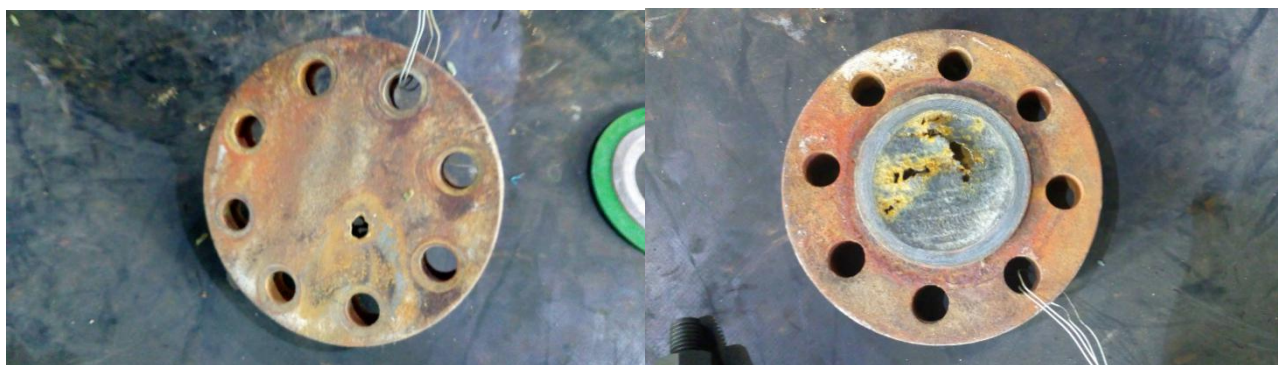
Acid fumes were noticed from the nozzle end blind (2" 300#) of a column during normal operation. The end blind was found holed through in the central portion. Material of

**Figure 5: Failed end blind – External surface (left); internal surface (right)**

The end blind weld overlay was analyzed after the failure. The thickness of the weld overlay was found to be 1.6 to 1.9 mm instead of 3 mm (Overlay thickness at other locations as per drawing). The surface overlay weld composition was found to be significantly diluted with up to 24% iron (Fe). Comparison of the required monel composition with actual composition of the weld overlay is given below.

This end blind was never opened during periodic internal inspection of the column. All nozzles are customarily blinded / spaded for vessel entry during such inspections, as a safety requirement. Hence the overlay damage went un-noticed until failure.
