Severe Under-deposit Corrosion Damage in Suction Headers of Compressor House in LPG Recovery Unit

Indian Oil Corporation Ltd, Guwahati Refinery, India
manojk@indianoil.in

Keywords: Sour water, compressor, LRU, Under deposit

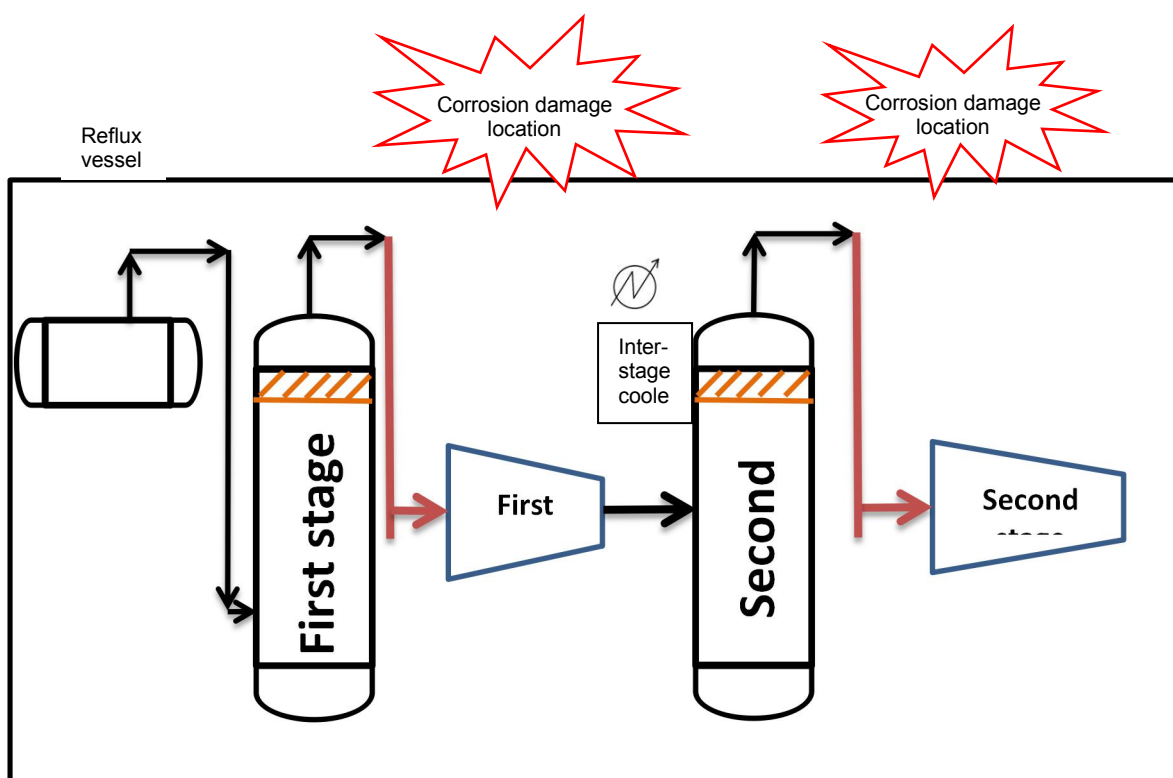
Figure 1: Process flow diagram of suction headers in compressor house in LPG Recovery Unit

The LRU unit at Guwahati Refinery has been set up for LPG recovery from off gas of the crude distillation unit (CDU) and DCU, Figure 1. In the LPG Recovery unit, off gas from the reflux vessel of the MF column passes through the 1st stage knock drum and strainer and compressed in the low pressure (LP) compressor. Compressed gas cools down in the inter stage cooler and subsequently passes through the 2nd stage knock out drum followed by the strainer. It is then compressed in the 2nd stage pressure (HP) compressor, and the final compressed gas is further processed in the rectifier and absorber column for LPG recovery. (Ref: 3)

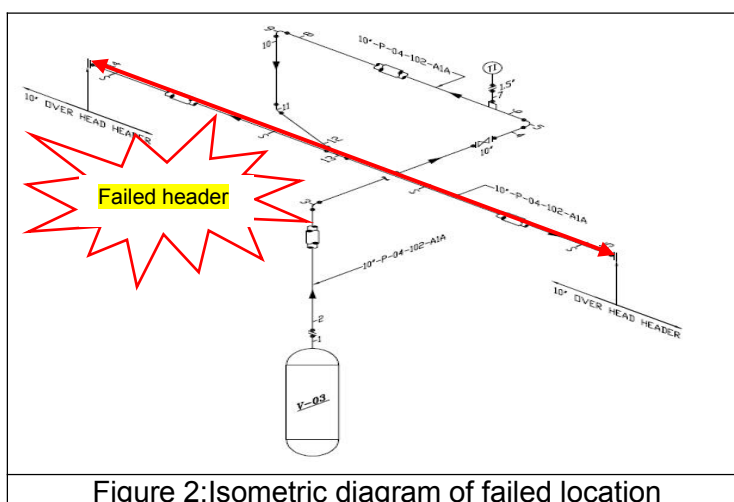
Thinning in the LRU compressor suction headers (12" dia. and 10" dia. lines, Figure 2) was observed between a span of approx. three years 2013 to 2016 during process change. General corrosion was observed throughout the internal surface with severe metal loss noticed at the 6 o'clock location of both the suction headers. The amount of damage was found less severe in the suction piping of the 2nd stage compressor. Corrosion was observed to be aggravated due to under deposit corrosion arising from coke fines deposition.

As a short term measure, the corroded headers have been replaced with new ones with existing carbon steel metallurgy and put in service.

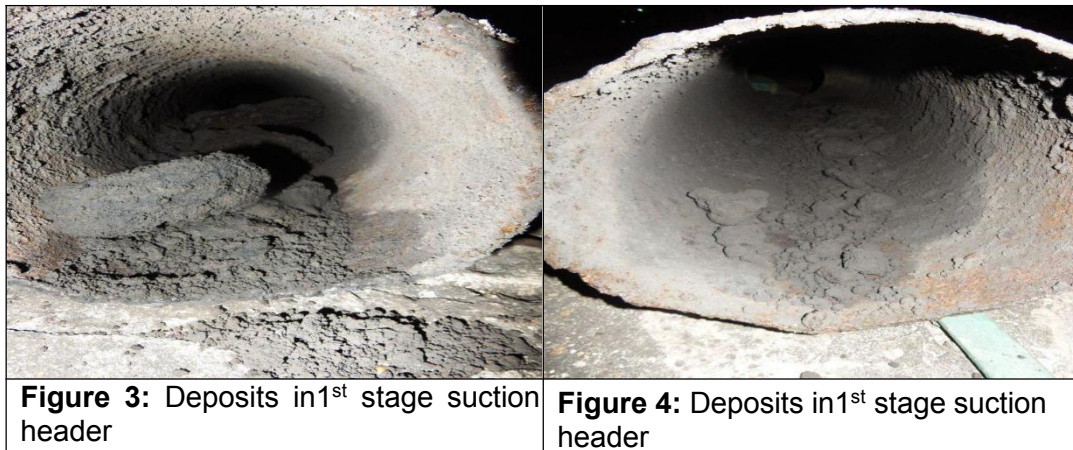
After cutting the header, lumps of black color moist coke fine deposit were observed in both the suction headers, which is in the horizontal section of the circuit. Volume of deposits was less in the 2nd stage header (Figure 3, 4). The deposits were cleaned by water jets, and it was found that the deposits were highly soluble in nature.

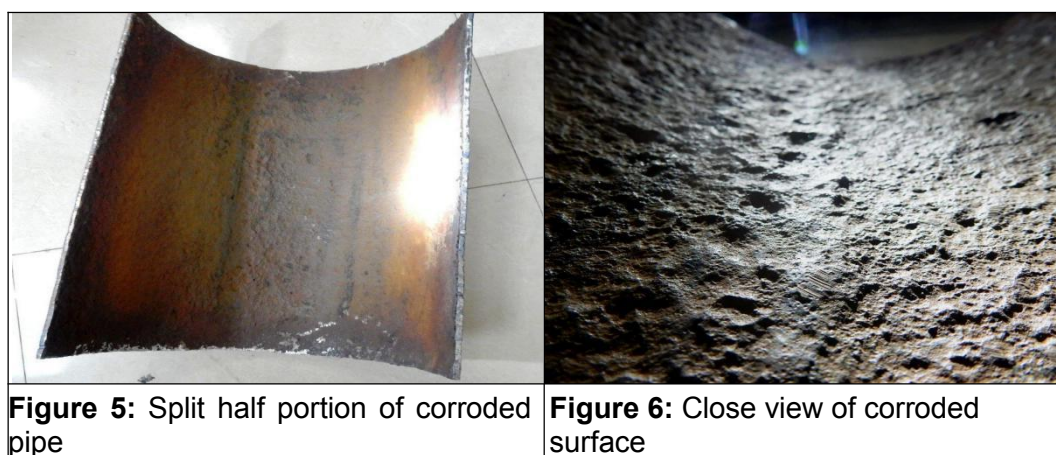
A sample of the damaged pipe piece was split for internal inspection. The internal surface of the pipe was found severely rusted (Figure 5). General corrosion and pitting were observed throughout the internal surface with severe metal loss noticed at the 6 o'clock location of both the suction headers. Pitting depth was approx. 1.5 to 2.0 mm (Figure 6). Minor corrosion was observed in the upper half section.

H_2S of the fluid in the presence of moisture at temperatures of $40\text{--}50^\circ\text{C}$ resulted in sour water acid corrosion of the piping with the characteristic of general corrosion. The corrosion was aggravated due to coke fines deposits in the headers with the characteristic of severe under deposit pitting corrosion.

High concentration of H_2S tends to increase the acidity of the solution. With higher temperature, concentration of H_2S decreases and hence the acidity of solution. At pH value 4.5 or more, a thicker porous sulfide film layer forms (Refer: 2) which lead to under deposit pitting corrosion, which is further multiplied by hygroscopic coke deposits.

1. Operate the unit within design pressure condition i.e. >0.75 kg/cm².
2. Maintain H₂S within design limit (0.5 wt %) although this is inevitable as presently there is no any facility of reducing H₂S in the stream.
3. Effectiveness of demister pad meeting with the high flow should be reviewed to ensure maximum elimination of moisture
4. Flush headers annually during the steam air decoking shutdown.

5. Monitor critical Corrosion Monitoring Locations (CMLs) with higher inspection frequency.
6. Metallurgy up-grade of suction header to SS 316 to accommodate process change.

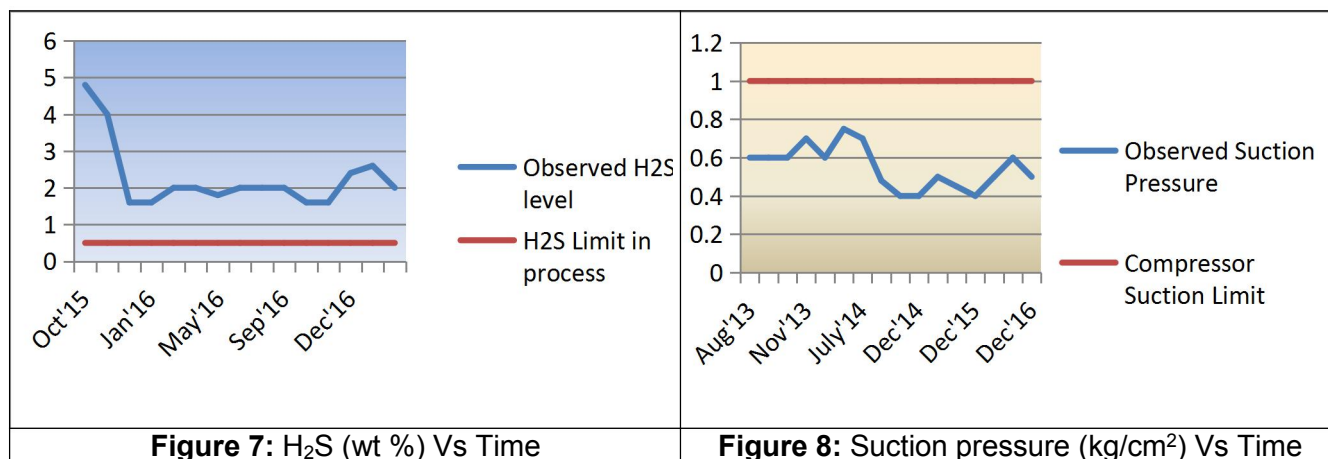
Figure 7: H₂S level in process fluid vs. Time

Figure 7 depicts that against the design limit of 0.5% H₂S in the process fluid, the system had been operated with up to 4 wt% of H₂S over the time period. High H₂S favors the corrosion mechanism taking place in the system.

Figure 8 shows that the compressor had been operated at low suction pressures up to 0.4 kg/cm² versus the general recommended suction pressure of ~1.0 kg/cm². Low suction pressure operation resulted in operation of the unit at high throughput.

Figure 9 describes that; unit was operated with flow rates up to 6200 kg/hr against the design capacity of 4400 kg/hr. This high flow was favorable for carryover of extra moisture and coke fines.

The feed of LRU, i.e. Off gas, is designed to have a maximum limit of 0.5 wt% of H_2S whereas Figure 7 revealed a higher limit of H_2S up to 4.8 wt%. The compressor of the unit was operated at a low suction pressure 0.4 kg/cm^2 (Figure 8) to maximize the process flow and increase the LPG production. The unit was operated with a flow rate up to 6,200 kg/hr. Moisture separation near to 100% from the stream is designed to be carried out in the KOD vessel with the help of a demister pad for a process flow rate 4,400 kg/hr. Higher flow (Figure 8) led to extra moisture and coke fines carryover with the stream. Coke fines carried with the fluid kept on accumulating and depositing in the horizontal portion of the circuit, i.e., the headers. Coke fines were observed in the 2nd stage headers also but to a lesser amount due to the use of a strainer, but of lower mesh size.

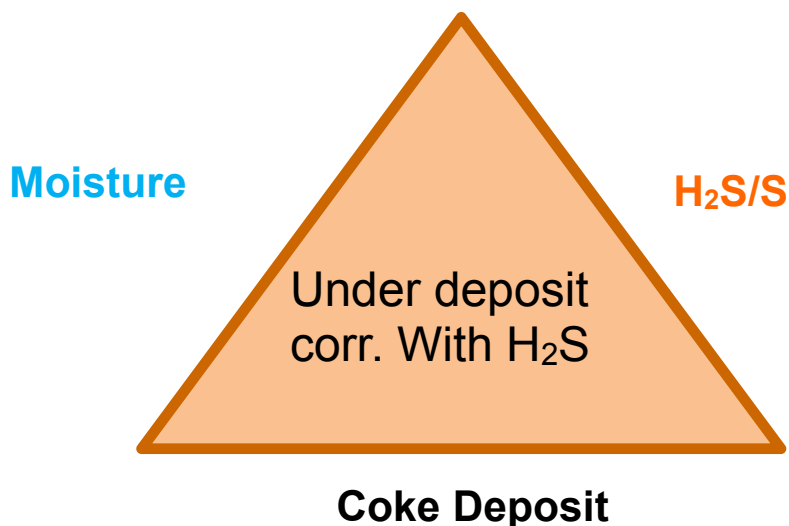
Figure 10: Corrosion Triangle

For better understanding of the corrosion mechanism with different affecting factors, a corrosion triangle was made, Figure 10.

Process data, graphs and wet analysis in the laboratory revealed that high H₂S of the system in the presence of moisture caused corrosion in the headers. Additionally, severe under deposit corrosion was facilitated due to favorable hygroscopic coke fines deposits coupled with favorable temperatures in the range of 40-50°C. It is clear from the corrosion triangle that among the three conditions, preventing at least any one will minimize the damage impact.

To prevent the moisture and coke fines carryover in the system, the stream flow should be maintained within designed limits, and the removal of the deposited coke at a fixed frequency is highly desirable.
