Hydrogen Blistering in Stabilizer Overhead LPG Condenser of Naphtha Splitter Facility

Indian Oil Corporation Limited, Guwahati Refinery, India
Email: zodapesj@indianoil.in

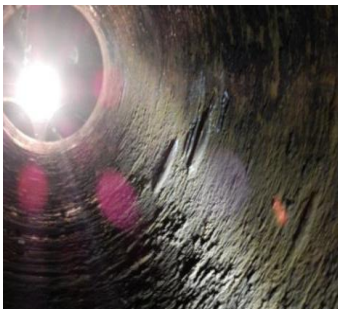
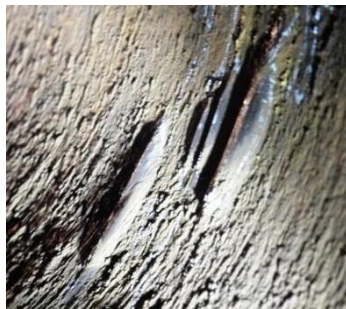
Visual examination revealed hydrogen blisters on the heat exchanger shell id and external surface of all the overhead condensers. The hydrogen blistering was randomly distributed and the quantity of blistering varied in nature for different exchangers. The diameter of the blisters observed varied from 2 mm to 4 mm in diameter. Thickness measurements were done at all the blister locations and shell plate where the surface appeared to be smooth. Thickness measured at the blister location was 3.7 mm where it is suspected to have lamination or internal rolling defects.

Figure 2 and 3: Blister on shell ID

- As per the past history of the stabilizer overhead condenser no observations of blistering were recorded on the id side of the exchanger shell. Due to operational requirements, high H₂S feed was processed for short duration of 4-6 months which caused blistering in the overhead condensers. The operating temperature range and operating conditions made hydrogen damage phenomenon to be very conducive.

- The existing facility of caustic dosing was reviewed and an increase in caustic strength was recommended when high H₂S feed is processed.
- To take care of corrosion, provision for specialized corrosion inhibitor like polysulfide dosing provision in the existing system is under review.
- All the stabilizer overhead condenser shells are planned for replacement in the near future with carbon steel NACE Material - killed steel normalized condition.

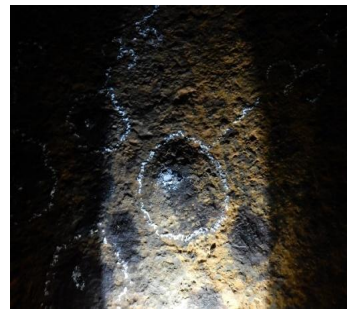
Figure 4: Blister after puncture

- To avoid further damage to shell and as an immediate measure, all blisters were punctured using a 2 mm dia. drill. The release of the gas will not allow the existing blisters to grow further which otherwise could lead to cracking.
