Failure Analysis and Integrity Assessment of Aging Boiler Bank Tubes of HRSG

Maushumi Kakoti Talukdar, Abhay Kujur and Anil Bhardwaj
IEOT, Phase II, ONGC , Panvel- Navi Mumbai, Maharashtra-410221
Email: Kakotit_mausmi@ongc.co.in

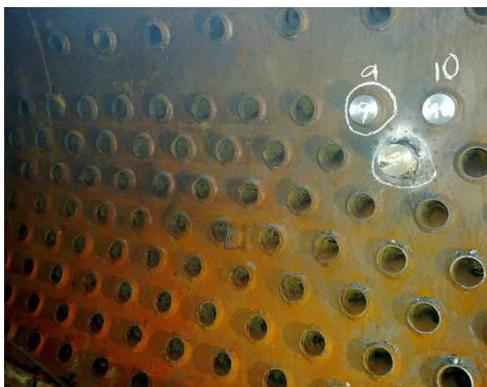
Figure 1: Boiler bank tubes of HRSG I

- The OD of the tube was 51.2 mm and the ID was 43.2 mm.
- There was no external corrosion.
- Internal surface of the tube did not have metal thinning.

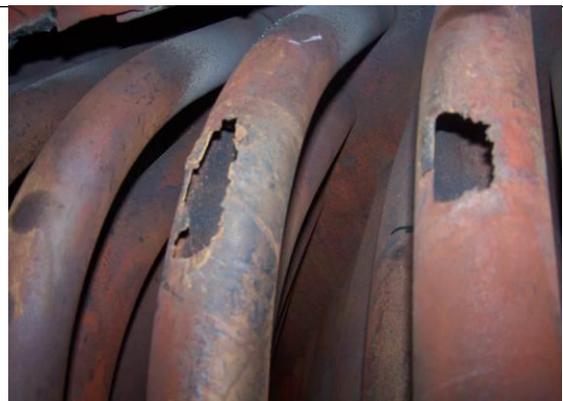
Figure 2: Failed tubes of HRSG-II

- The OD of the failed tube was 51.2 mm and the ID was 43.2 mm.
- There was no external corrosion.
- The tubing had ruptured at the outer periphery of the elbow of the tubes.
- There was a big hole of 60mm length and 20 mm breadth. Metal near the hole had thinned down to the extent of 0.88 mm (Figure 2).
- Internal surface of the tube did not have metal thinning except near the hole. Internal corrosion typical of flow assisted corrosion was observed at the 12 O'clock side of the bend.

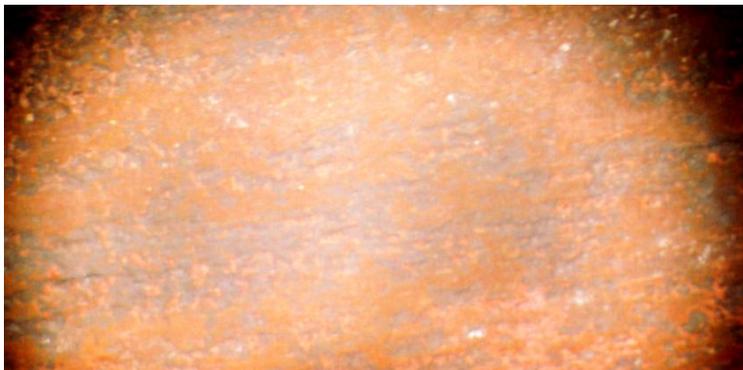
Under the stereomicroscope, directional pattern of attack from Left to right typical of flow assisted corrosion were observed at the outer surface of the bend. Such marks were absent at the other parts of the bend.

Figure 3: Internal attack in the HRSG-I showing the directional pattern typical of Flow Accelerated Corrosion (FAC)

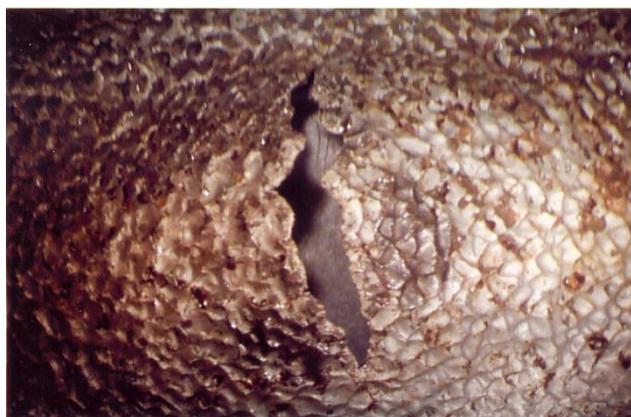
Features typifying the flow accelerated corrosion were more pronounced in the failed tube sample of HRSG-II. Scallops and directional pattern of internal attack at the outer surface of the elbow typical of FAC were clearly visible.

Figure 4: Internal attack in the HRSG-II showing the directional pattern typical of Flow Accelerated Corrosion (FAC)

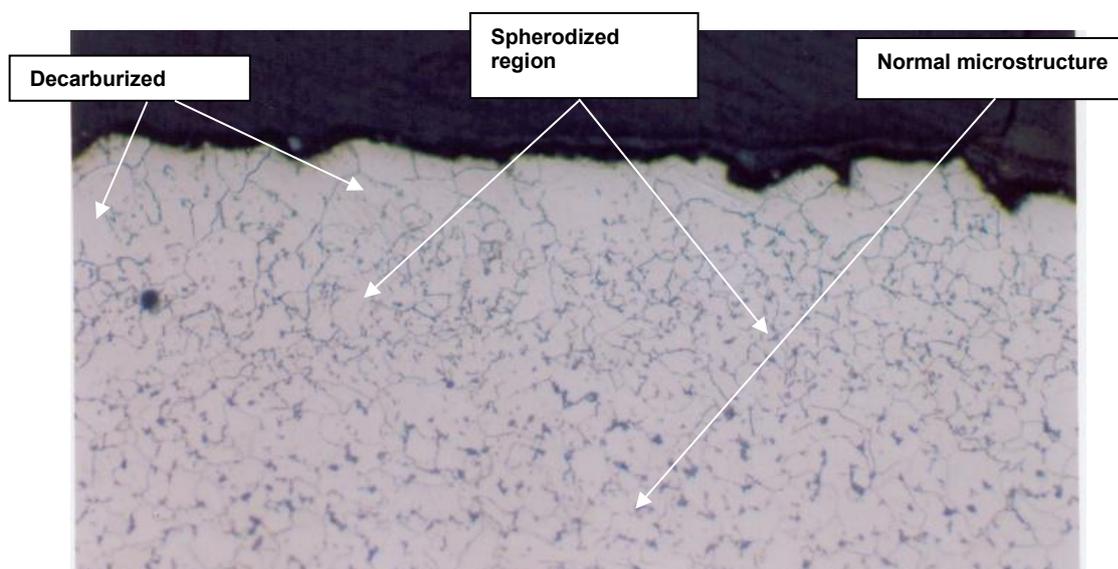
Figure 5

The microstructure of the parent metal revealed uniformly distributed pearlite in the matrix of ferrite.

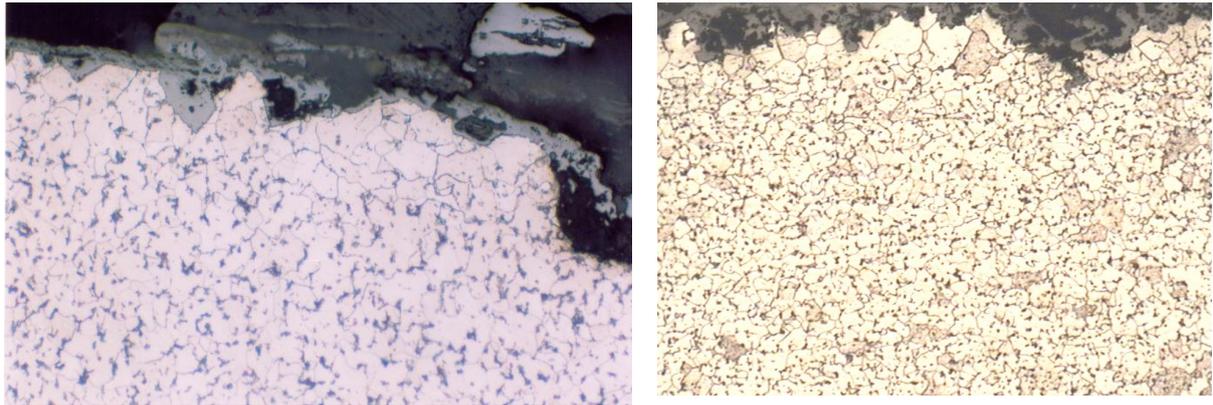
Due to prolong heating of tubes at the sub critical temperature range, spheroidization of the pearlite had taken place. Lamellae of cementite in the pearlite had broken at the ferrite grain boundaries. Both the internal as well as the external surface of the tube had undergone decarburization as well as metal loss in intergranular manner (Figure 5). The microstructural features observed on the tube sample of HRSG-I (Figure 6) was identical to those observed on the failed sample of HRSG-II (Figure 7).

Figures 6 and 7: Internal surface of the tube of HRSG I&II showing ferrite pearlite microstructure and intergranular metal loss. (Mag.-200 X ,Etchant-2% Nital)

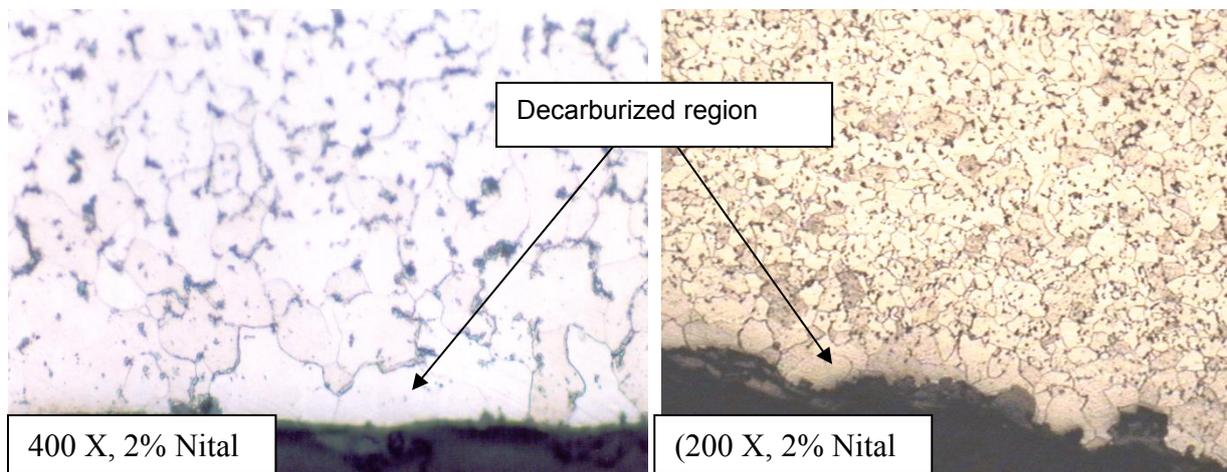
Figures 8 and 9: External surface of the tube showing distinct band of decarburized microstructure and intergranular metal loss in the decarburized zone.

The metallographic studies confirmed the ferrite pearlite microstructure of a carbon steel material. It also suggested that the material had undergone spheroidization and decarburization due to prolonged heating in the subcritical temperature range and metal loss had occurred both on the external and internal surface of the tubing in an intergranular manner (Fig 8&9). The features observed on the tube sample of HRSG-I (Figure 8) were identical to those observed on the failed sample of HRSG-II (Figure 9).

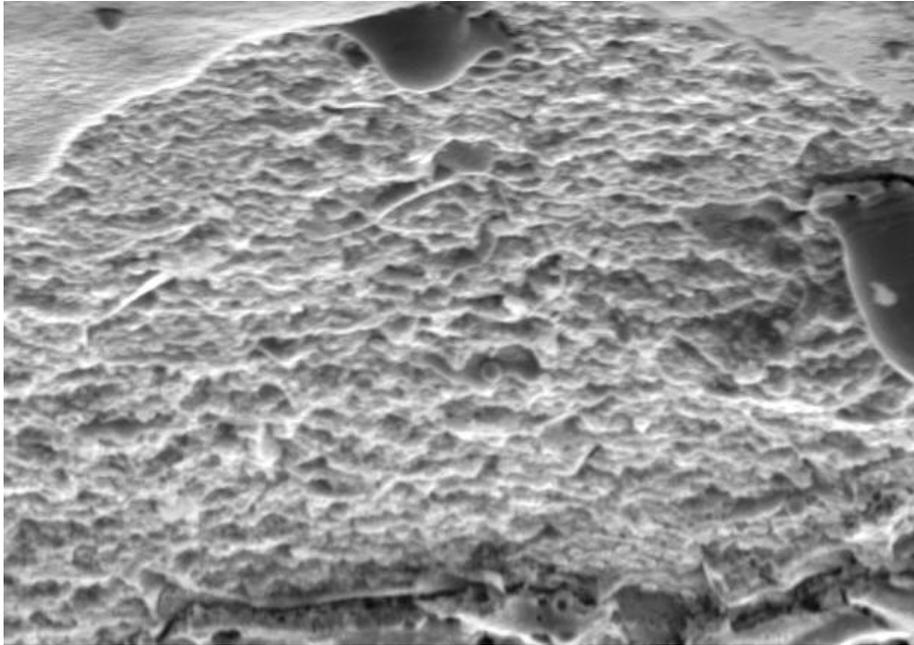
At the outer bend of the tube sample, morphology typical of FAC attack was observed in both HRSG I (Figure 10) and HRSG II (Figure 11) samples.

Figure 10: Scallops typical of FAC as observed at the outer bend of HRSG-I.

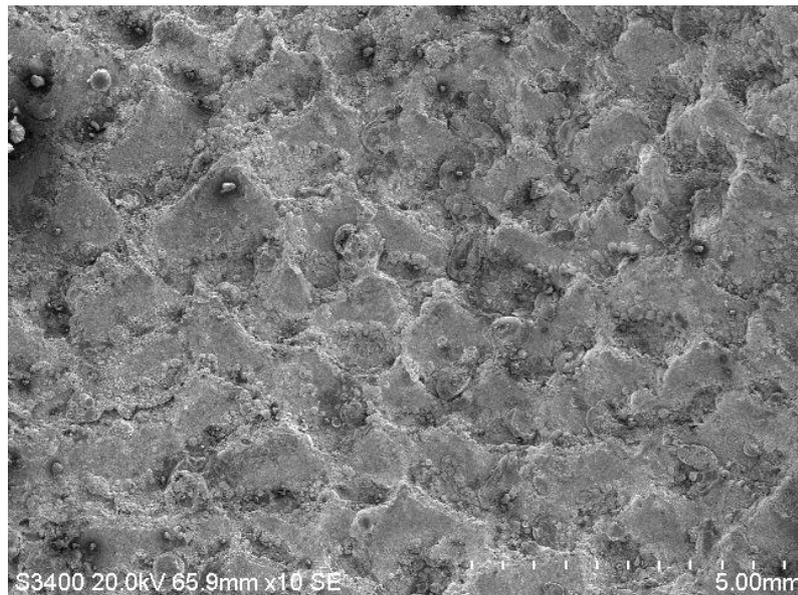
Figure 11 : Scallops typical of FAC as observed on the failed sample of HRSG II.

In the case of the tubes of HRSG-II, FAC in consonance with similar microstructural changes resulted in the direct removal of iron from the internal surface of the tube. These metal particles in turn became abrasive to internal surfaces and potentially accelerated the rate of metal loss from the tube surface by erosion which consequently led to its failure.

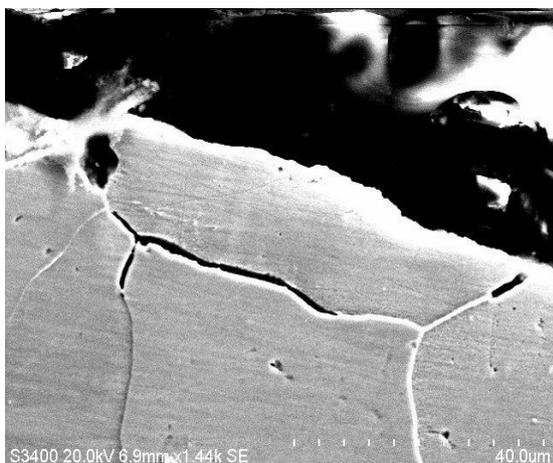
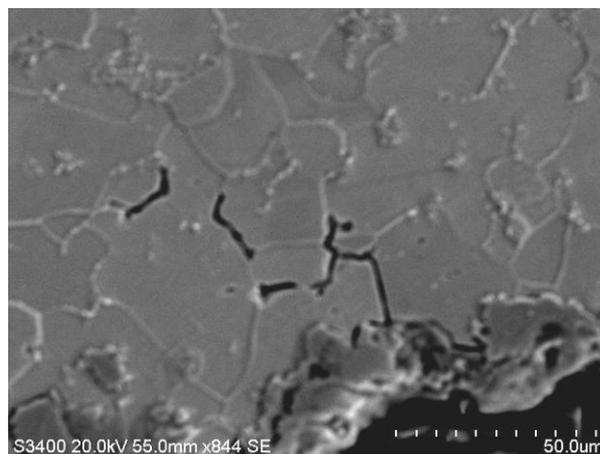
SEM observation of the etched specimen prepared from the transverse section of tube sample revealed distinctly the intergranular metal loss in the decarburized region both for HRSG I (Figure 12) and HRSG II (Figure 13).

Figures 12 and 13: Decarburization and intergranular metal loss as observed on the etched specimen of the tube samples of HRSG-I and II.

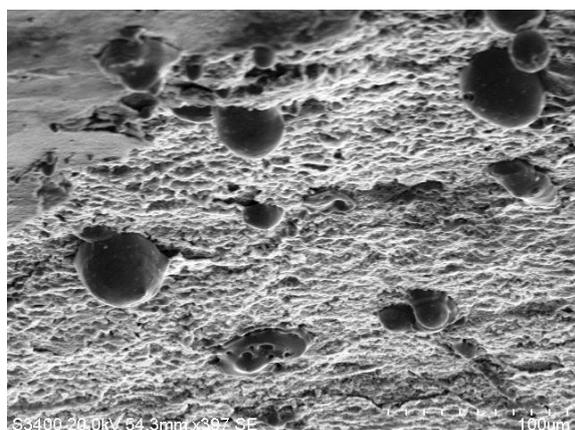
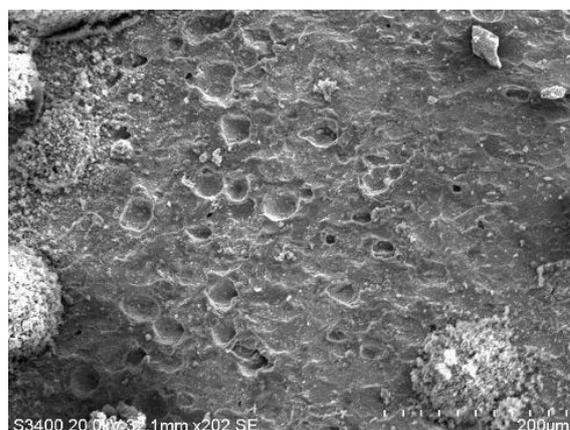
Figures 14 and 15: Metal loss in the form of pits on the tube surfaces of HRSG-I and II as observed under SEM.

The SEM study revealed features typical of flow assisted corrosion (FAC) attack on the tube samples of HRSG-I and II. The etched samples prepared for metallography were observed under SEM and decarburization and removal of grains in intergranular manner were also observed (Figures 12 &13). Metal loss in the form of pits was also observed on the tube surfaces of HRSG-I and II (Figures 14 & 15).
