**Liquid Metal Embrittlement in Outlet Pigtailed of Reformer of Hydrogen
Generation Unit in Digboi Refinery**

outlet pigtails and caused huge flash of fire. Such failure caused shutdown of the Hydrogen unit for substantial amount of time. This paper describes about the LME (Liquid Metal Embrittlement) in Alloy 800HT reformer outlet pigtail tubes which finally resulted in fire & property loss.

Keywords: HGU; Reformer; Pigtail, Liquid Metal Embrittlement, Alloy 800 HT, Molten Metal Corrosion

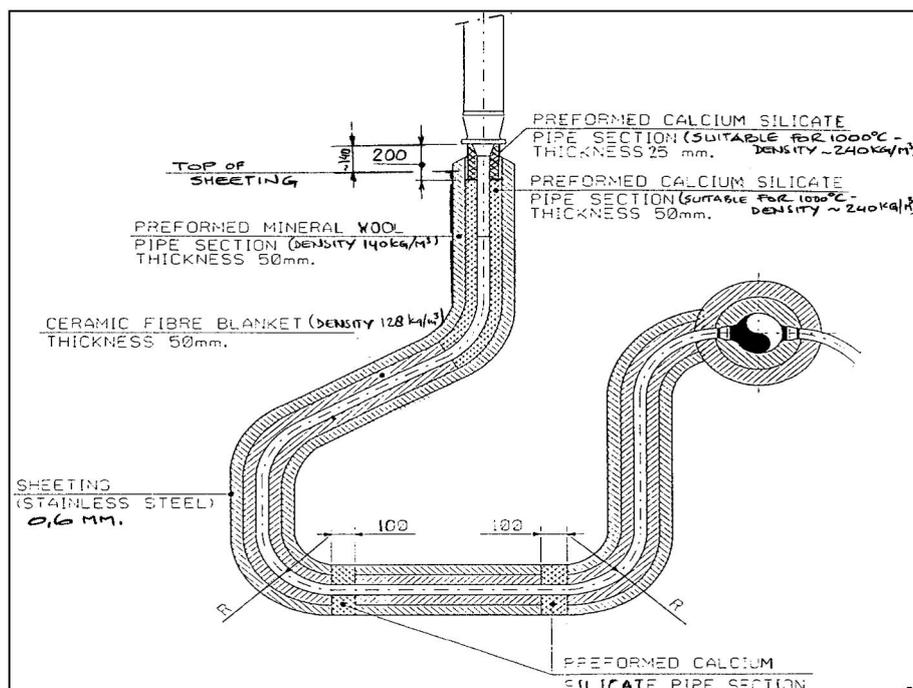
Figure 2 Design and Insulation Details of Outlet Pigtail

The Unit was commissioned in the year 2003. In April 2009 turnaround, rectification of the insulation of the outlet pigtails in Row-A was carried out as per original specification (refer Figure 2). However, the outlet pigtail tubes (20Cr-33Ni) were inadvertently wrapped with Aluminium foil. After completion of the maintenance job, the unit was commissioned on May 07, 2009. After 3 days of operation, on 10th May 2009, in the morning shift, huge flashes of fire was reported at 2 nos. outlet pigtail tubes. Subsequently, the unit was brought down.

Consequently, application of stainless steel foil has been made mandatory for all high temperature piping and other applications. The system was further strengthened with three-stage (i.e. before-during-after application) PMI check.

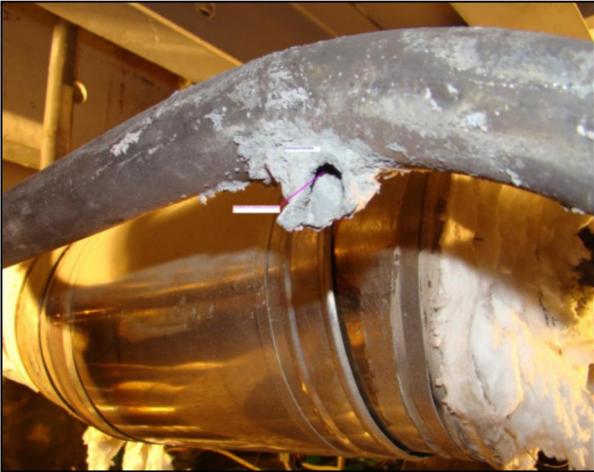
Following the unit shutdown, the reformer tubes were pneumatically tested with nitrogen at 5.5 Kg/cm²g. Leaks were detected at six locations in Row-A outlet pigtails. At the outlet pigtail of tube 2, leaks at two locations were found while one leak each at outlet pigtail of tubes 01, 11, 12 and A13 was observed. No leak found in outlet pigtails of Row B tubes.

Figure 4 Failed Tube

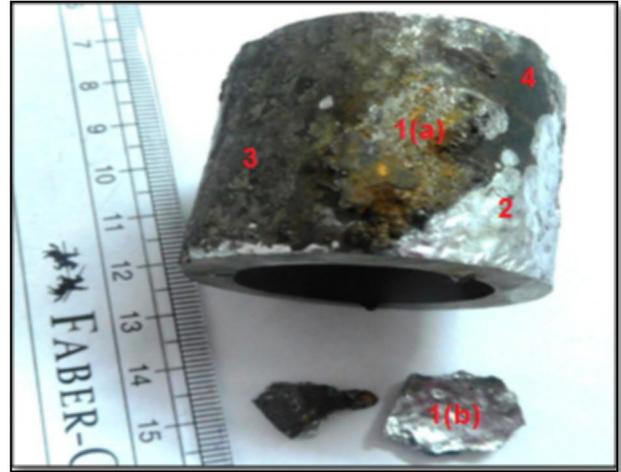
Figure 5 Cut Sample piece of the Outlet Pigtail Tube (1(a) &(b)- Adherent Oxide Layer; 2-Chipped Surface; 3-Greyish Tube surface; 4- Greyish-black oxide layer)

On close observation of the outlet pigtail tubes, various surface features were observed. As seen in Figure 5, an adherent oxide layer having rough texture with uneven profile was observed on the outer surface of the outlet pigtail tubes at many locations. The surface of the cut section of one of the tube was exposed by chipping away the oxide layer. A shiny silver-like uneven surface was observed with pit-like localized, closely spaced metal loss. A shiny dark grayish uneven surface adjacent to the adherent oxide layer was also observed. The rest surface of the tube had thin grayish-black oxide layer with smooth profile indicating in-service oxidation of the tubes. All the surfaces were checked using XRF based Positive Material Identification (PMI) to establish the composition of the observed surfaces.

PMI of the sample piece was done at locations as marked in figure-5 and the results are as tabulated in Table 1. At cross section of the tube i.e. in middle portion, PMI revealed Alloy 800 HT and no deviation was observed. The composition of the inner side of the chipped out oxide layer (1(a) & 1 (b)) predominantly had Aluminium, which implies the melting of the Al-foil over the tubes. The bright shiny surface (2) shows that Chromium has depleted at the surface. At the greyish-black oxide layer, chromium was found in excess.

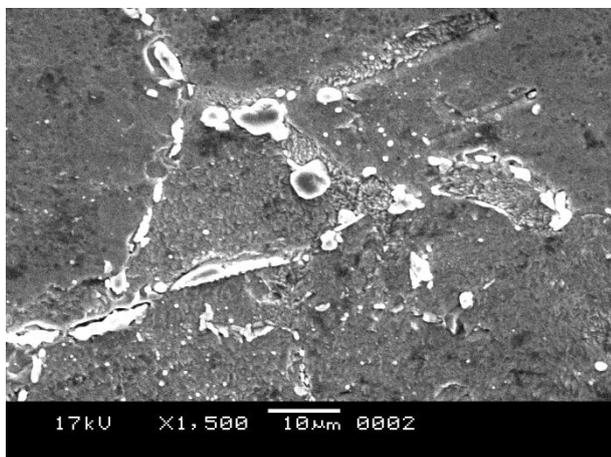
Figure 6 Microstructure of Cross-Section near Outer Surface showing carbide precipitation and micro-cracks at Mag-1500x

The microstructure of the tube cross-section was developed from a sample piece extending from inner diameter of the tube to the exposed outer diameter. The obtained micrographs are given in Figure 6-9 at magnification ranging from 250x to 1500x. In figure 6, the segregation of secondary carbides at grain boundary in an austenitic matrix is visible. The secondary carbides is accompanied with foreign particle deposition. This phenomenon was observed throughout the cross-section. Also, micro-cracks are observed adjacent to the secondary carbide bodies, primarily at the locations towards the outer periphery of the tube.

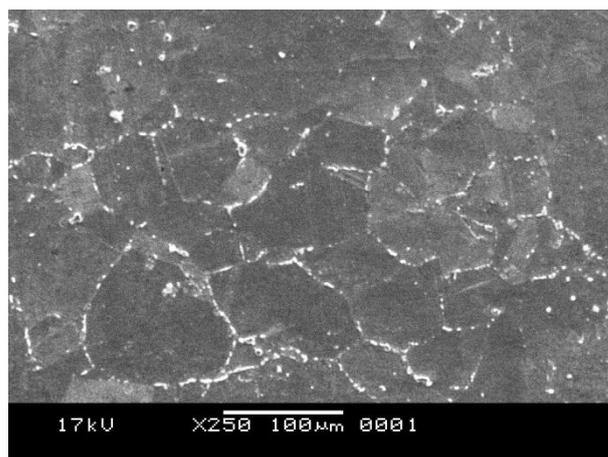
Figure 9 Microstructure of Cross-Section in the Middle showing secondary carbides at Mag-250x
