**Paper No.  
CR25**

## **Analysis of the failure of the ultrasonic scanning of bottom plate of storage tanks to detect localized corrosion**

**Santanu Saha**

Intertek – Inspec; Sharjah; United Arab Emirates  
*Santanu.saha@intertek.com*

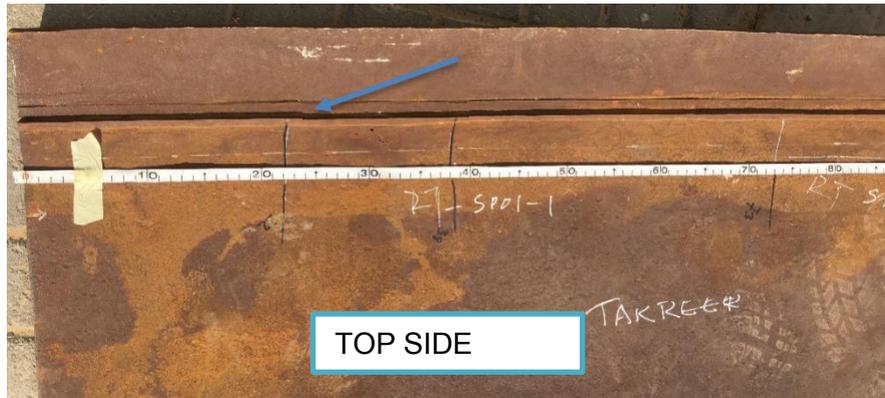
Shell to bottom weld; Shell removed.

Figure-1: Bottom plate Top side. The general surface condition is mostly satisfactory with the exception a few localized corrosion pits at two locations.

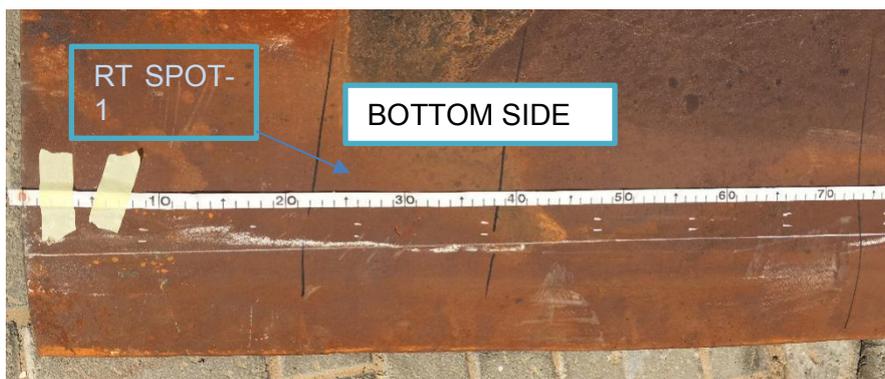
Figure-2: Bottom plate bottom side. The general surface condition is mostly satisfactory with the exception a few localized corrosion pits at two locations.

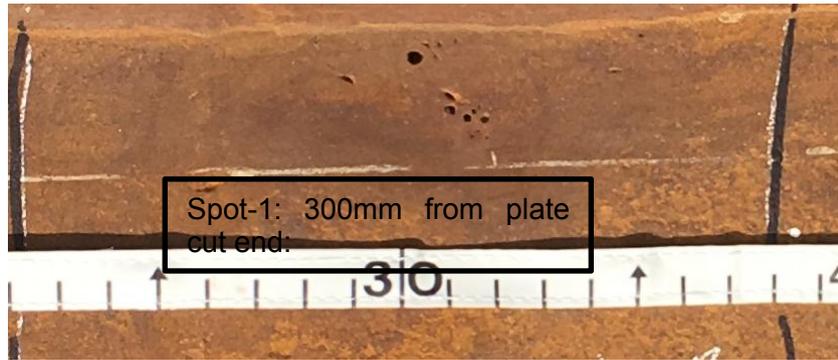
Figure-3 and 4 below are a correlation between top and bottom plate corrosion indications for Spot-1. Similarly figures 5 and 6 are the same correlations between top and bottom portions of spot-2. Although the pits on the top and bottom sides are almost located nearby but there is no through hole and hence the connection between the top and bottom indications could not be determined by visual examination. The selected spots were then subjected to Radiography. Figures 7 and 8 are Radiographs of Spot-1 and spot-2 in digitized formats. From figures 7 and 8, it is understood that there are extensions of visible pits inside the plate in oblique directions (not vertically through thickness direction) and it is clear that there are links between top and bottom pits in some complicated paths passing through the plate. It is not clear that the plates were having previously existing inclusions or air gaps which may accelerate the corrosion progression and thereby leakage of containment. No previous evidence of such flaws could be collected.

Figure-3 (SPOT-1): Visual photograph show highly localized pin-hole type corrosion pits @ 300mm from end spread over a length of 30mm. photograph from face A (Bottom plate top side).

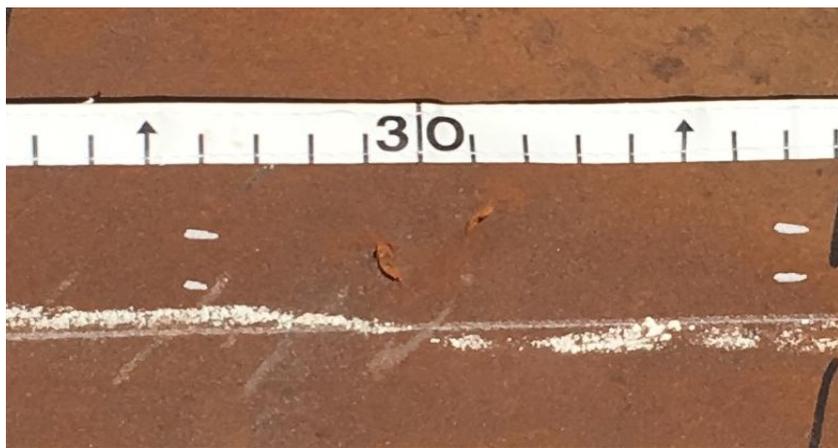
Figure-4 (SPOT-1): Visual photograph show localized corrosion pits having sharp edges @ 300mm from end spread over a length of 25mm. photograph from face B (Bottom plate bottom side).

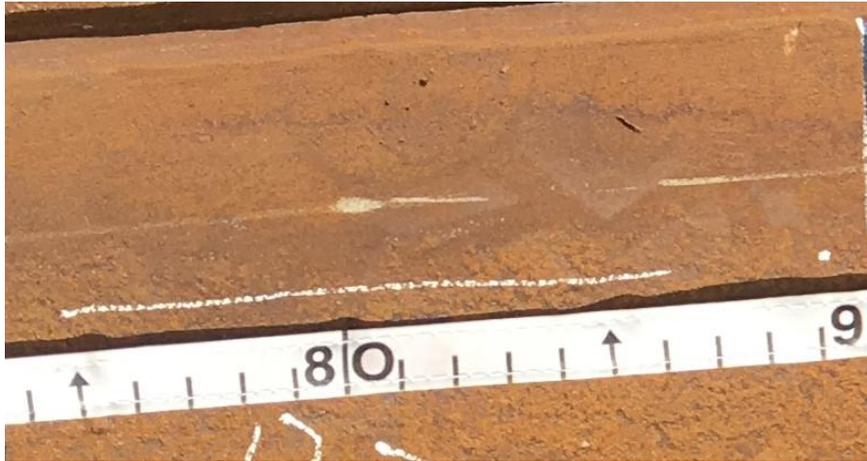
Figure-5 (SPOT-2): Visual photograph show scattered highly localized pin-hole type corrosion pits @ 800mm from end spread over a length of 50mm. photograph from face A (Bottom plate top side). A sharp edged corrosion (dent mark) also noticed nearby.

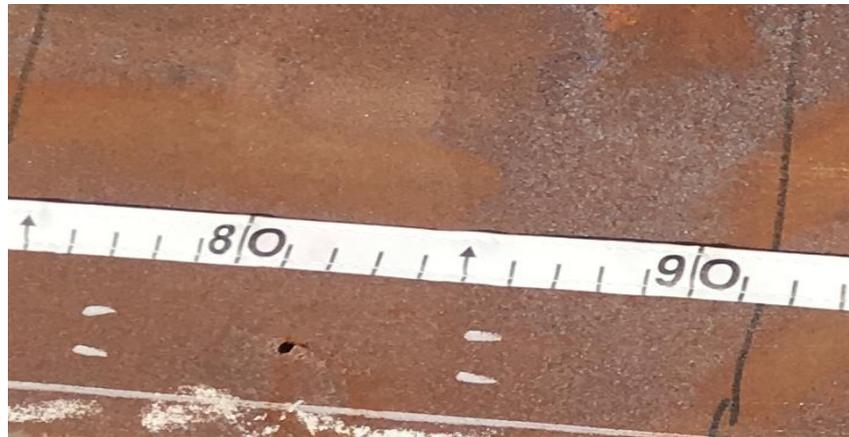
Figure-6 (SPOT-2): Visual photograph show a highly localized pin-hole type corrosion pit @ 810mm from end. Photograph from face B (Bottom plate bottom side).

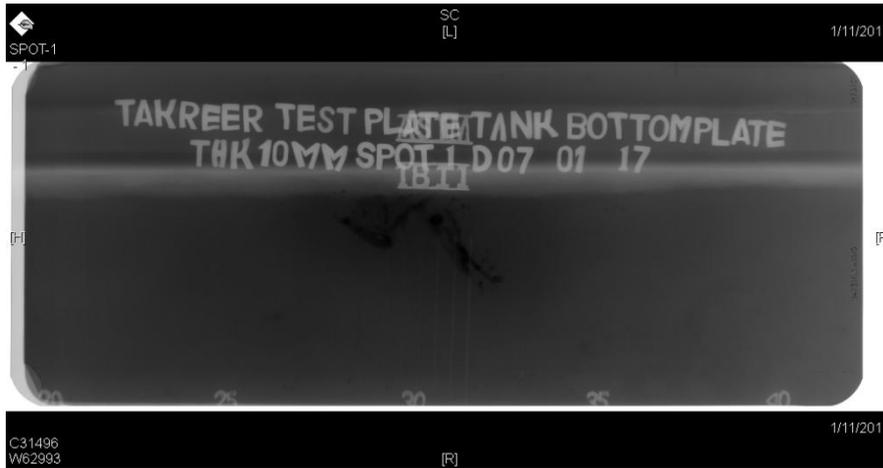
Figure-7 (SPOT-1): Digitized radiograph of Spot-1 show extended corrosion inside the plate thickness @ 300mm from end.

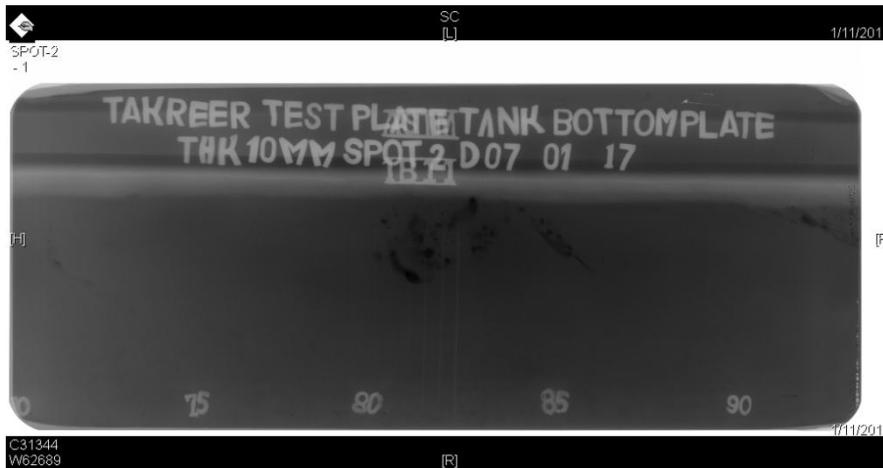
Figure-8 (SPOT-2): Digitized radiograph of Spot-2 show extended corrosion inside the plate thickness @ 800mm from end.

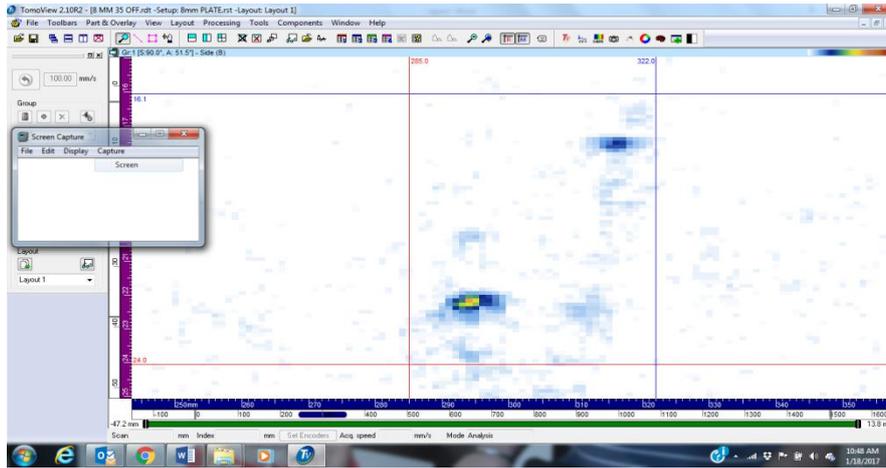
Ultrasonic Phased Array angle beam examination have been performed at those locations and some snap shots and results are given in figures 9 to 10 below for spot-1 and in figure 11 and 12 for spot-2. Phased Array results also showed indications under the surface and extended to some extent but links between the flaws are not quite evidence in Phased Array results.

Figure-9 (SPOT-1): B scan (Side sectional view) of UT Phased Array shows rounded type indications.

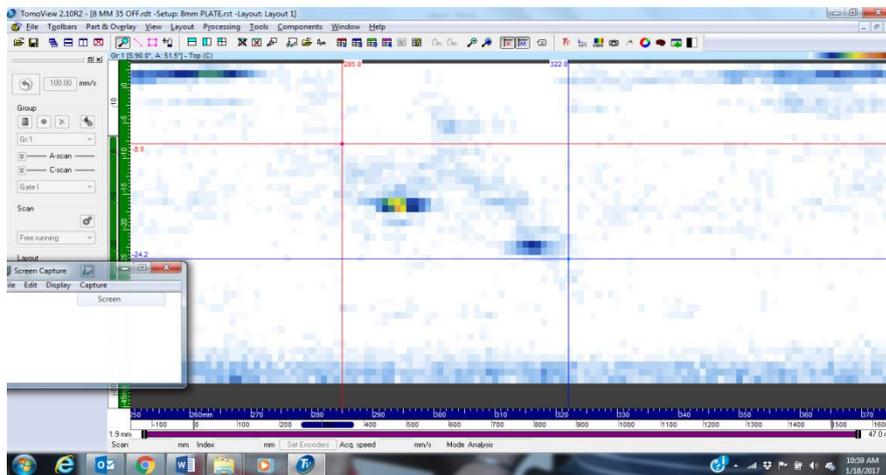
Figure-10 (SPOT-1): C scan (Top view) of UT Phased Array shows rounded type indications.

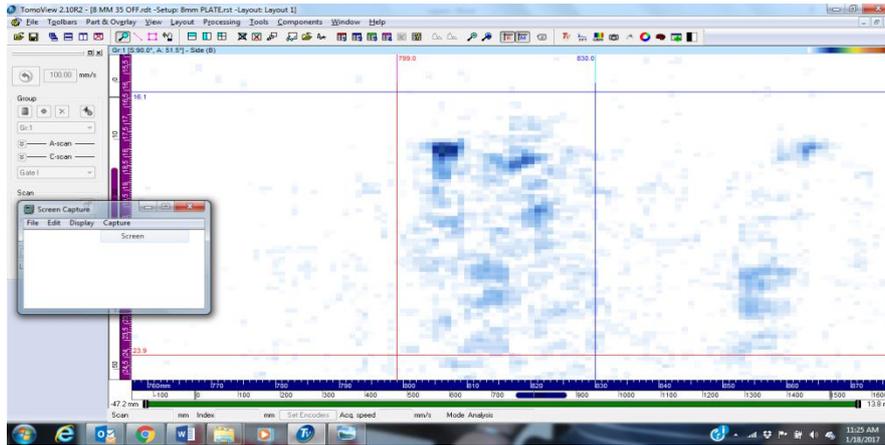
Figure-11 (SPOT-2): B scan (Side sectional view) of UT Phased Array shows rounded type scattered indications confined within 800 – 830mm from end. The sectional view shows indications starting from the top side (1mm from top surface) and several other indications extended to the bottom. No clear link between the flaws is evident.

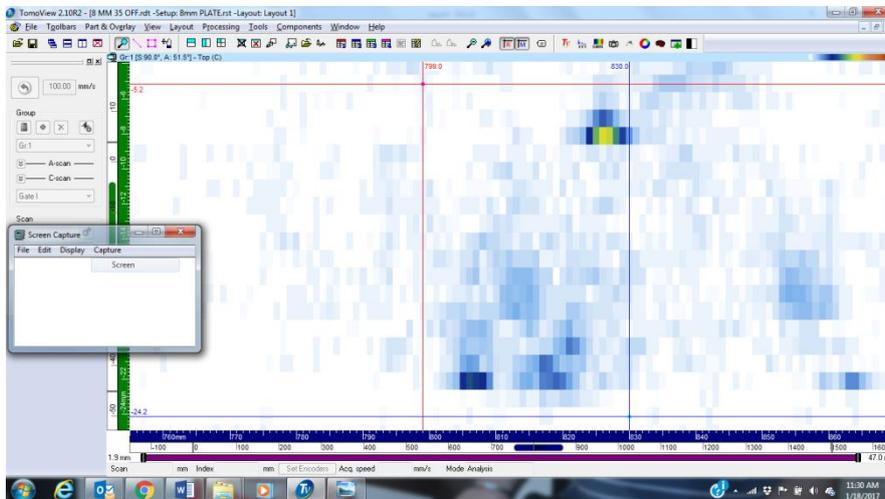
Figure-12 (SPOT-2): C scan (Top view) of UT Phased Array shows rounded type indications. The pattern of major indications and associated indications almost matches with the radiography view and shows there may be interconnections between the flaws. The indications are almost 5-6mm offset from the shell to bottom plate welds.
