**Paper No.
CR33**

Root cause analysis of Rupture in a Cross Country Crude Oil Transportation Pipeline - A case study

G.C. Thakur

Indian Oil Corporation Limited R&D Centre, Faridabad, India
thakurgc@indianoil.in

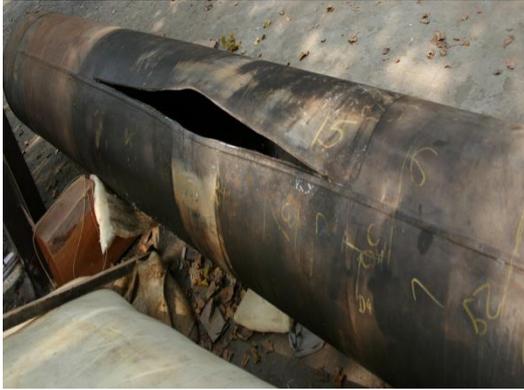
Fig. 1(a): View of failed pipe

The as received photograph of the failed sample is given in Fig.1(a) and Fig.1(b). The failed pipe reveals a longitudinal rupture opening. The total length of the fracture is measured to be 1520 mm. The fracture is seen to have initiated along HAZ and propagating towards parent metal. A closure look at the rupture surface indicates a number of pockets of fatigue fracture zone extending to a different extent along the pipe thickness direction (Fig.1(c)). No signs of external surface corrosion marks are seen. The internal surface of the pipe is also seen to be free from any appreciable pitting or corrosion /metal loss in the fracture zone.

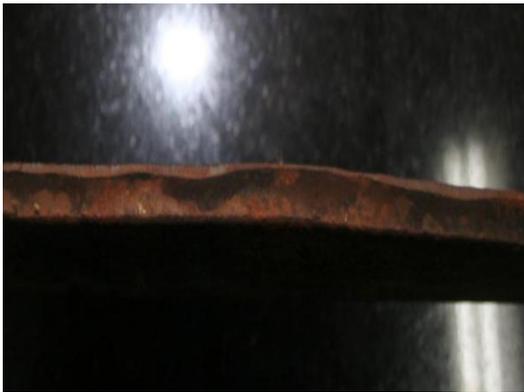
270 mm from the fracture initiation region (on the left side) showing 5% of fatigue zone in the thickness direction.

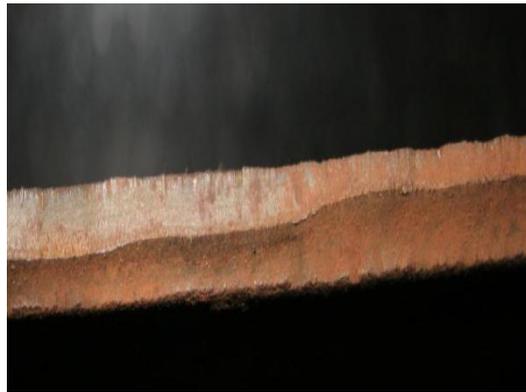
575 mm from the fracture initiation region (on the left side) showing 60% of fatigue zone in the thickness direction

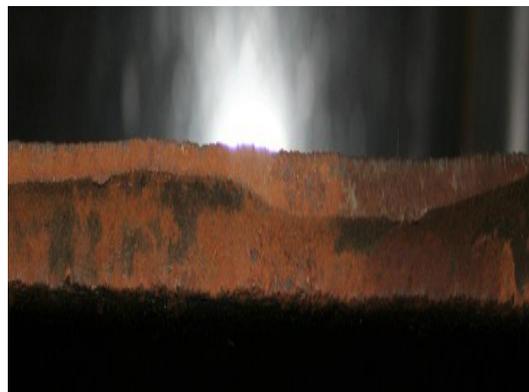
675 mm from the fracture initiation region (on the left side) showing 50% of fatigue zone in the thickness direction.

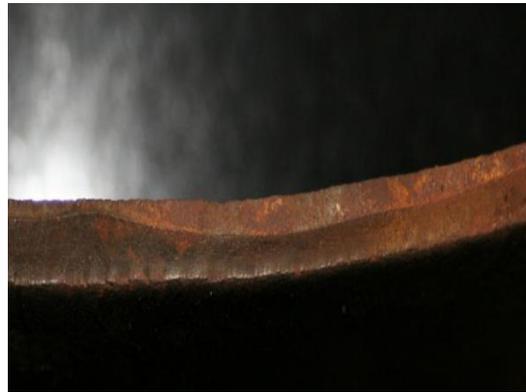
900 mm from the fracture initiation region (on the left side) showing 60% of fatigue zone in the thickness direction

Fig. 1(c): Other pockets of fatigue crack initiation points

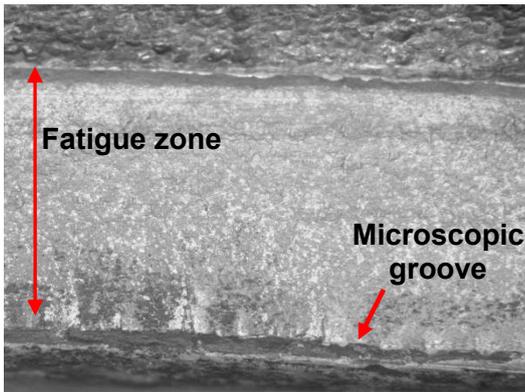
The fracture initiation zone as seen under stereoscopic microscope reveals multiple fatigue crack initiation in close proximity at the inner surface propagating towards the outer edge (Fig.2a). The whole rupture line segmented in 1 inch lengths over the 38 inch length of the spread on either side to the fracture initiation zone, revealed multiple nucleation of crack from the inner surface to a varied depth in thickness direction (Fig. 2b). Presence of a microscopic groove of 0.36mm depth is also observed at a distance of 0.2 mm from the inner surface all along the fracture length (Fig. 2(a) to (c)). The Individual cracks in the fracture initiation zone are seen to be initiated from this microscopic groove and growing to a maximum of 0.6mm along the thickness direction. Individual cracks are also seen to be joining at the midsection (Fig.2(d)). A graph showing the extent of fatigue region and fast fracture region across the thickness along the rupture line is shown in Fig. 2(e). A clear fatigue zone of 80% of the thickness at the initiation point is observed. The crack length along longitudinal axis of the pipe at fracture initiation zone is measured to be around 40 mm. Also, some amount of weld misalignment as well as weld defect (LOF) are observed on the failed sample (Fig. 3).

Fig 2a: Fracture initiation region revealing multiple fatigue crack initiation

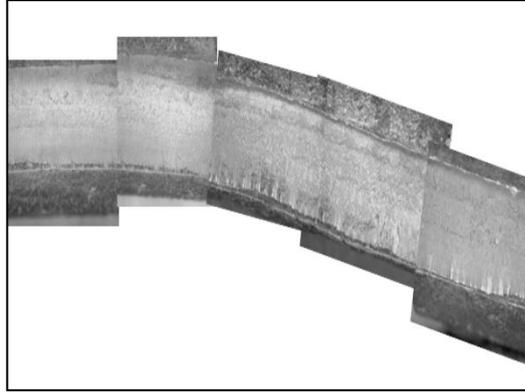
Fig 2b: Multiple crack initiation at different pockets along fracture line at two different magnifications

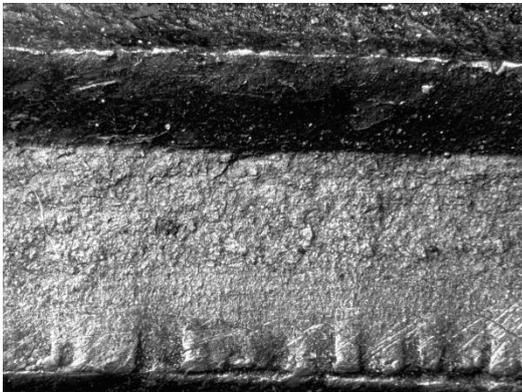
Fig 2c: Showing joining of micro cracks in mid section

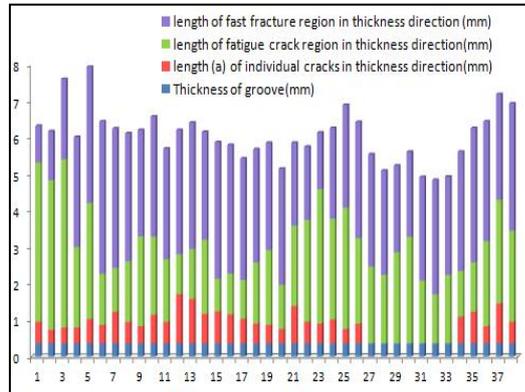
Fig 2d: Extent of fatigue and fast fracture region across the thickness along the rupture line

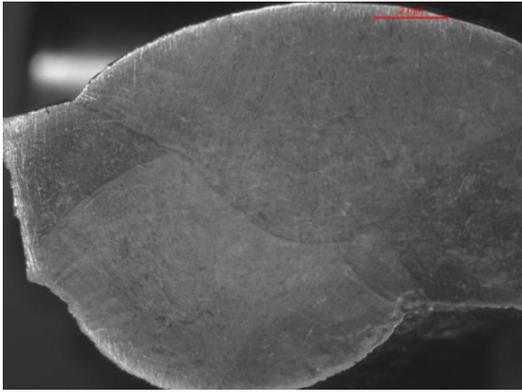
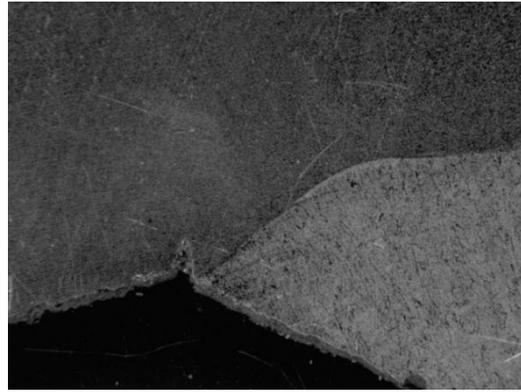
Fig 3: Weld region showing weld misalignment as well as weld defect (LOF)

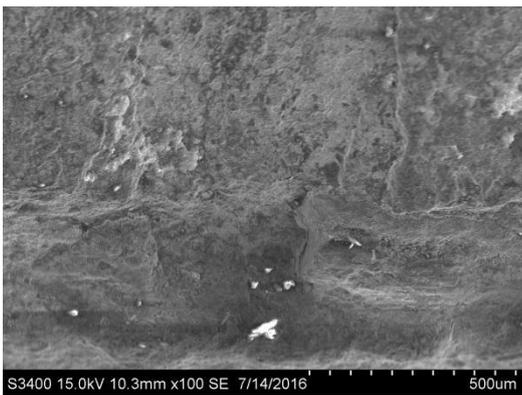
Fig 5: SEM Fractograph

The fracture surface has further been evaluated under the Scanning Electron Microscope (SEM). The SEM Fractography confirmed the presence of microscopic defects at inner surface of the failed pipe (Fig.5). Also, the fatigue crack propagation zone near the crack initiation point along with the flat fracture surface could be seen.

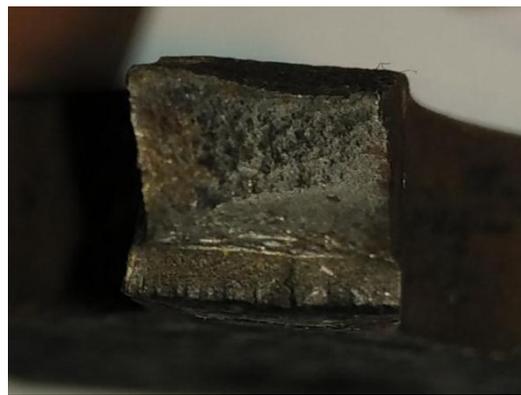
Fig 6. Fracture surface of broken tensile specimen.

- * Tensile fracture surface of weld transverse sample reveals pre-existing fatigue crack zone.
- * Unfailed regions adjacent to pipe rupture reveals presence of pre-existing defects characterized as Lack of fusion which are further confirmed by Phased array ultrasonic testing.

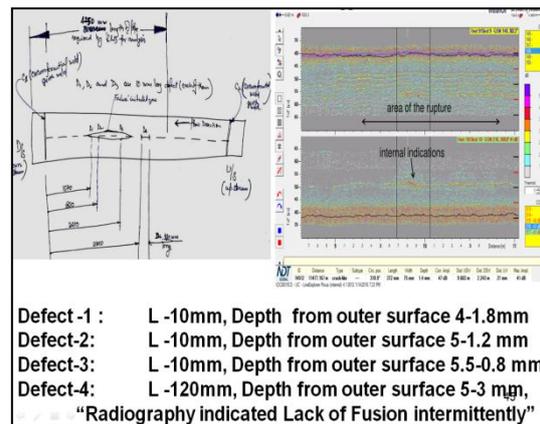
Fig. 8: NDT Findings on rupture line

Phased Array Ultrasonic Testing in order to assess the entire failed pipe for the presence of crack like defects, porosity etc. in the longitudinal weld seam. The PAUT studies indicated presence of three discontinuities of length 10 mm each and another of length 120 mm. The radiography of these locations containing the defects indicated the presence of intermittent lack of side wall fusion (Fig. 8).
