## **Failure Investigation of Super Heater Tubes of a Boiler in Oil Refinery**

Ruptures were observed in the ASTM SA213 T22 & SS 347H super heater tubes of a boiler in an oil refinery after a service period of two years. Cut sample tubes from the failed regions were investigated for analysing the root cause of failure.

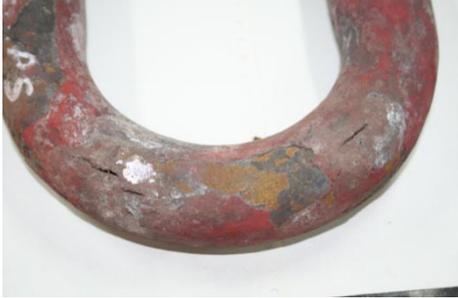
Fig 1A

Viewing tube sample at higher magnification (under stereo microscope) revealed thickening of magnetite layer/oxidation damage respectively on tube internal / external surface contributing to thickness loss on T22 tube sample where as such observations were missing for SS 347H tube sample. Refer Figs 1 A/B/C & Fig 2.

**Fig 1A:** Shows multiple localized bulging on tube preferentially at 5-7 O' Clock position & not aligned in single plane.

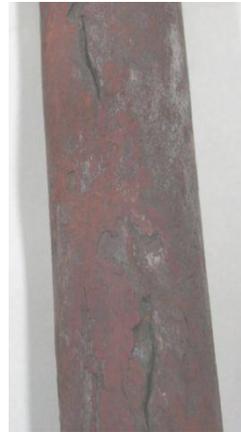
Fig 1B

**Fig 1B/C:** Shows failure as thick lip opening.

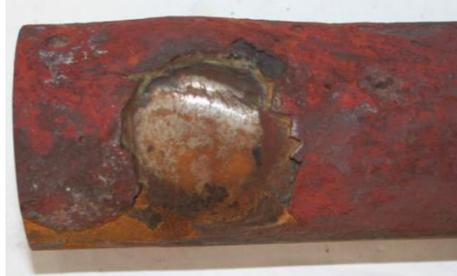
Fig 2

**Fig 2 :** Shows bulging / severe localized oxidation / exfoliation of oxide scale.

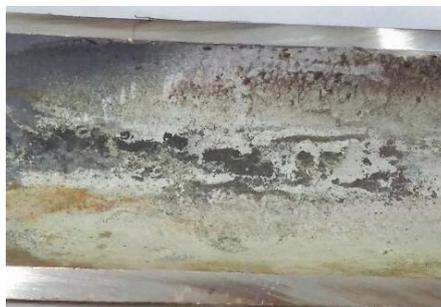
Fig-3A

SEM / EDX analysis of whitish random deposits inside the tube indicated appreciable amount of sodium suggesting possibility of soluble salt deposition from BFW carry over. Refer Figs 3 A/B/C & Fig 11.

**Fig 3A:** As received tube sample shows appreciable whitish deposits inside the tube.

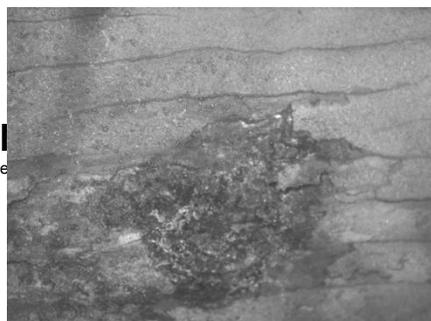
Fig – 3B

**Fig 3B:** Shows some corrosion marks/deposits on tube ID surface on viewing at a high magnification under stereomicroscope.

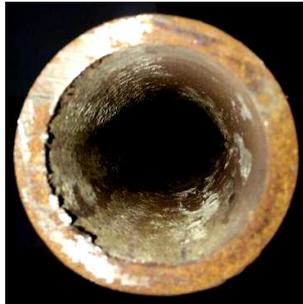
Fig 3C

**Fig 3C:** Shows randomly distributed

whitish deposits on tube ID surface.

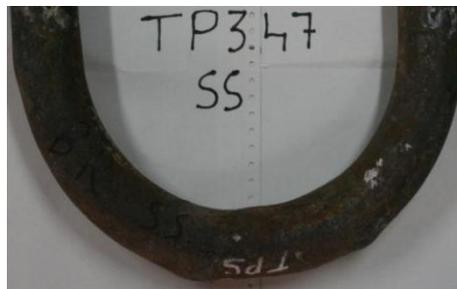
Fig-4A:

Multiple bulges in the U bend & longitudinal crack in connected straight portion were observed in both failed region of T-22 & SS 347H metallurgy tubes & failed locations were not found aligned vertically rather distributed in tube half circumference indicating impact of random internal deposit followed by differential overheating in the high heat flux zone. Refer Figs 4A/B.

**Fig 4A :** As received photograph of failed SS 347H tube shows multiple localized bulges on tube U-bend, preferentially at 5-7 O' Clock position.

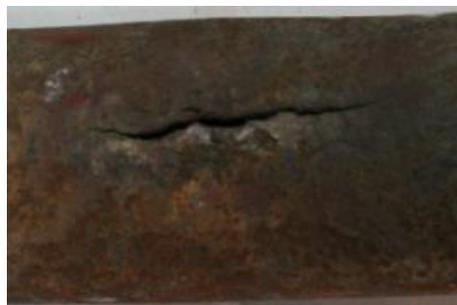
Fig-4B:

**Fig 4B :** As received photograph of failed SS 347H tube shows thick lip opening.

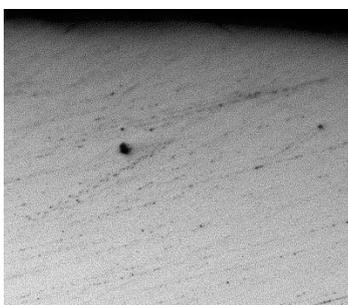
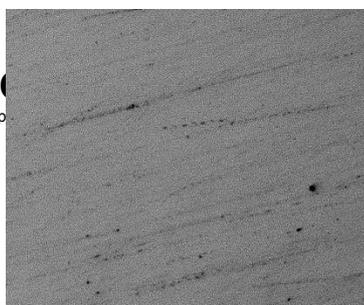
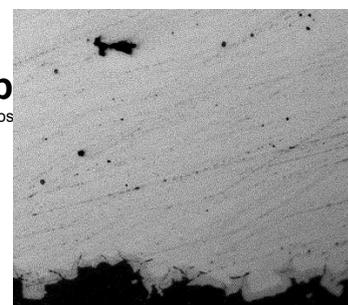
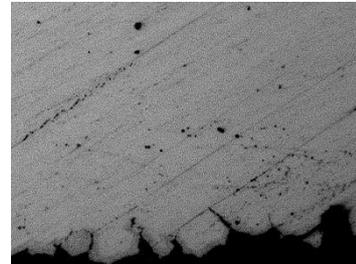
On Metallography, polished 2.25Cr-1Mo & SS 347H specimens revealed presence of creep voids, micro cracks in both the tube metallurgy samples & additional sensitization in SS specimen.. Refer Figs 5 A/B/C, Figs 6A/B/C & Figs 7 A/B/C.

**Fig 5A/B/C & 6 A/B/C: 2.25Cr-1Mo Tube:** specimens under optical microscope (200X) in the bulged region showed presence of creep voids / oxide penetration on polished surface of CT (Circumferential Thk) & LT (Longitudinal Thk) cross-sections of specimen.

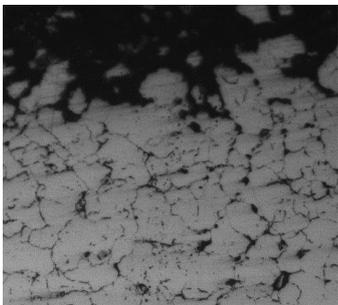
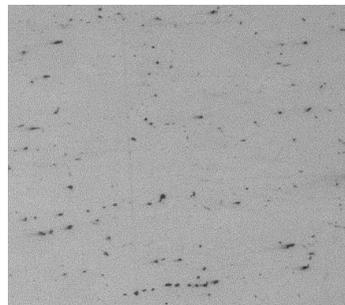
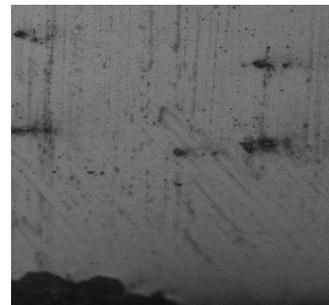
**Fig 7A/B/C:** Polished surface (200 X) of SS 347H specimens showed presence of creep voids on polished surface. Oxide penetration & sensitized grain boundaries can also be seen in the specimen at outside edge.

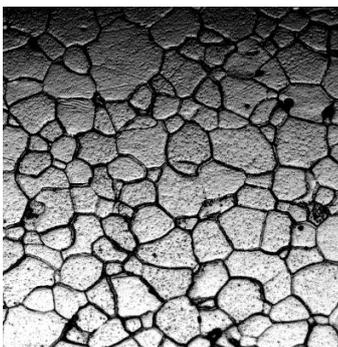
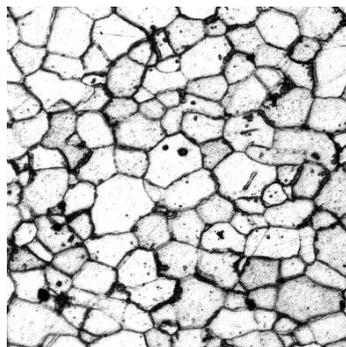
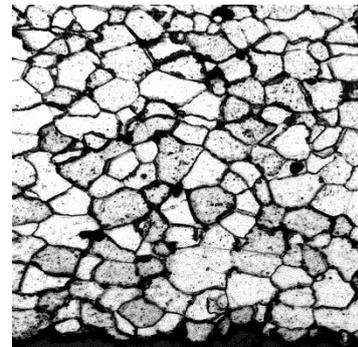
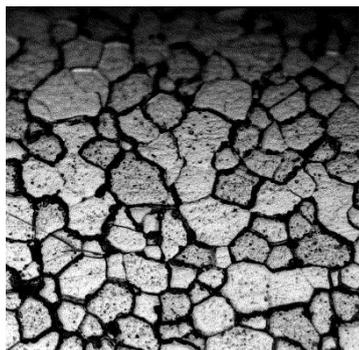
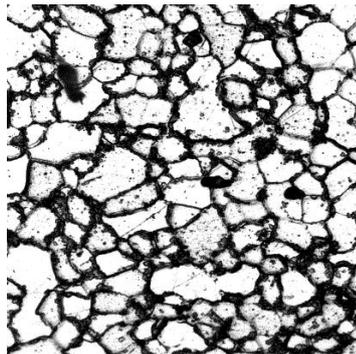
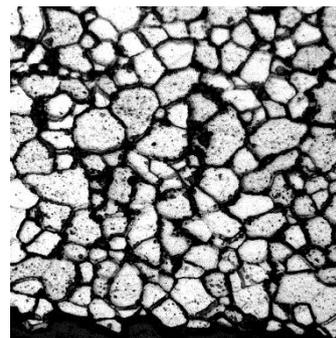
Metallography of specimen after etching revealed ferrite matrix, bainitic carbides transformed to globular form and carbide precipitation in both at Grain boundaries and inside the grain suggesting localized overheating / metallurgical degradation of material & Creep voids / micro cracks suggesting progress of creep phenomenon in 2.25Cr-1Mo specimen. Refer Figs 8 & 9 A/B/C

**Fig 8A/B/C & 9A/B/C:** Ferrite matrix with most of the bainitic carbides transformed to globular form & considerable carbide precipitation both at Grain boundary and inside the grain as well as Creep voids & micro cracks at grain boundaries on etched specimen of CT & LT cross-sections on viewing under optical microscope at 200X.

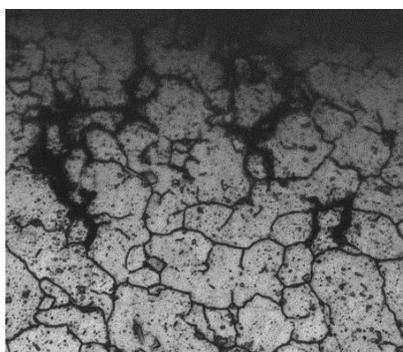
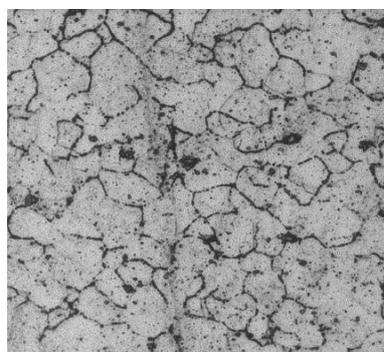
Etched specimen SS 347H revealed grain-boundary carbide precipitation (Sensitized microstructure) as well as small carbide precipitates within the individual austenite grains and oxide penetration & creep voids / micro cracks suggesting progress of creep in the overheated zone. Refer Figs 10 A/B.

**Fig 10 A/B:** Tube specimen under optical microscope showed sensitization in SS 347, Creep voids / micro cracks in etched condition.

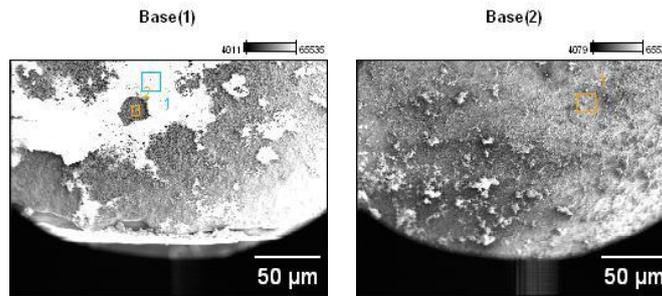
Analysis revealed presence of Na, Ca, P etc as high as Na (40.1%), Ca (51.5 %), Cl (3.5 %), P (7.7 %) suggesting possible BFW carry over along with saturated steam & soluble salt deposition on tube ID surface.

**Fig 11:** SEM-EDX Analysis of Internal tube deposit shows high percentage of Na, Ca, P etc. indicative of BFW carry over along with saturated steam and deposition of soluble salts inside primary super heater coil.

- long term randomly localized overheating arising out from BFW carry over along with saturated steam to the Super Heater coils favouring, deposition of soluble salts in BFW at hot areas inside the tube & thereby inducing reduction in heat transfer / overheating of tube at internal deposit locations & failures of tube from accelerated creep phenomenon.
- High temperature material degradation like Creep, oxidation & micro structural degradation at above overheated locations were found contributing to the failure of tubes in the form of thick lip rupture.

In view of above, it was recommended to identify the possible causes of Boiler water carry over along with saturated steam & necessary remedial measures to avoid such premature failures in future.
