Failure analysis of 6” spool of Process Gas Compressor cooler outlet at Offshore Process Platform

Abhay Kujur*, Maushumi K Talukdar, Sangeeta R. Prasad, Anita Sharma, A. Santra and Anil Bhardwaj

Institute of Engineering and Ocean Technology
Oil and Natural Gas Corporation Ltd.
Panvel, Navi Mumbai-410221

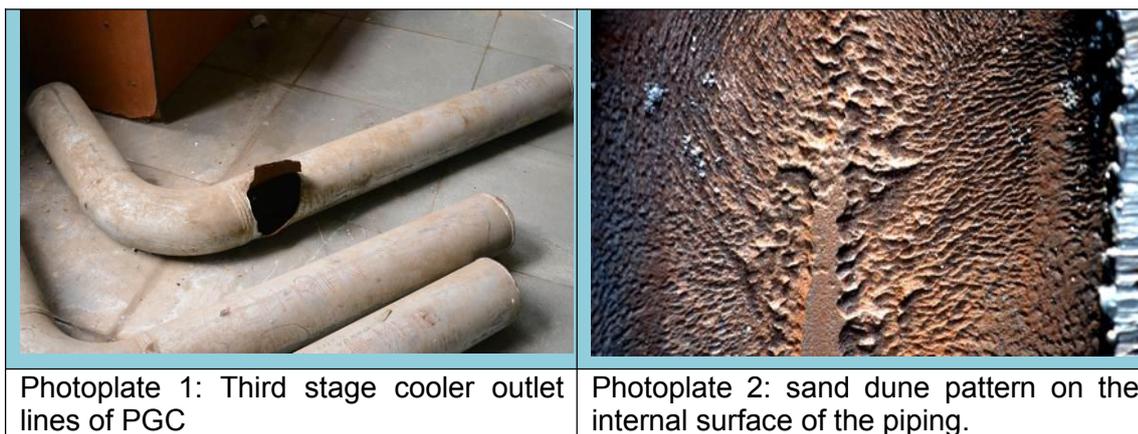
Failure had taken place in the straight portion downstream of welded joint to the elbow. Failure was in the form of thin metal sheet busted out of the pipe at 6 O'clock to 9 O'clock position downstream of extrados of the elbow (Photoplate 1).

Busted portion of the piping bore the sand dune pattern (Photoplate 2) which was aligned along the flow direction.

Visual inspection of the failed surface showed the classic sand dune like surface contours oriented along the direction of fluid flow which is typical of Flow Assisted Corrosion (FAC)

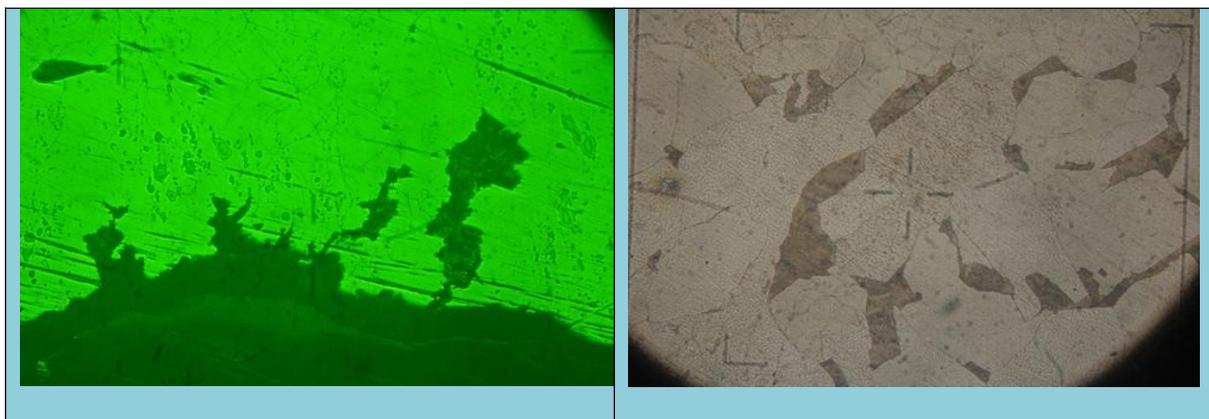
As-polished sample from longitudinal section showed no significant inclusions in it. However, small pits typical of acid attack were observed in it (Photoplate-3) which might have resulted due to exposure to acidic condensate from the gas intercoolers.

Photoplate 3 : Longitudinal section of the as-polished sample showing pits typical of acid attack. Magnification: 200X.

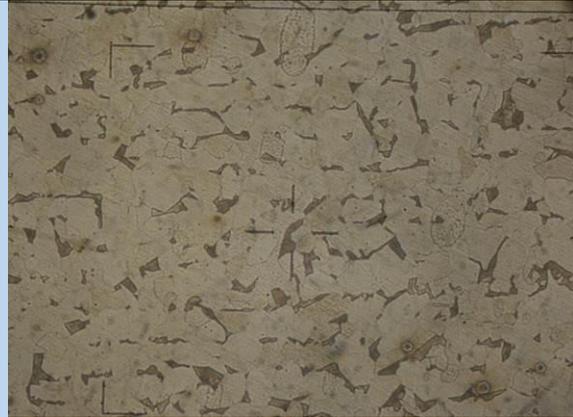
The specimens were then etched with 2% Nital. Observation of transverse section revealed a microstructure of uniformly distributed ferrite and pearlite (Photoplate-4). The PGC cooler outlet line had acceptable microstructure of normalized ferrite and pearlite as required by ASTM 106 for Grade 'B' material.

Photoplate 4: Transverse section showing normalized ferrite and pearlite. Magnification: 400X, Etchant 2% Nital

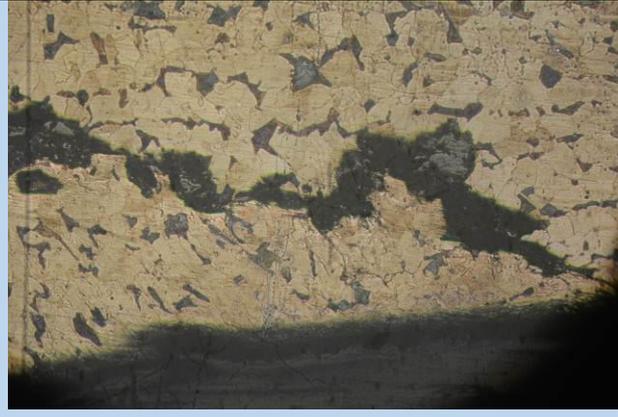
The examination of the etched longitudinal section showed normalized ferrite and pearlite microstructure. In the HAZ, fine grained ferrite and pearlite microstructure was observed (Photoplate-5). Longitudinal section also showed acid attacks at several places (Photoplate-6).

Photoplate 5: Fine grained microstructure observed on the HAZ. Magnification: 200X, Etchant 2% Nital

Photoplate 6: Longitudinal section showing acid attacks at several places. Magnification: 200X, Etchant 2% Nital

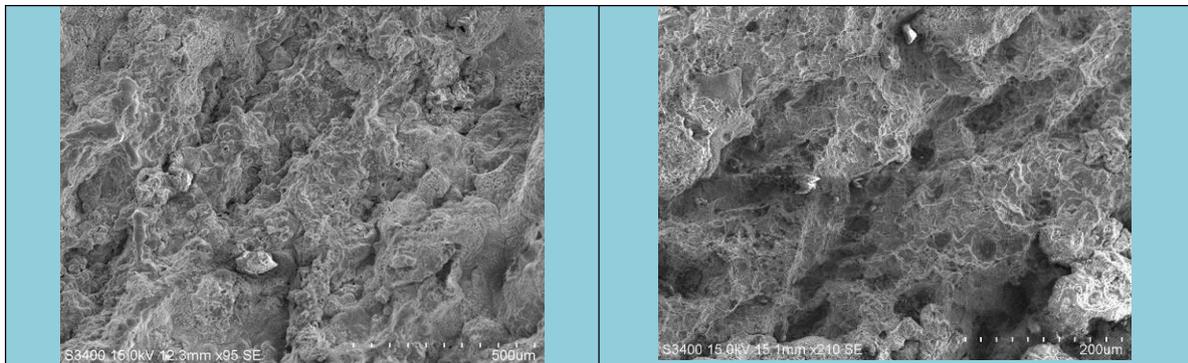
The compressed gas is cooled by passing it through inter coolers which leads to condensation of water. In the cooler outlet lines pressure drop and turbulence is created due to change in cross-sectional area of discharge header of cooler and outlet lines, presence of bends/ elbows in the piping. This causes erosion corrosion of the piping material by rapidly moving fluid (gas, condensate and water) from the gas cooler. In the failed sample, depressions were formed at the initiation sites, which were aligned to the direction of fluid flow (Photoplate 7& 8). These grooves are typical evidence of erosion corrosion mechanism. Closer examination of these grooves showed small pits on it that indicate the influence of corrosive condensed water which aided in erosion corrosion of piping (Photoplate 9). Observation of pits on higher magnification showed the morphology typical of chloride attack on the metal surface (Photoplate 10). Through EDS analysis it was confirmed that the region of this morphology predominantly contained chlorides. In many pits this morphology was observed.

Photoplate 7& 8: Grooves typical of erosion corrosion observed on the failed piping sample

In SEM analysis also grooves typical of erosion-corrosion mechanism were observed. Closer examination of these grooves showed small pits on it that indicated the influence of corrosive condensed water.

As the existing metallurgy of ASTM A 106 Grade B material along with corrosion inhibitor may not be suitable under the high velocity corrosive fluid flow condition in PGC cooler outlet line, it was recommended to use 316/316L dual grade CRA material piping.

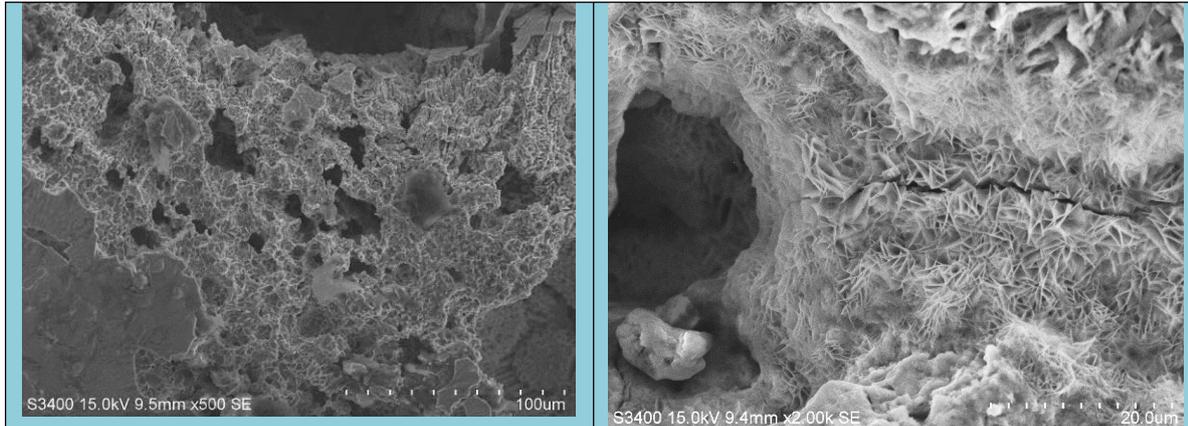
Photoplate 9: Pits observed on the grooved region showing influence of corrosive condensed water.

Photoplate 10: Observation of pits at higher magnification showing the morphology of chloride attack.

EDS analysis of pitted region on failed piping surface confirmed the influence of corrosive species like chloride.
