**Paper No.
MCI22**

Microbiological Induced Corrosion in Newly Built Tanks

Ameer Hamza

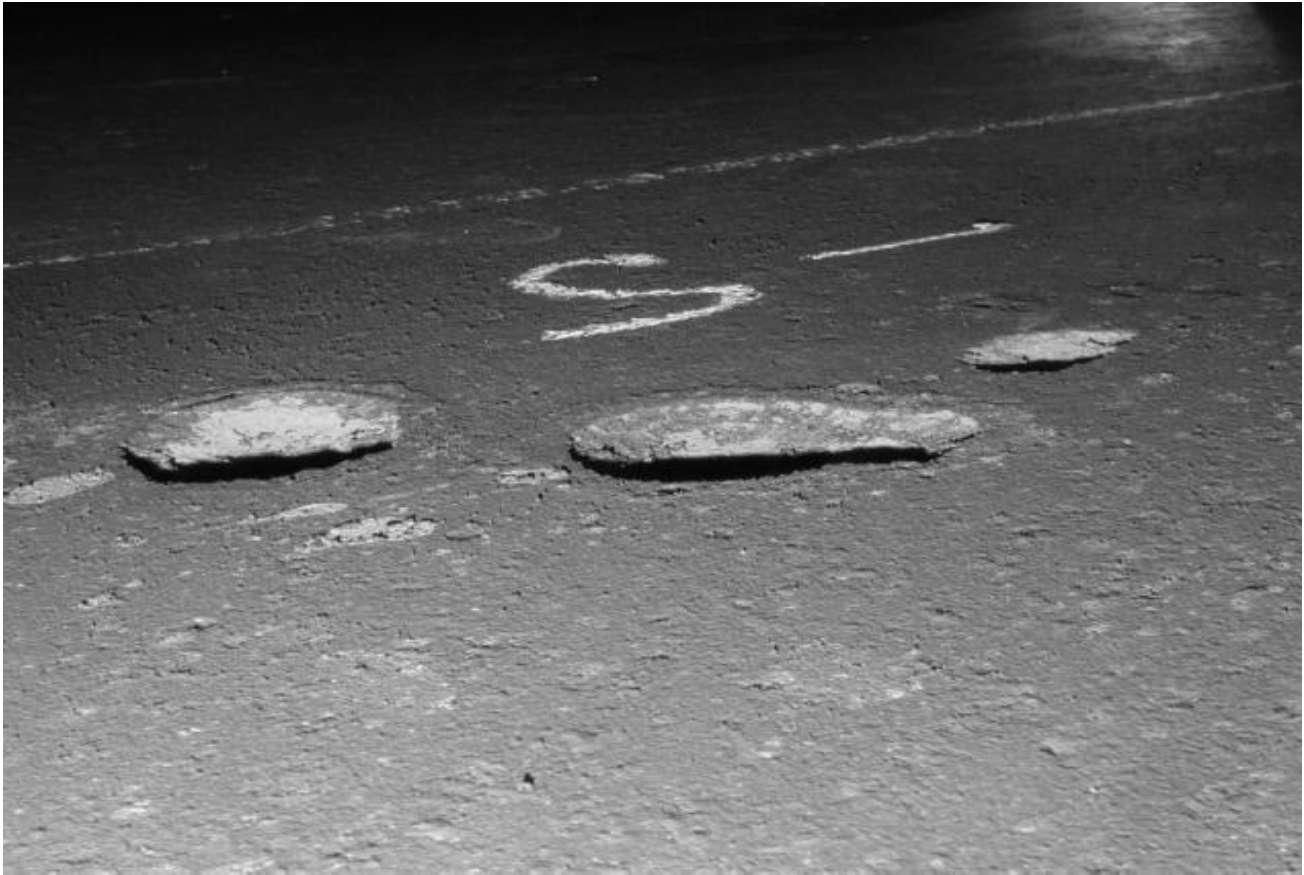
Figure 1: Pitting on the Bottom Plate of Storage Tank due to MIC

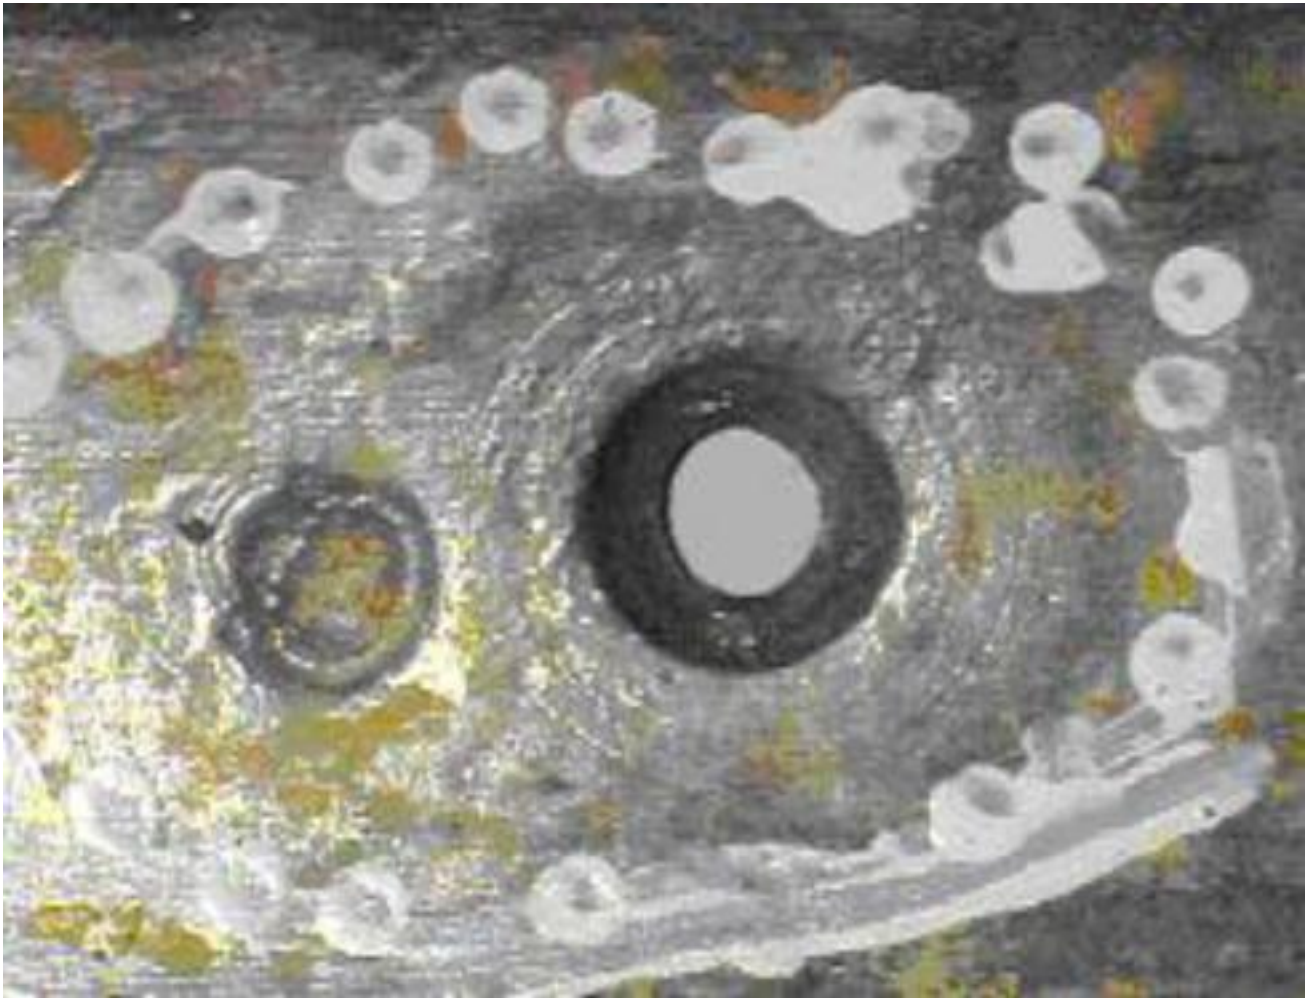
Figure 2: Pitting on the Bottom Plate of Storage Tank due to MIC

It was also observed that the affected area was found in wet condition, in spite of the fact the hydrotesting and drying activities were done from very long time, This wetness area can also be easily felt by the bare hand movement on the affected portion and easily observed in deep pitted area of the bottom plates. Refer to Figure-2

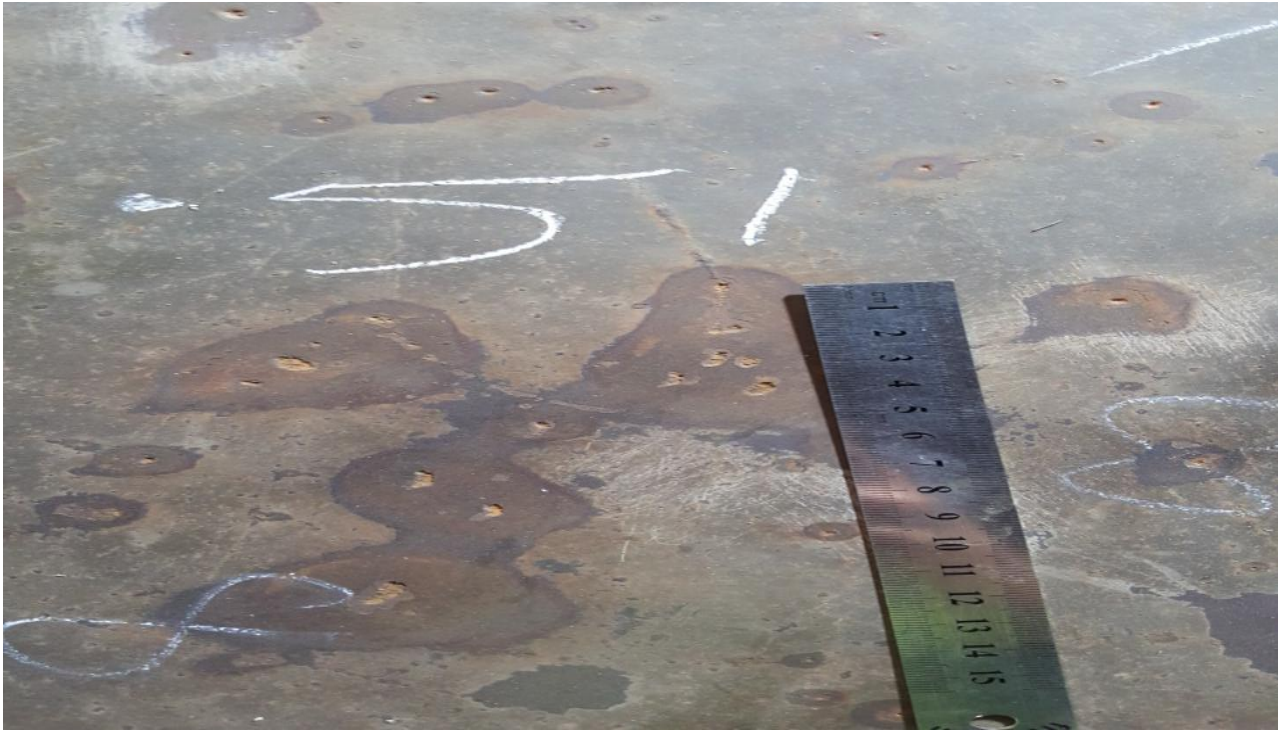
During the investigation, it was observed that the appearance of the pits was surrounded by shiny brownish appearance and spread across the tank with the density of 25-50 pits per square meter. More number of pits is observed at the location where stagnant or low flow condition of water can easily be take place on the bottom plate of this tanks. Refer to Figures 3 & 5 which indicate about the affected tanks with pitting corrosion on bottom plate of the tanks with brownish shiny appearance.

Figure 3: Affected Area on the Bottom Plate of Tanks (Brownish)

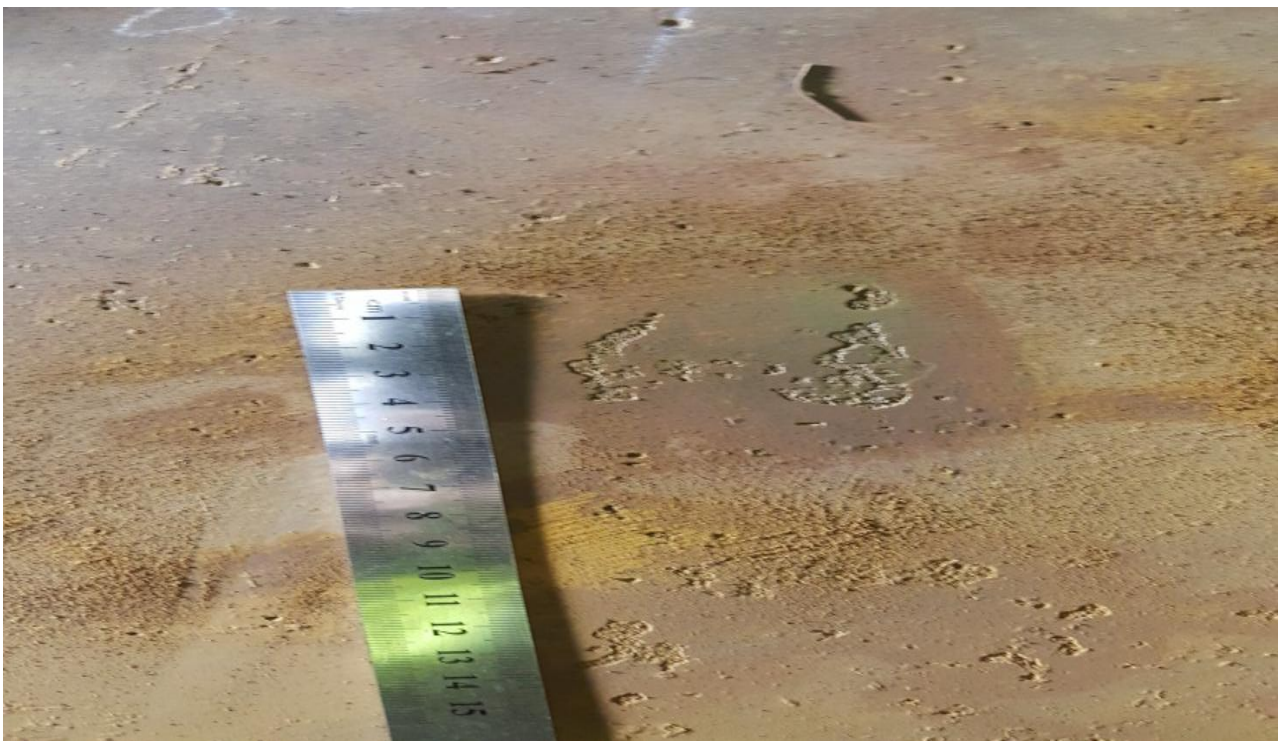
The tested water has been stored for several days in the tanks without any biocide treatment and has been recirculated for testing as well rinsing for other tanks installed in the refinery, Figure 4 will provide the complete detail of hydrotesting sequence which was been carried out in the refinery for the affected tanks, All of the tanks were affected by pitting corrosion in similar fashion on the bottom plate of the tank. The water source used for testing was untreated well water which had been stagnant in the tanks for a period of more than 100 days during and after testing. The tanks were open to the atmosphere after the completion of test with stagnant water present on the bottom plates.

Figure 4: Affected Area on the Bottom Plate of Tanks (Wet Area After Drying Process)

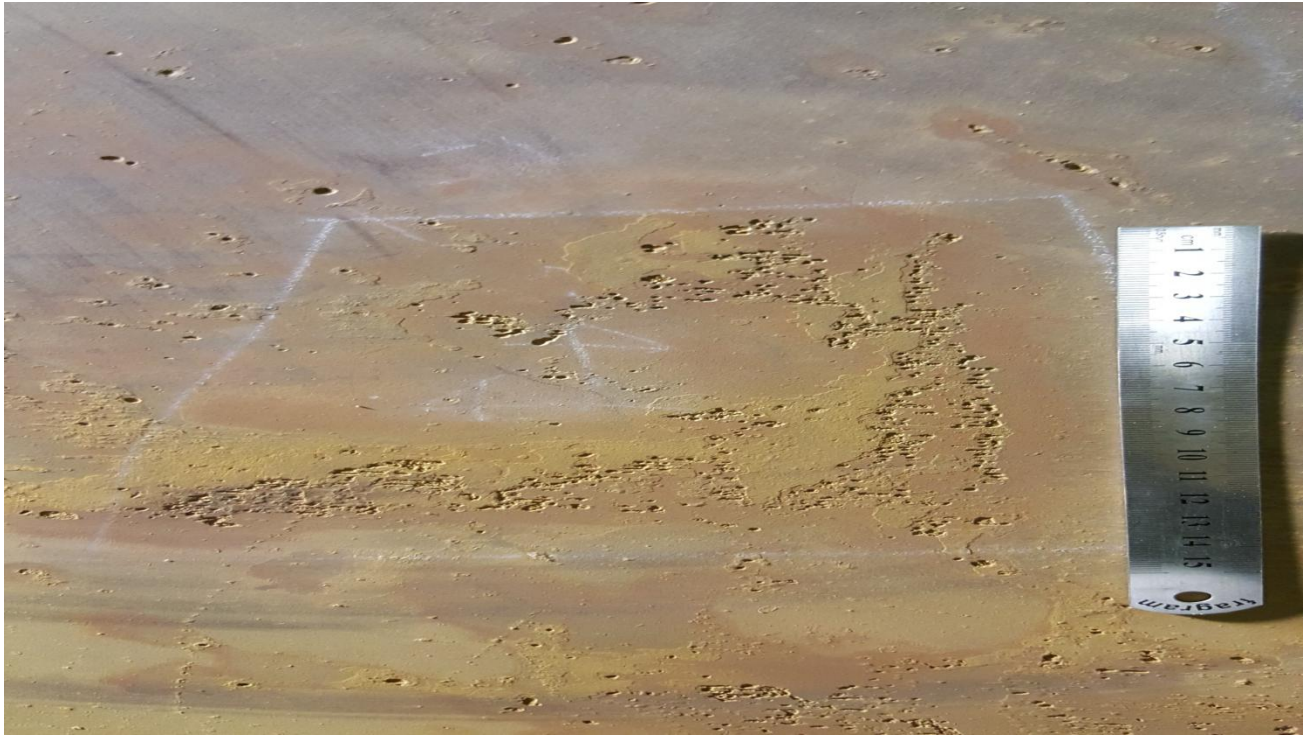
During visual examination of this affected area, it was observed that the length of pits usually varied from one spot to other and they were interconnected with each other and this pits are encircled with appearance of shiny brownish color around the pits. Apart from this it was observed with mechanical damages presented on the some of the locations on the bottom plate of tanks, which might have occurred during the fabrication stage due to poor workmanship while performing welding as well as by improper application of scaffolding pipes used during fabrication stage. Refer to Figure 5.

Figure 5: Affected Area on the Bottom Plate of Tanks (Pit Density)

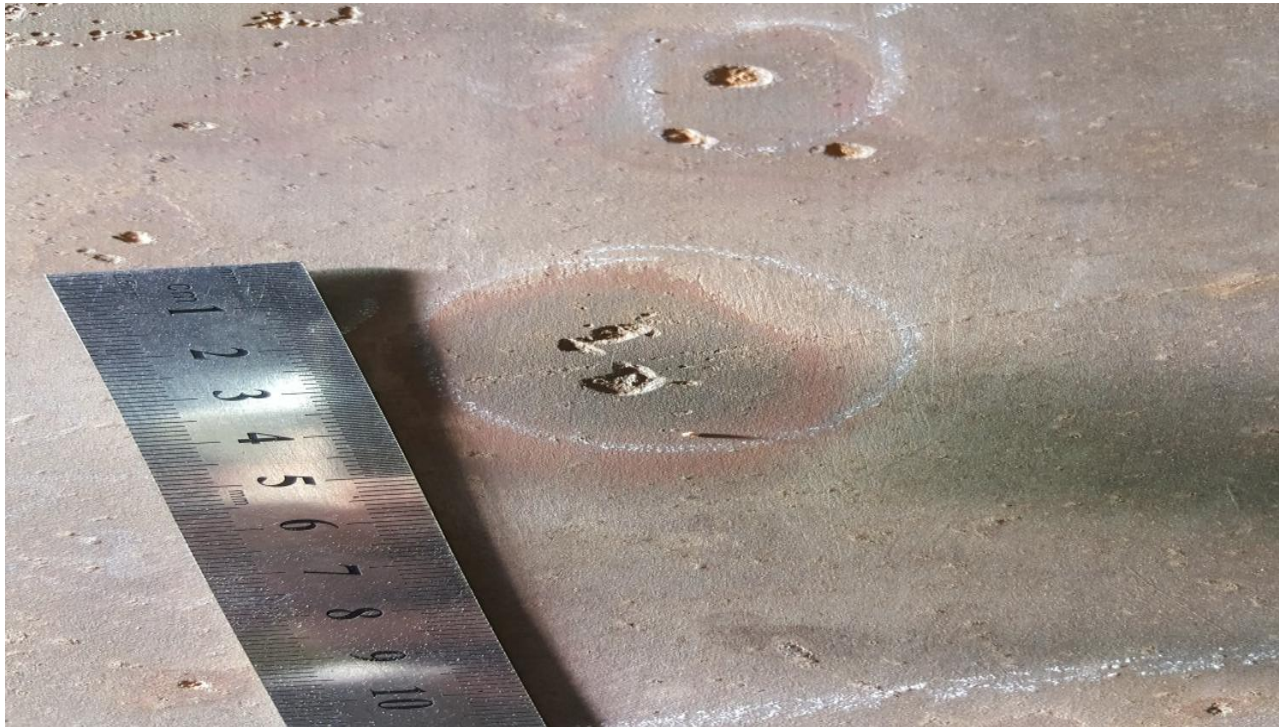
The depth of pits was measured by using ultrasonic examination along with mechanical caliper, which resulted in the range between to 2-3 mm approximately, which clearly showed the sign in loss of the assigned corrosion allowance on the bottom plate of this tanks prior to putting the tanks in to service. Similarly mechanical damages were also measured which have depth with loss of metal in range of 1-2 mm approximately. Refer to Figures 6 & 7.

Figure 6: Deep Pits along with Mechanical Damages

However deeper defects were repaired by welding and ground flush and smooth to reduce potential further pitting/crevice corrosion.

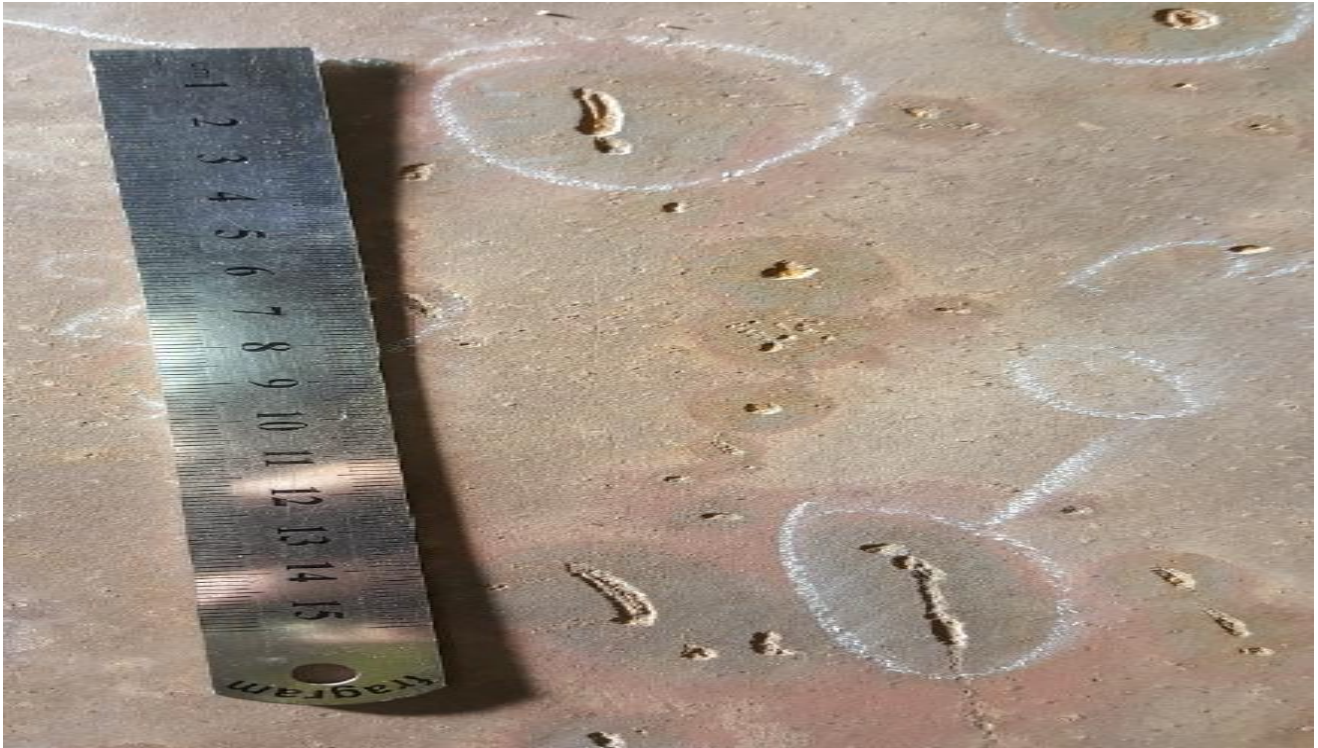
Figure 7: Mechanical Damages

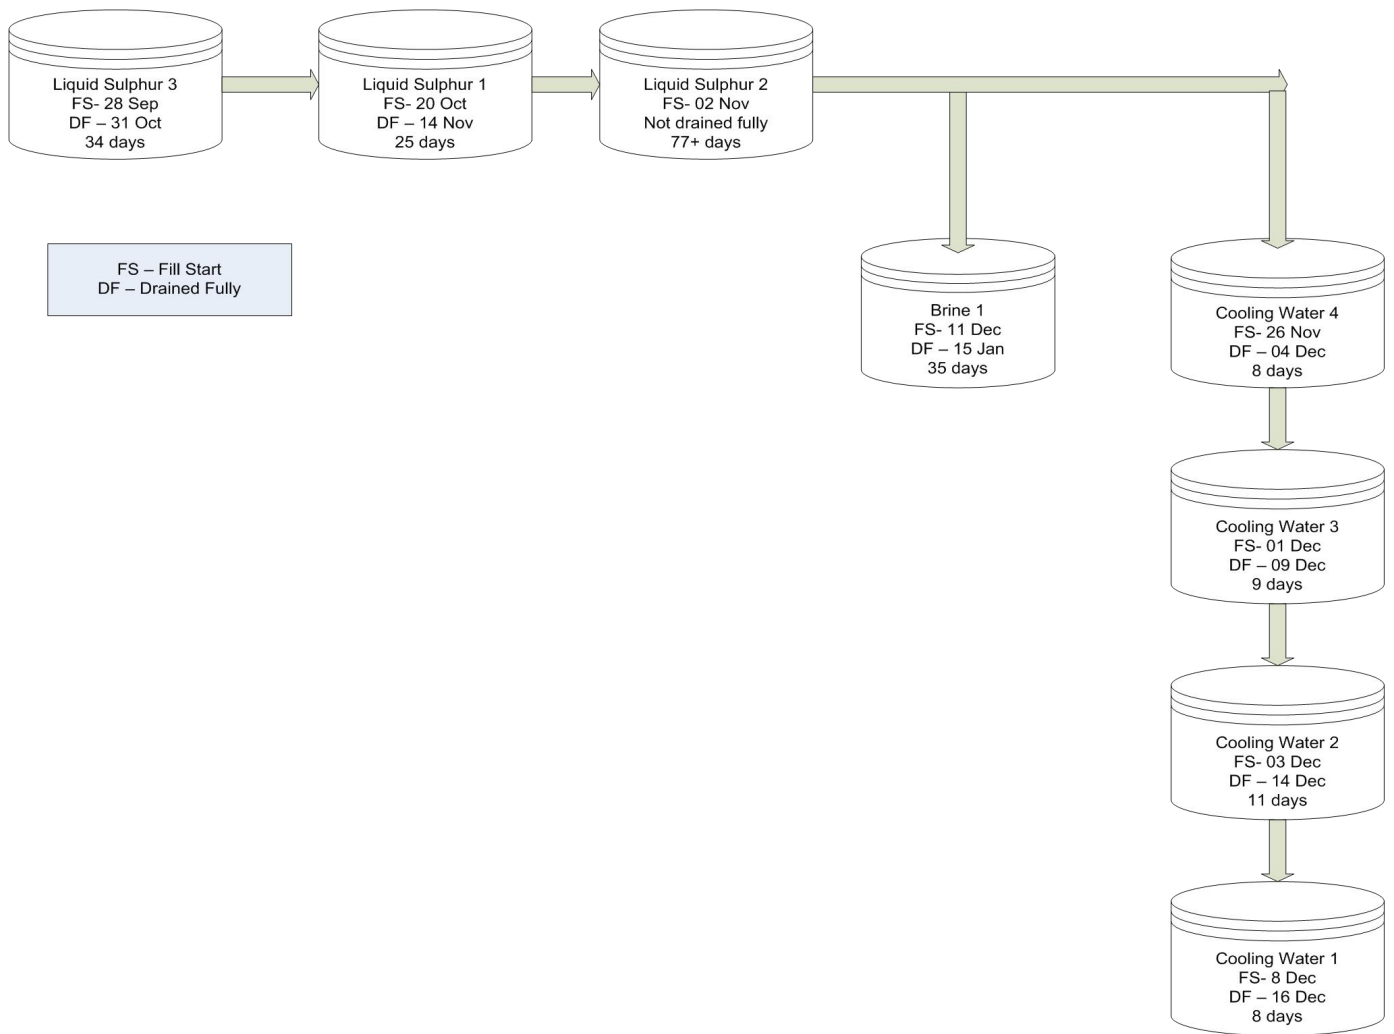
Secondly it is to be noted they are no filters used during the filling and transferring of the water from one tank to another. Therefore sedimentation, particle and bacteria are carried from liquid sulfur tank 3 to all other tanks downstream as shown in Figure-9.

Figure 9: Hydro Test Sequence Flow chart

Whenever there is transfer of water from one tank to other tank it shall be done by using proper filters to avoid carrying foreign materials from the source tanks. This filter used for filling shall be 50 micron before used in hydro static testing of the tank or equipment.
