**Microbiologically induced corrosion of austenitic stainless steel
equipment in coastal environment**

Indian Oil Corporation Ltd, Paradip Refinery, Paradip, Odisha, India
mitrask2@indianoil.in

NIGIS * CORCON 2017 * 17-20 September * Mumbai, India

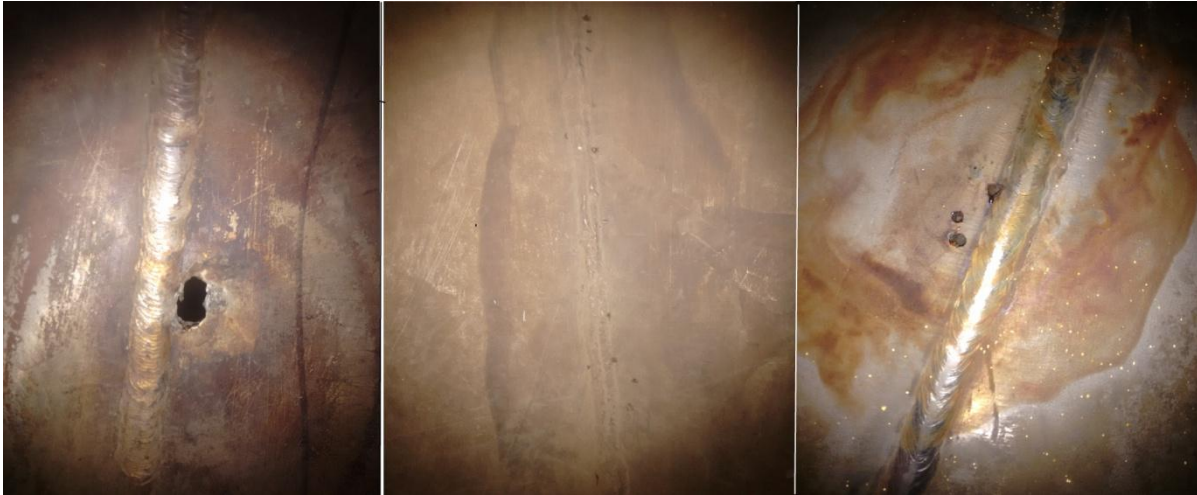
Severe pitting observed near the weld joints as well as parent metal of CBD vessel

Tubercle marks were seen around the pits indicative of the microbial induced corrosion. Cross-sectional examination of the pit was carried out which revealed the presence of sub-surface tunneling in the stainless steel. Corrosion deposit was also found near the pitting.

The chloride content in water stagnant in the vessel was found to be only 25 ppm. Under normal conditions low chloride water is not harmful to SS316. Chromium, molybdenum and nitrogen present in the stainless steel grade 316 provide greater resistance to the localized corrosion. Generally, 316 grade of austenitic stainless steel is used up to 5000 ppm of chloride at 40 C. Corrosion is not caused by microbes directly. They rather initiate or accelerate the electrochemical process. The presence of bacteria in the stagnant water causes the noble shift of open potential of stainless steel. Weld and HAZ have generally low pit initiation potential due to which the pitting generally initiate at weld joints and HAZ.

It is believed that Iron and Iron/Manganese bacteria colonize and form mounds at the weld seam to create concentration cell. Under these mounds, dissolution of ferrous and manganese takes place. Although the chloride ions are present in low concentration they are most abundant form of ion present in water. They are attracted towards the dissolved ion to maintain charge neutrality. The ferrous and manganous ions are oxidized by bacteria to form ferric and manganic. They form highly acidic chloride solution in the pit.⁴

Extensive repair job had to be done in the vessel in order to commission the unit. The vessel was removed from the pit after breaking the concrete over it and removing the sand of the pit. Extensive die -penetrant test of the vessel was carried out to identify the pittings which were not visible to naked eyes. All the identified defective locations were removed by grinding. Penetrant test was carried out again to confirm that all defects have been removed. Once confirmed that all the defects have been removed, welding was done. Since most of the pitting were concentrated around the weld joint of the vessel, circular seams were patched externally using SS316 plate. Vessel was

steamed with LP steamed for 07 days. After steaming, the Vessel was filled with water and quaternary ammonium compound (QUAT) biocide was mixed with it so that the remaining microbes present in vessel are killed and further damage to the vessel is prevented. The same was again kept for 10 days before water draining and taking the vessel into service.

Multiple cases of similar failures have also been reported in past. To prevent the failure of stainless steel equipments and piping due to formation of microbes, it is recommended that that for hydrotest, ballast testing etc, cleanest possible water i.e. demineralised water , steam condensate etc shall be used. Regardless of water quality, water from the vessel shall be drained, dried and inspected within 3-5 days after hydrotest. Proper isolation and preservation of the idle equipment and piping shall be done to prevent the ingress of water⁵.

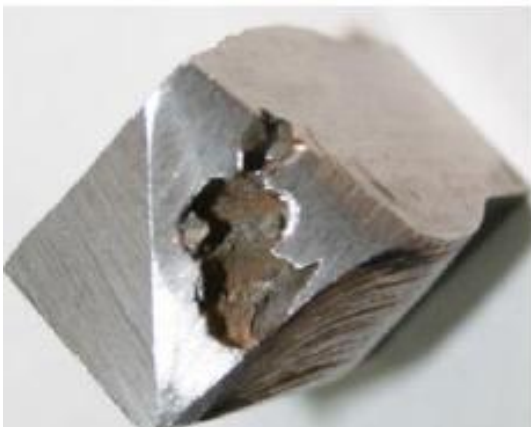
Cross section of the pit

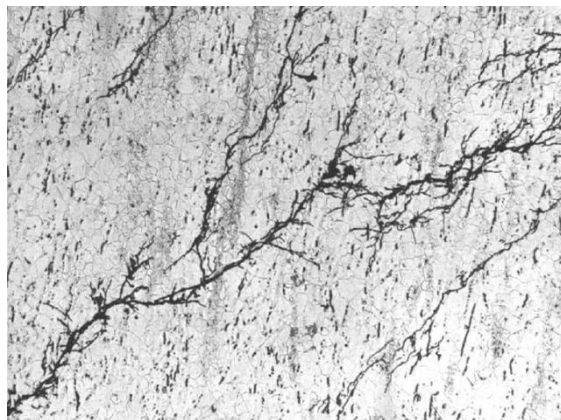
Metallographic image of pit near HAZ at 250X

Sectional metallography of the pit interior close to HAZ was carried out.. Branched transgranular cracks were observed in the HAZ region suggesting the presence of wet chloride condition inside the pit.³
