CASE STUDIES ON PROBLEM FACED IN CP SYSTEM DUE TO GROUNDING INTERCONNECTIONS.

NAVNEET KUMAR SHARMA

GAIL GAS LIMITED, AGRA
navneetsharma@gail.co.in

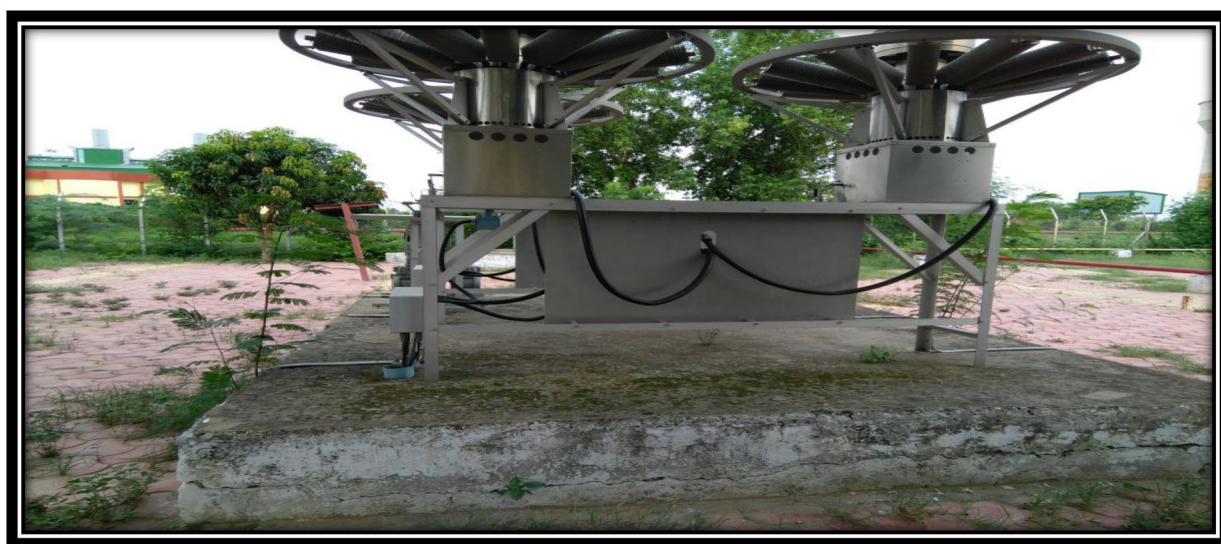
FIGURE 2: TEG SYSTEM WITH MOUNTING STRUCTURE

Now we got sure that power system itself is creating positive grounded power supply behavior even without any contact with the earthing system physically as all the visible contacts with the system were removed. This was mainly because of solid grounding achieved through the supporting metallic GI structure for the TEG system provided at the site. The support system which was made up of GI frame was giving perfect grounding to the positive side of the TEG system and it was grouted deep in the ground and providing enough grounding system to change the behavior of the power supply.

Although the problem was resolved by providing the alternate power supply, but other options like providing galvanic isolation between input and output circuit could also be used if the same input power supply was to be used for operating the CPPSM.

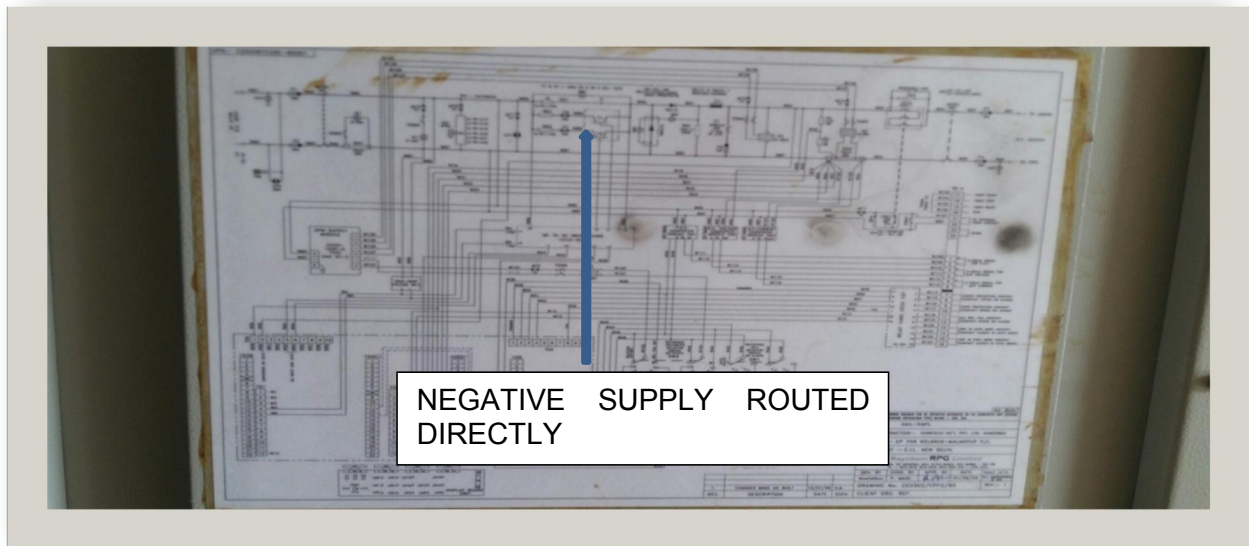
FIG 3: 24 V DC CPPSM CIRCUIT DRAWING

Now in case the supply is positive grounded- The positive supply voltage will be controlled by the bridge rectified to achieve the desired positive supply voltage but the negative supply will be passed through as such without any upside/downside. Here we were getting negative supply voltage of -22 Volts with respect to the ground.

So even in no load condition Anode to cathode voltage- 22 volts approximately (0- (-22)).

That's why even in case of no load condition the Anode current/CP current will be= $22/R$

In no load condition the current was in excess of 20 Amps and leading to fault condition not only for the current protection MCB but also to the feeding power supply. This was precisely happening in this case and no physical interaction was occurring in the output circuit with the actual grounding system at the station. Till now we were only concentrating on the physical connection with the grounding system but in actual the nature of power supply because of physical connection at source and which was also not visible and the design of the circuit were creating this problem.

Thus it is evident that the negative supply must be either grounded or floating type for the proper working of the CP system if the CPPSM is not having electrical isolation between input and output side. Otherwise also maximum 1-2 Volts of negative voltage can be allowed with respect to the ground for the working of the system which can easily be offset by voltage control provided in the positive side assuming the driving potential for current injection is good enough to compensate for the no load voltage in the circuit. In case the negative supply voltage is more than that, we must put isolator between the input and output supply voltage. Further such kind of grounding issues in the main power supply may arise and it is important to have some insight into the normal working of the CP circuit which may help in doing the troubleshooting exercise. This problem was quite regular in the CP stations of this pipeline system which could be addressed permanently with these fresh inputs. All the TEG hardware which was showing positive supply grounding was isolated and thereafter the CP system was found to be working perfectly alright. There may also be a situation in which current increment is marginal as in case of floating power supply and unit may supply slightly higher current than what is actually required. This may be more serious when the anode ground bed resistance is quite less. So the best solution can be by provide galvanized isolation between the input and output side.

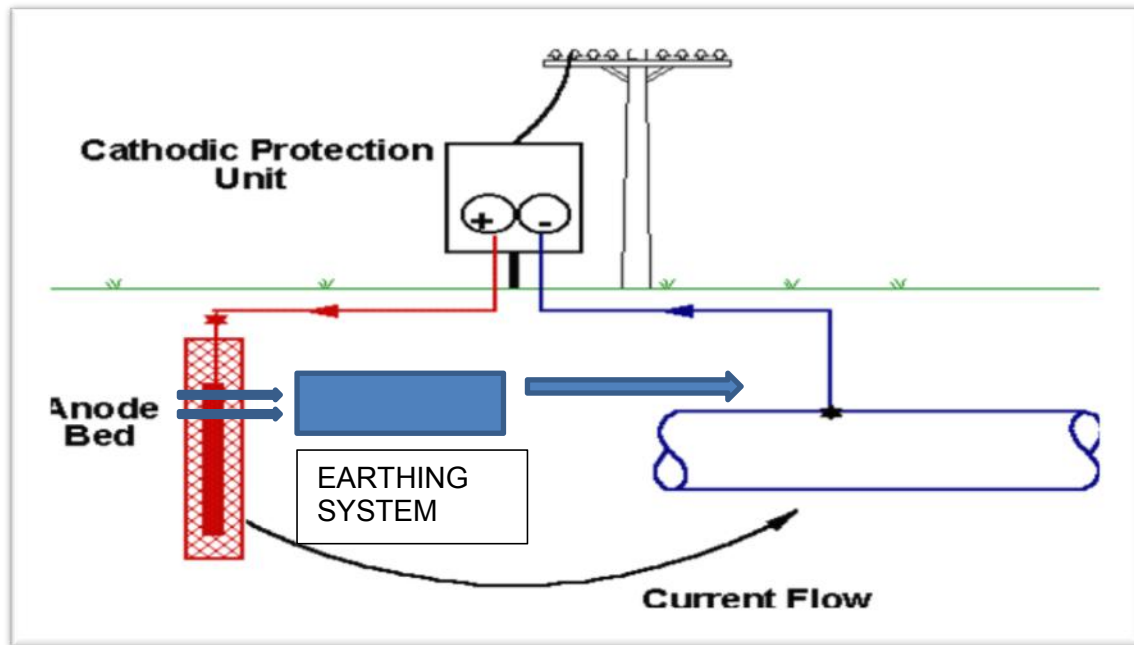
FIGURE 4: CIRCUIT SHOWING SHORTING OF CP DRAIN CABLE WITH STATION GROUNDING SYSTEM

- It became quite clear that the existing drain point Cathode cable is either accidentally came in contact with the grounding electrode or connected underground with the earthing system.

- The shorting was observed between the Cathode junction box and the pipeline using the megger testing of the existing cable.
- Accordingly a new cable was provided from the Cathode junction box and the pipeline.

All the CP cables and the grounding system are designed for the underground sections. There can be a possibility of partial or direct shorting between them which can create circulating of CP current within the premises of a terminal station/plant. This can increase the current level in the pipeline section but in actual it is not feeding the pipeline section and may lead to inadequate CP protection to the pipeline section. In order to address such situations in a timely manner, the system should have various checks and measures by devising preventive maintenance checklist to point out these subtle changes which may happen during the operations of the CP system. Further there can be a system of current appropriation at various levels in the CP system which can indicate the actual current that is feeding into the pipeline. Apart from these measures the same concept may be extended to develop system for identifying approximate current flow in the pipeline sections to have an indication of unintended current diversion which may happen due to presence of other underground utilities.
