**Cracking of AISI 321 stainless steel welds in solar thermal power plant:
Root cause analysis**

ABSTRACT

NIGIS * CORCON 2017 * 17-20 September * Mumbai, India

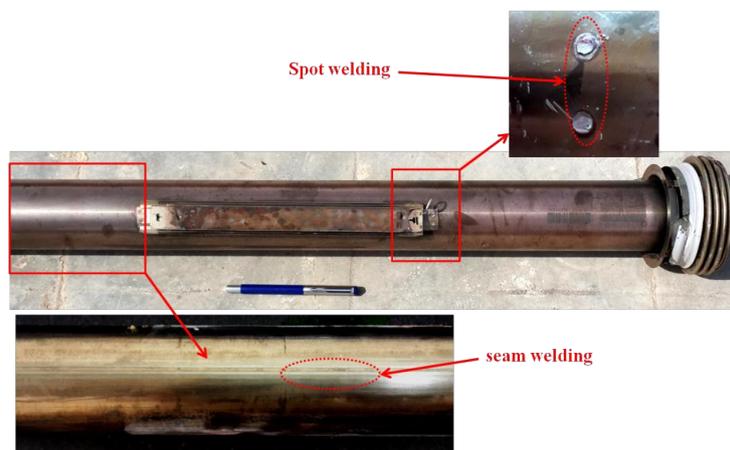
Figure 1: AISI 321 SS heat exchanger pipe indicating the location of seam weld and spot weld

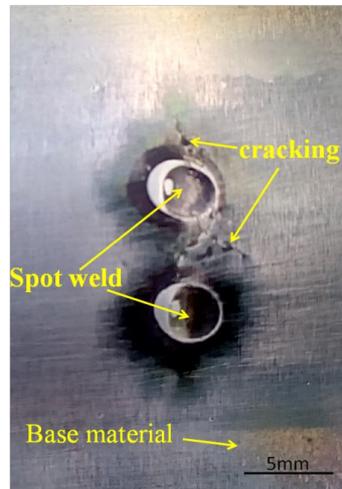
No macro cracks were detected on the surface of the pipes by visual examination. However, stains of thermic fluid were found near the seam weld and the spot welded regions. Dye penetration test was adopted to check for micro cracks on the surface of the pipes especially the welded regions. Hairline cracks near the weld zone were detected by this method as shown in Figure 2.

Figure 2: Hairline cracks detected near the spot welded region of the pipe by dye penetration test.

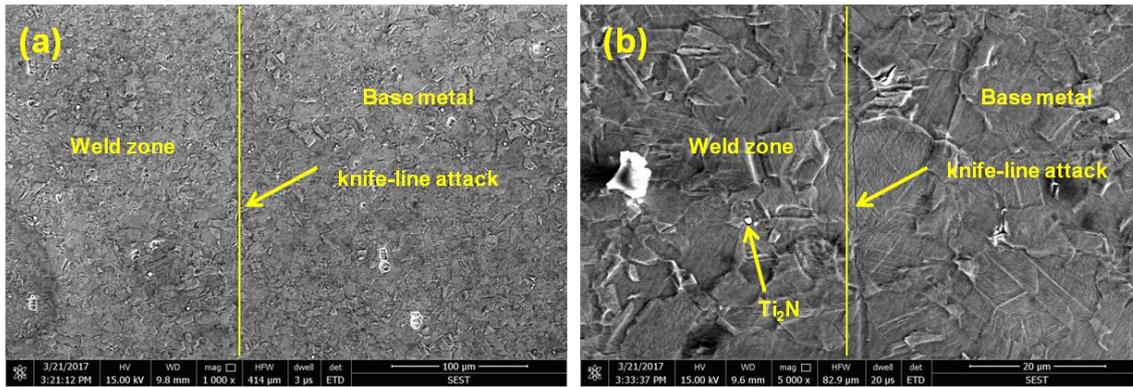
The cross section of the laser beam welded region of the pipe of AISI 321 SS is shown in Figure 3. The weld fusion zone contained the ferritic structure and the base material had equiaxed polygonal grains with intermetallics. Detailed investigation of the cross-section of the pipe at various locations of the interface revealed that very fine cracks do exist just at the interface of the fusion zone and the base material.

Figure 3: Optical Micrograph of cross section of LBW 321 SS pipe (a) showing cracks at the interface of the fusion zone and base material (b) image of the interface at a high magnification

Figure 3 (a) shows the weld zone with the attack at the interface of the fusion zone and base material. Figure 3 (b) gives a magnified view of the cracked region. The attack in the case of laser beam welded samples were very sharp in nature just at the interface of fusion zone and a base material exhibiting the typical characteristics of 'knife-line attack' in stabilized grades of stainless steel like AISI 321 and AISI 347. The TiC/ NbC dissolve at temperatures above 1150°C. The region just adjacent to the fusion zone is exposed to very high temperatures. Thus the carbon in this region remains in solid solution and no carbides (TiC/ NbC/Cr₂₃C₆) were precipitated due to rapid cooling. However, at a later stage if this alloy gets exposed to the sensitization temperature range of 400-750°C Cr₂₃C₆ precipitates form in this region making the alloy susceptible to intergranular corrosion. Hence proper post weld heat treatments of these alloys are compulsory before these can be put to service [7]. In the present case study, the service temperature to which the pipes had been exposed in the solar thermal power plant was 400°C and the service environment i.e. the thermic fluid flowing through it contained Cl⁻ ions. Hence the AISI 321 SS welds exhibited intergranular corrosion along a very narrow region just adjacent to the weld fusion zone which is a characteristic of a knife- line attack. Hence the leakage of the thermic fluid from the pipe in case of laser beam welded pipes were due to the occurrence of knife-line attack due to improper post weld heat treatment applied to the AISI 321 SS.

a) The laser beam welded pipes underwent knife-line attack due to improper post weld heat treatment of the welds. The attack led to leakage of the thermic fluid through this region.

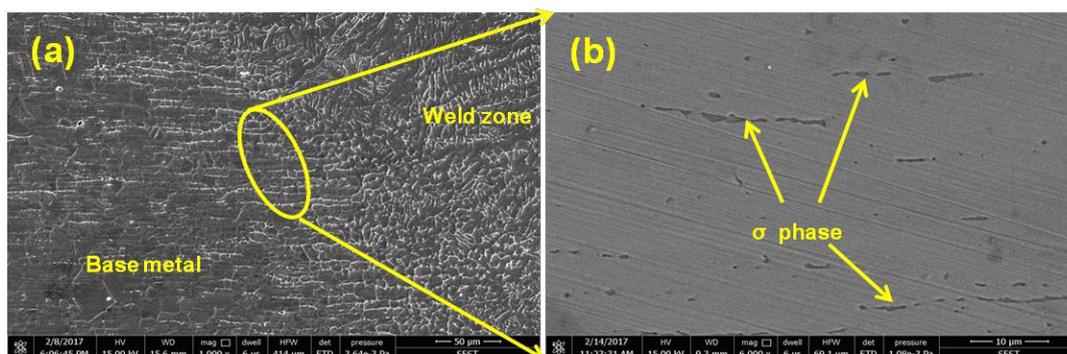
Figure 4 (a) shows the FESEM micrograph of the pipe in the MIG welded region showing the interface of the fusion zone and the base material (in this case the specimen was etched in 10% oxalic acid solution). The average grain size of the base metal is $\sim 30 \pm 10 \mu\text{m}$. FESEM images of the weld region revealed a high density of σ phase formed near the weld region and extended throughout the austenitic base material. Figure 4 (b) shows the FESEM micrograph of the pipe in the MIG welded region showing the interface of the fusion zone and the base material (the specimen is etched in 10% KOH solution, in order to reveal the σ phase. The micrograph clearly shows the σ phase formation near the interface of the weld region. The morphology of σ phase is stringer like and it is oriented in the hot working direction of the plate from which the pipe is fabricated. The needle-like morphology of the σ phase results in high-stress concentration at the tips resulting in stress assisted dissolution. Hence the formation of σ phase is detrimental for the corrosion behavior and cracking resistance of the austenitic stainless steel AISI 321 SS. It is difficult

to prevent the precipitation of σ phase when Cr content is above 20 wt% in SS. In addition to this, the presence of strong ferrite stabilizers (like Cr, Si, Mo) in SS rapidly leads to the formation of σ phase. When the Cr content is below 20 wt. %, the precipitation of the σ phase is not readily observable in austenitic stainless steels [9].

Figure 4: a) FESEM of cross section of metal inert gas welded AISI 321 stainless steel pipe near the weld interface and b) FESEM image of the σ phase at higher magnification (etched using 10% KOH solution)

b) The MIG welded pipes had a high density of detrimental σ phase precipitated near the weld zone which resulted in corrosion at the interface of the σ phase and austenitic matrix resulting in leakage of the thermic fluid. Such a failure can be avoided by keeping careful control over the filler wire composition. Lowering the ferrite content in the filler wire would prevent such an attack.

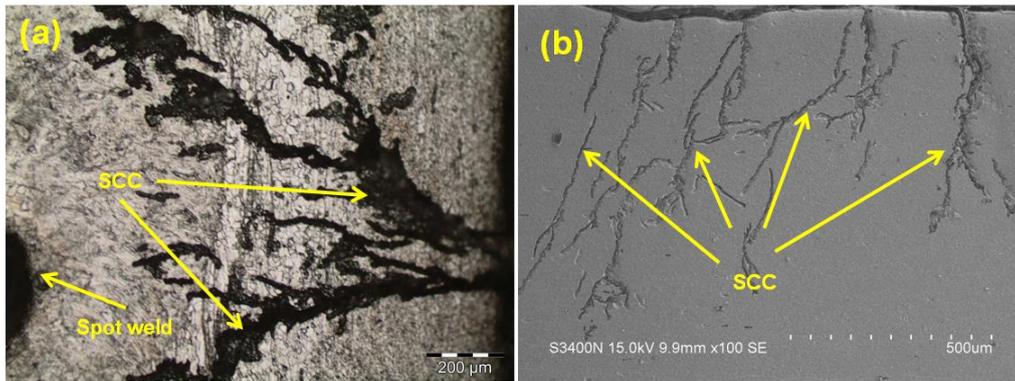
The microstructural characterization of the spot welded region provided clear evidence of the occurrences of stress corrosion cracking in this region of the AISI 321 SS pipes. Figure 5 (a) shows the cross-sectional view of the pipe in the region near the spot weld with a number of cracks. Figure 5 (b) gives the magnified view of cracked region and the spot welded region can be seen as a dark patch near the outer surface of the pipe. The Figure clearly indicates that the cracks initiated from the inner surface of the pipe and extended towards the outer surface. Extensive cracking was observed and the cracks were transgranular in nature. Crack branching and transgranular cracking are a characteristic feature of chloride induced stress corrosion cracking of austenitic stainless steel in chloride environment. SCC is a phenomenon which occurs under the synergistic action of tensile stresses, aggressive environment and susceptible material. Austenitic stainless steel is highly susceptible to chloride induced SCC in presence of tensile residual stresses and Cl^- ions [] Hence, the initiation of SCC from the inner surface of the pipe indicates the presence of tensile residual stresses in the inner surface of the pipe which may result from improper post weld heat treatment.

Figure 12: Shows the optical micrograph of stress corrosion cracking in the spot welded region of AISI 321 SS pipe. Transgranular cracks with extensive crack branching seen

c) Chloride induced stress corrosion cracking of the spot welded region led to the leakage of the thermic fluid from this region. Proper post weld heat treatment should be given to relieve the tensile residual stresses present in the inner surface of the pipes to prevent such stress corrosion cracking instances in future.

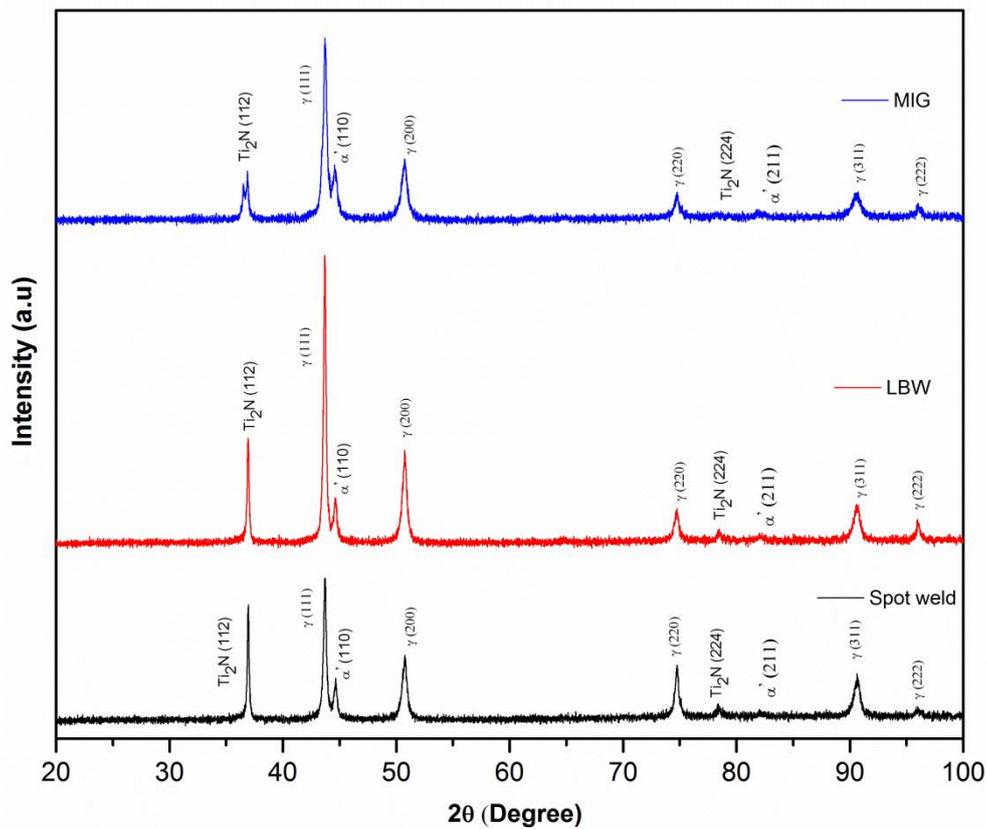
The X-ray diffractograms of the weld regions of the LBW, MIG weld and spot welded specimens, along with the base material are shown in Figure 3. The presence of the signature peaks of austenite for the all weld specimens can be clearly seen. Whereas the other peaks also identify those are Ti_2N and martensite.

Figure 3: X-ray spectra of 321 SS under different welded conditions
