**Case Study on Premature Failure of Super-Heater Tubes in Oil & Gas
Fired Boiler**

Keywords: Keywords: Boiler, Super-heater, Creep, Oxidation, Long term Overheating

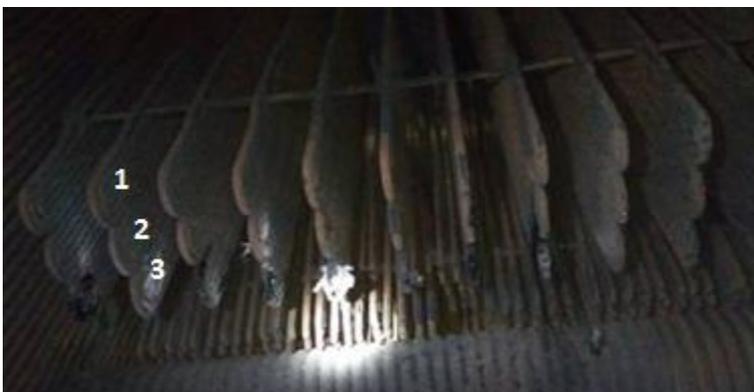
Figure 3. Arrangement of hanging platen Superheater Coils as seen from bottom of tubes. Location of failure was concentrated in first 7 tube clusters (counting from left) in the 3rd row (MOC SA 213 TP 347H), which was away from the burner.

Note: Failure was also observed in the steam cooled spacer tube. (Horizontal tube in the figure)

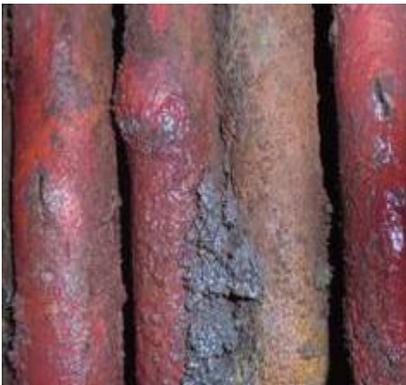
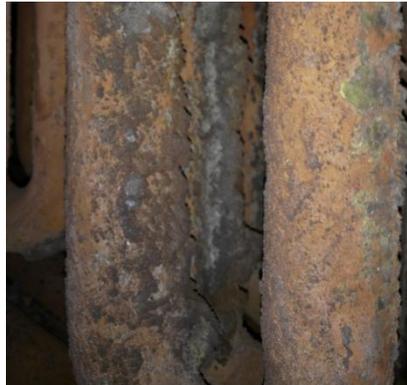
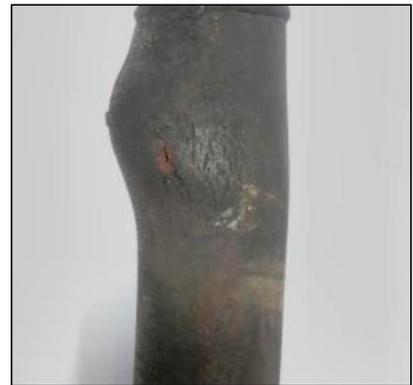
- 5.1 Thick and hard clinker deposits were observed on the external tube surface of both T22 & TP347 H tubes. Narrow openings in the tubes were observed when the deposits were forcefully removed from the swollen part of the tubes as shown in Figure 4, 5 & 6.

- 5.2 Severe localized swelling was observed in the coils near the U bends in all the 15 affected tubes. Other than localized swelling no appreciable OD growth was observed in the tubes.

- 5.3 Multiple cracks aligned parallel to the longitudinal direction of the tubes were observed. Narrow openings with thick lip, indicative of long term overheating, were also observed in the tubes.

Heavy clinker deposits can be seen in the tubes. Localized swelling and narrow openings with thick lips can also be seen in the images.

8.3 External cleaning of tubes were carried out using grit blasting to remove all external deposits from the tubes.

8.4 Ceramic ropes were tied on the bends of Superheater coils in the high heat flux zone to maintain the tube skin temperature below design limit.

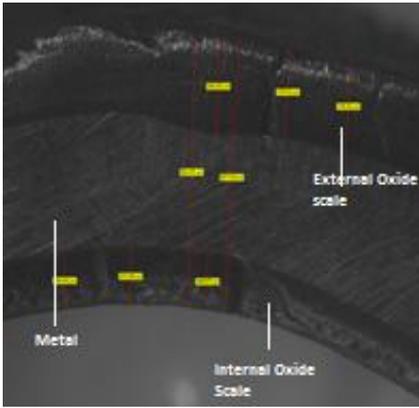
- 5.4 Thick & adherent oxide scale formation was observed on the internal & external surface of T22 tubes. Upon dissecting the tubes thickening of magnetite layer was observed in the internal tube surface. Cracking of the internal & external oxide layer was observed in the bulged location of the tubes.

Figure. 6
Stereograph along the thickness of tubes showing thick oxide scales

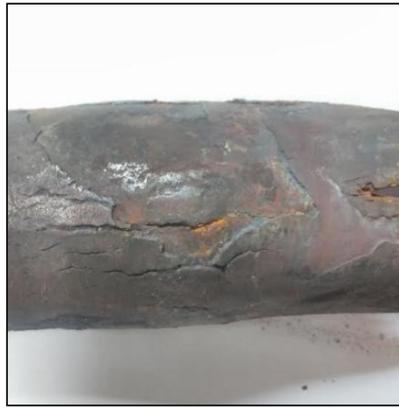
Figure. 7
Oxide scales on the external surface of the tube. Cracks in the layer can be seen in the bulged portion of the tube

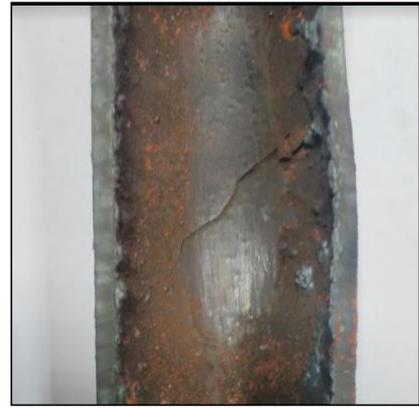
Figure. 8
Oxide scales on the internal surface of the tube.

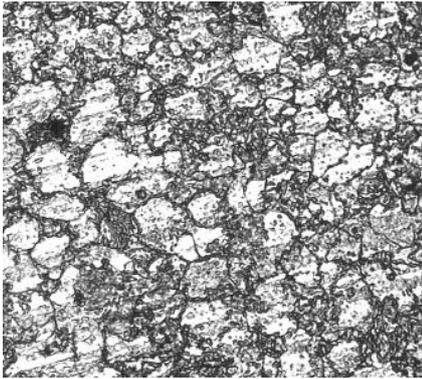
7.1 Microstructure of the T22 samples, as shown in Figure 9a, 9b & 9c, consist of deformed polygonal grains forming the ferrite matrix. Unlike the undamaged tube location, the microstructure of bulged location has globular carbide precipitation inside the grains and on the grain boundaries. Creep voids along the grain boundaries were also seen in the microstructure.

Figure 9a.
Microstructure of SA 213 T22 Tube away from the rupture location at 200X.

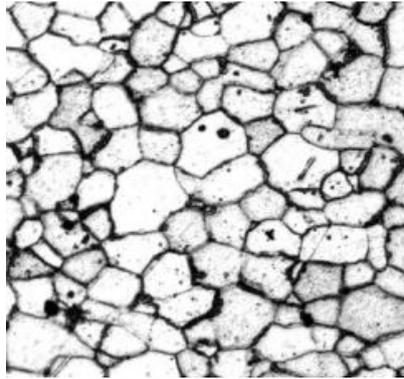
Figure 9b.
Microstructure of SA 213 T22 Tube at the rupture location at 200X. Unlike Fig 8a, globular carbide precipitation and microvoids can be seen in the matrix & grain boundaries

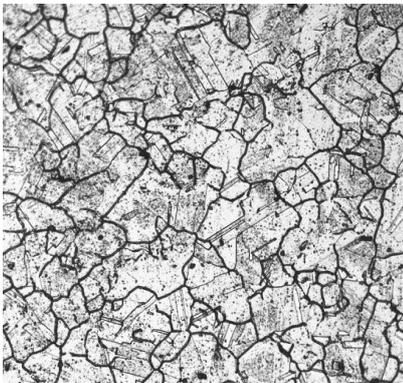
7.2 Microstructure of TP347 H tubes, as shown in Figure 10a, 10b & 10c, shows austenite grains with heavy carbide precipitation on the grain boundaries, marking the sensitization of the stainless steel material. Moreover creep voids at grain boundaries suggesting creep damage can also be seen.

Figure 10a.
Microstructure of SA 213 TP347H Tube away from the rupture location at 200X.

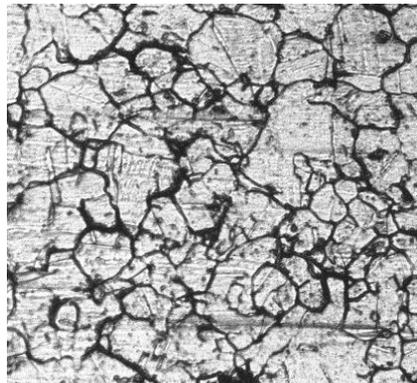
Figure 10b.
Microstructure of SA 213 TP347H Tube at the rupture location at 200X. Carbide precipitation along grain boundaries indicating sensitization can be seen in the microstructures.
