**Paper No.
PPU22**

Failure of HRSG tubes during Pre-Commissioning Hydro test

Mahesh.S

Bharat Petroleum Corporation Limited, Kochi Refinery, Kerala, India
maheshs@bharatpetroleum.in

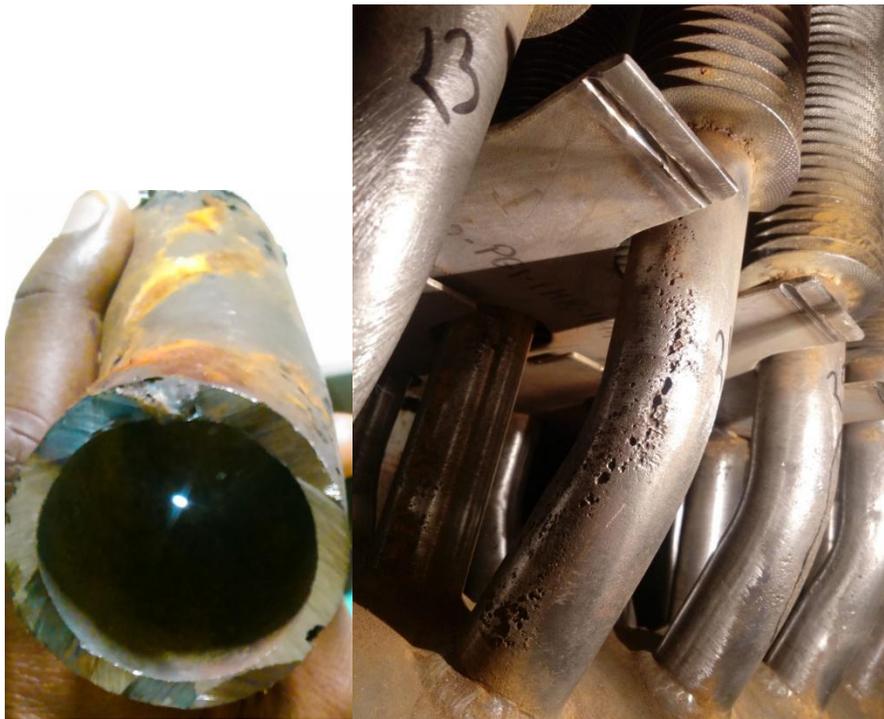
Figure-3 : Super heater tube, T91, pin hole & pitting

To carry out the repair work insulation was removed for nearby tubes also. Pitting was observed in some of these tubes as well, hence inpection was extended to all the accessible areas of modules. It was observed even pitting was there on T91 tubes. Please refer figure-3 for the hole & pitting on T91 tubes. Figure-4 shows some pitting on the economizer tubes.

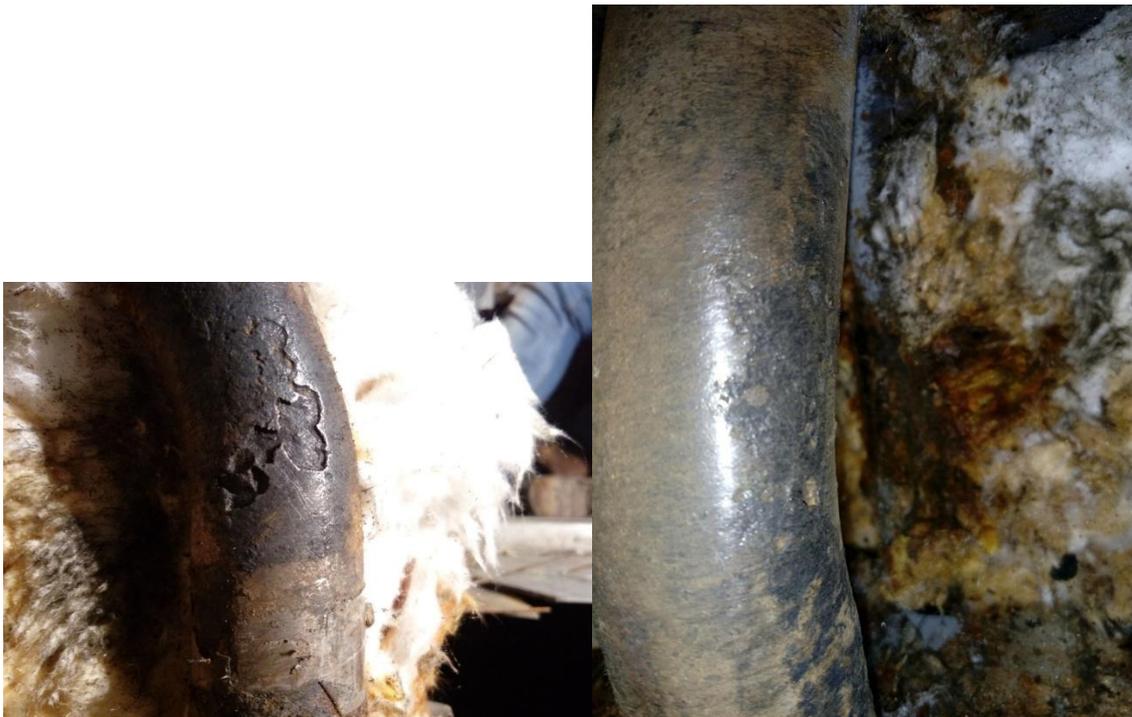
Figure 4 : Economiser tube pitting

As a first step after the leakage, baffle plates and insulation were removed to access the leakage spot. Inspection of Economiser module revealed pitting of tube which had led to leakage.

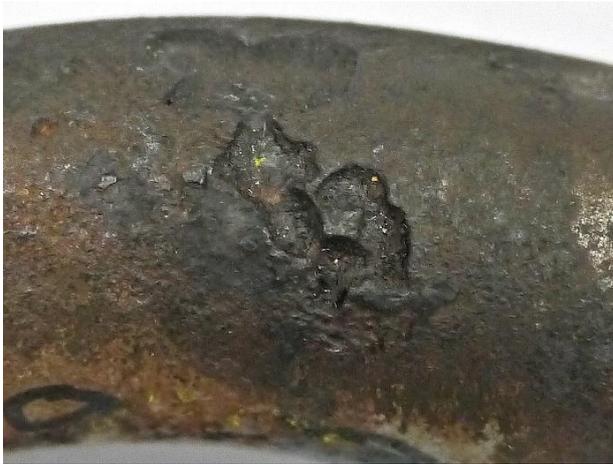
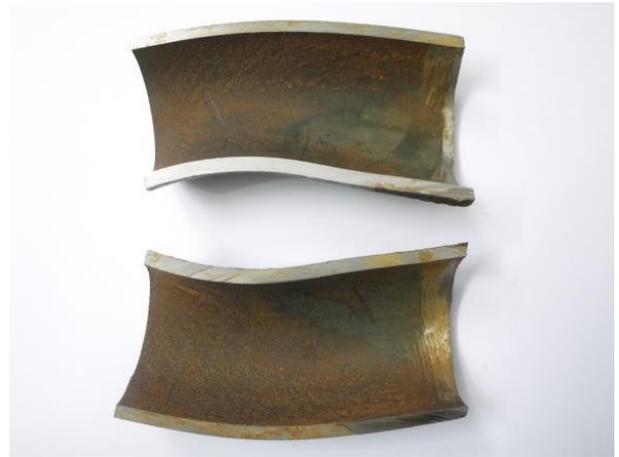
Figure 5: Economiser tube detailed analysis

Based on peculiar pitting pattern observed on the tube surface, tube sample were analysed for microbiological pitting. After analysis, it was confirmed that the failure of the tube was due to microbial induced corrosion (MIC). Refer Figure-5 for the photos. EDS analysis result are available in Table-3

Pitting is in cluster form having uneven contours and depth are noticed spread over the outer surface. The depth into the tube matrix is uneven and slanted having spongy appearance due to interconnectedness of small size pits in adjacent surroundings. Along with these features and presence of high level of carbon and sulfur in EDS analysis into the pit, points towards onset of MIC (microbial induced corrosion) damage.

No specific pattern of pitting was observed on the tubes and this pitting was found to be taking place at random. It can be concluded from above analysis that failure has occurred due to MIC.

Root cause for failure is the ingress of rain water & its presence for a long duration in the ceramic wool insulation during storage & erection. Also the quality of paint is also to be ascertained as the paint was applied considering the operation philosophy. Protection during storage period was not considered (against CUI) while selecting the paint. Hence it is important to ensure that such system has proper painting and sealing till the completion of erection to avoid such failure in the future.

Shows close-up view at one such location of pits. They appear to be in cluster form having uneven contours and depth. Pit surface looks blackish in appearance.
