# Integrity Challenges & Control - Tank Bottom Corrosion Shakeel Isak Girkar

This paper focuses on case study of crude oil tank bottom plate failure due to corrosion and discusses its causes, design and installation errors, analysis of CP effectiveness, inspection strategy, interpretation of damage mechanism and recommendations.

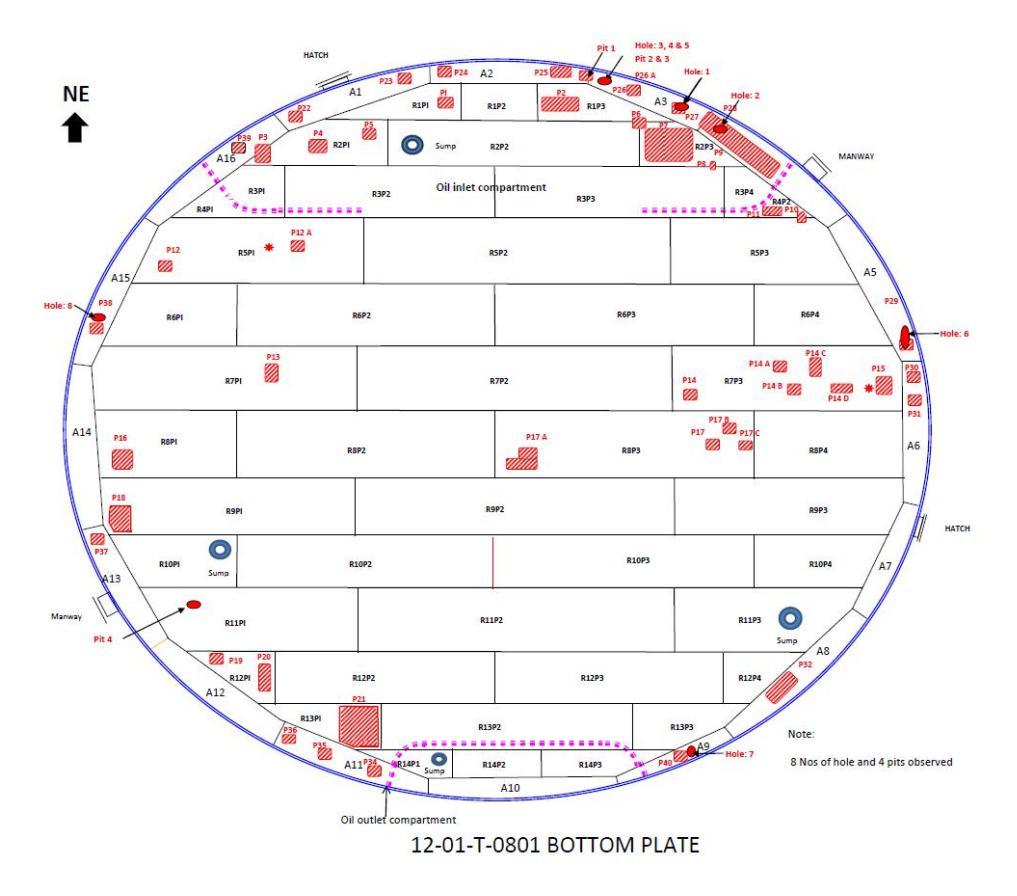
Figure (1)

Magnetic Flux Leakage (MFL) and subsequent confirmation with Ultrasonic Test (UT) scanning of bottom and annular plate revealed an average metal loss from 60% to 70%. Soil side corrosion was the predominant factor resulting in heavy metal loss of the bottom plate. Through thickness holes were also observed at 8 locations (Figure 1&2)

It was noted that the external corrosion pits were developed on or near to the annular plate.

- Scale analysis from the cut plates showed that the majority was iron oxide mixed with sand.
- MFL & Subsequent confirmation with UT scanning of bottom and annular plate revealed metal loss between 60% to 70% (ref fig.1&2)

- In view of extensive underside corrosion attack of tank bottom annular plates (associated with high loss of wall thickness) it was recommended to replace the affected annular plates completely with new plates, perform the welding of annular plate with shell and carry out field hydro test.
- Apply GRE lining system (3.00mm OFT) at tank floor and shell up to 2.5 mtrs. height (water level) meanwhile eliminates the installation of sacrificial anodes.
- Repair and rectify the sealing arrangement as per approved foundation drawing to achieve 100% sealing and avoid moisture ingress.
- Replace the crushed stone with clean sand in the marked zone with a min. depth of 50mm underside the annular plate, which will avoid air gaps and ensure better Cathodic Protection.

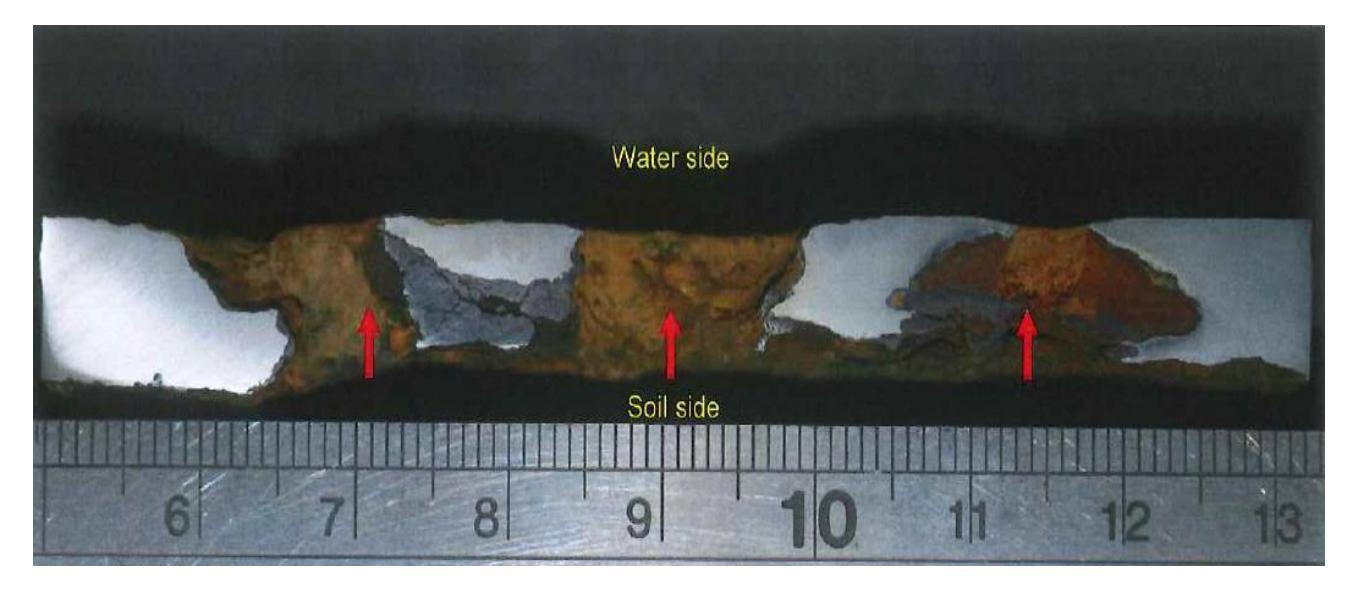
Figure (5)

- iii. No evident corrosion damage was found on the water side of the three samples.
- iv. Failure of the three plate samples can be mainly attributed to severe pitting corrosion. All the corrosion pits / holes initiated from the soil side surface, which is likely due to accumulated moisture on the soil side of tank bottom plates.(Figure 5 and 5a)

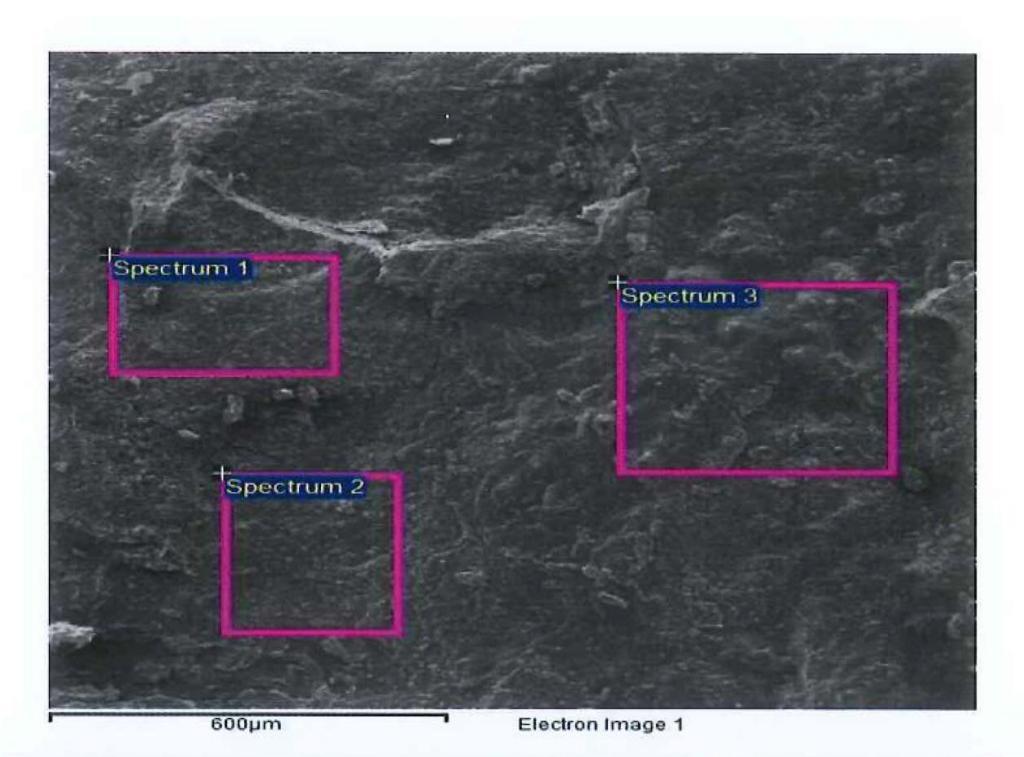
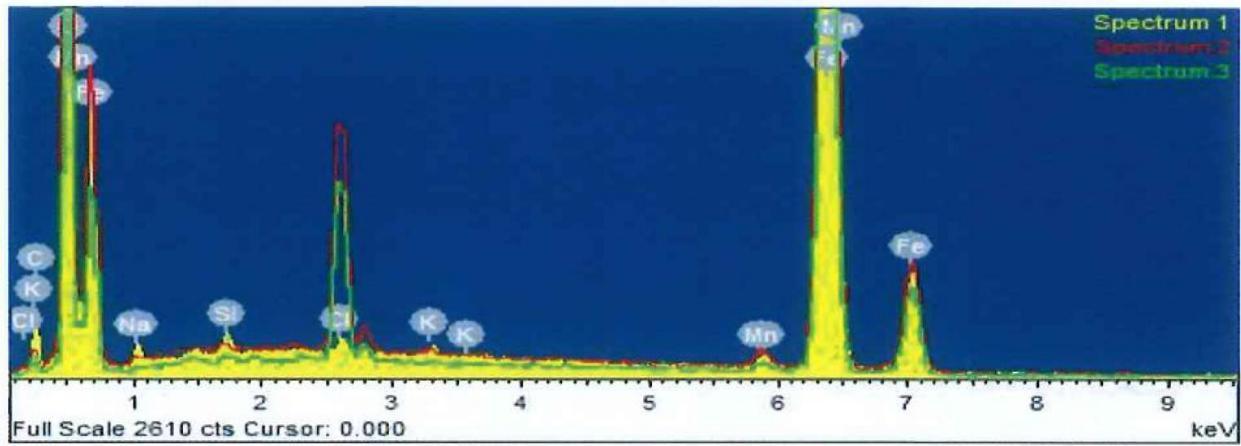
Figure (6)

- v. The observed pits / holes are filled with black and brown color corrosion products, SEM EDS analysis showed that these are mainly Iron Oxides with high amount of Chlorides. (Figure 6)

SEM EDS analysis shown that the corrosion products are mainly Iron Oxides with high amount of Chlorides.

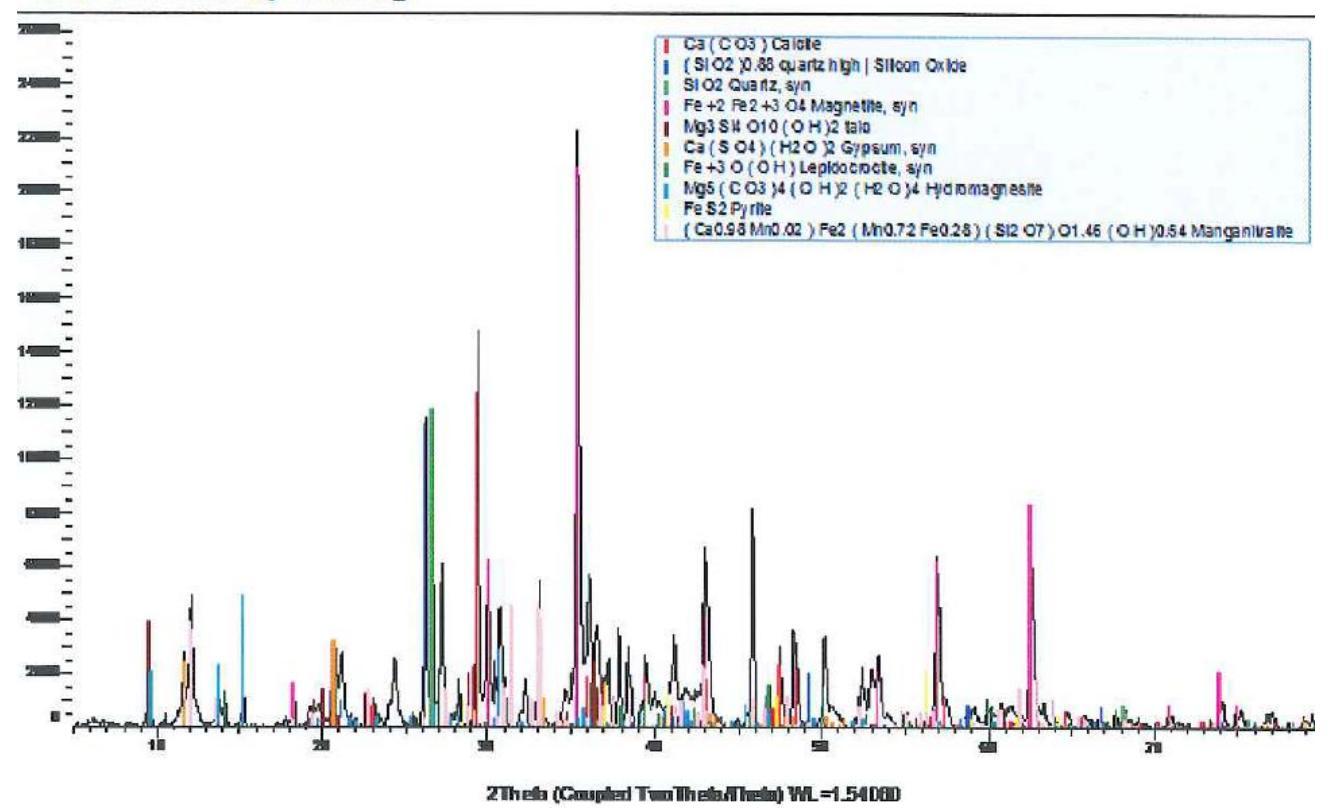
#### Figure (7)

- vi. XRD analysis on soil Lump covering pit confirms the tubercles consist of mainly iron oxides and hydroxides.(Figure 7)

X-ray diffraction analysis of the sample plates' soil side indicated the tubercles consisting mainly of iron oxides and hydroxides.
