### Corrosion of CO<sub>2</sub> absorbers – whys and wherefores Ramakrishnan Seshagiri

#### L&T Hydrocarbon Engineering Limited, Mumbai, India

#### ABSTRACT

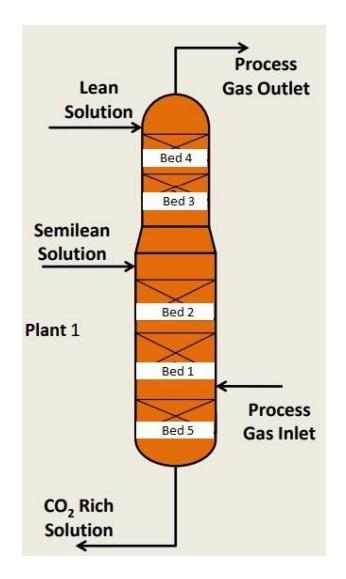
Figure 1. Schematic of CO<sub>2</sub> absorber of Plant 1

Grooving of absorber walls were observed at 0° to 50° and from 180° to 360° taking reference from process gas inlet nozzle which is located between bed 1 and bed 5 (Figure 1). Metal loss ranged from 7 mm to 18 mm along the grooving. Puncture/hole was observed at 22° near the distributor lateral end hole. Impingement marks were observed at 40° and 180° where maximum metal loss up to 33 mm occurred. Much of the grooving was observed adjacent to the process gas inlet nozzle. The top portion of the process gas inlet nozzle was found badly corroded and heavy deposition of GV solution was also observed. The tray supporting ring experienced heavy GV solution deposition and was corroded beyond repair. Rest of the bed portions like middle section and top sections of the absorber walls were not affected. The corroded portions of absorber shell, process gas inlet nozzle and tray supporting ring are shown in Figure 2.

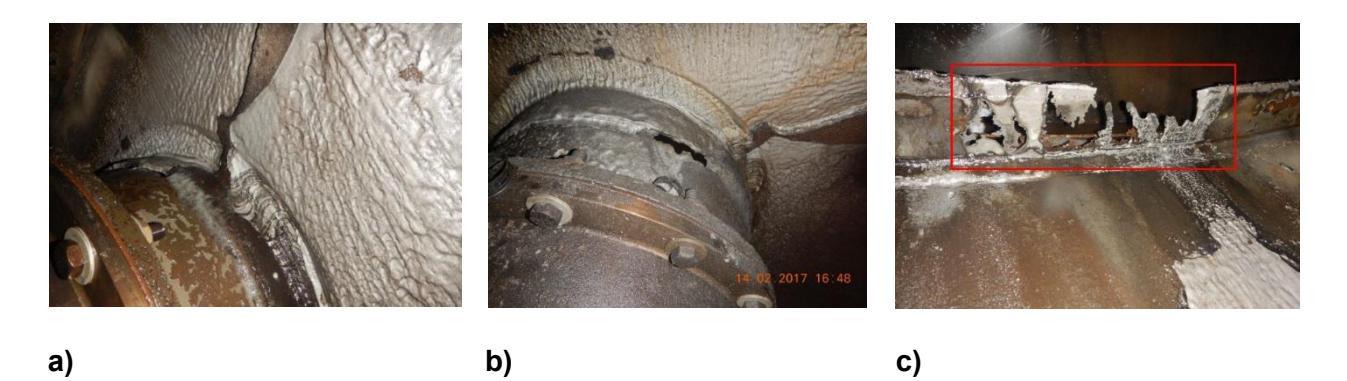
Figure 2. Plant 1 – CO<sub>2</sub> absorber section a) Grooving on absorber walls b) Corroded portion of process gas inlet nozzle c) Corroded tray supporting ring

Cut samples from the corroded process gas inlet nozzle and tray supporting ring were brought from the plant for analysis. Top portion of inlet nozzle showed heavy deposition of GV solution and complete metal loss portion (Figure 2). Solution flow patterns were also observed on the top portion of the nozzle.

Profound thinning and extensive corrosion were observed on the tray supporting ring (Figure 2). A portion of of the tray supporting ring had experienced complete metal loss beyond repair.

The failure of the process gas inlet nozzle and the tray supporting ring may be attributed to channeling of GV solution which caused excessive GV solution deposition. Improper bed and packing arrangement, destabilizing upsets might have caused channeling of GV solution flow. Due to excess GV solution flow on the nozzle and tray supporting ring, the meta-vanadate passivation layer was affected resulting in rupture of passivation layer and subsequent corrosion which is substantiated by the very low V content in PMI results.

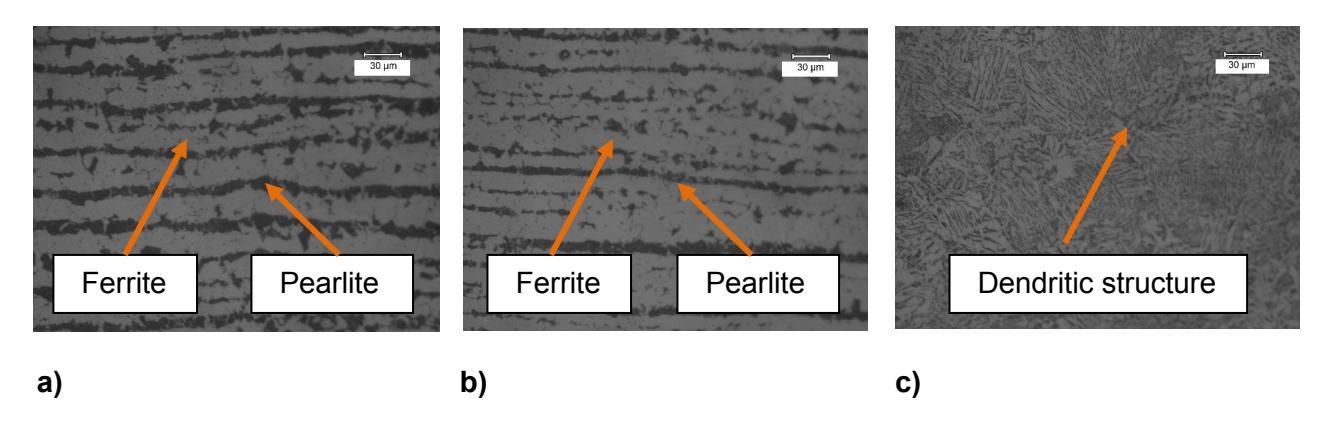
Cross section of samples from nozzle and tray supporting ring samples were cut, polished and etched in 2% nital solution and observed under Olympus GX51 optical microscope at 500x magnification which revealed banded microstructure ferrite-pearlite (Figure 3) indicating base material and dendritic microstructure indicating nozzle weld.

## Figure 3. a) Microstructure of process gas inlet nozzle parent metal b) Microstructure of tray supporting ring c) Microstructure of process gas inlet nozzle weld region

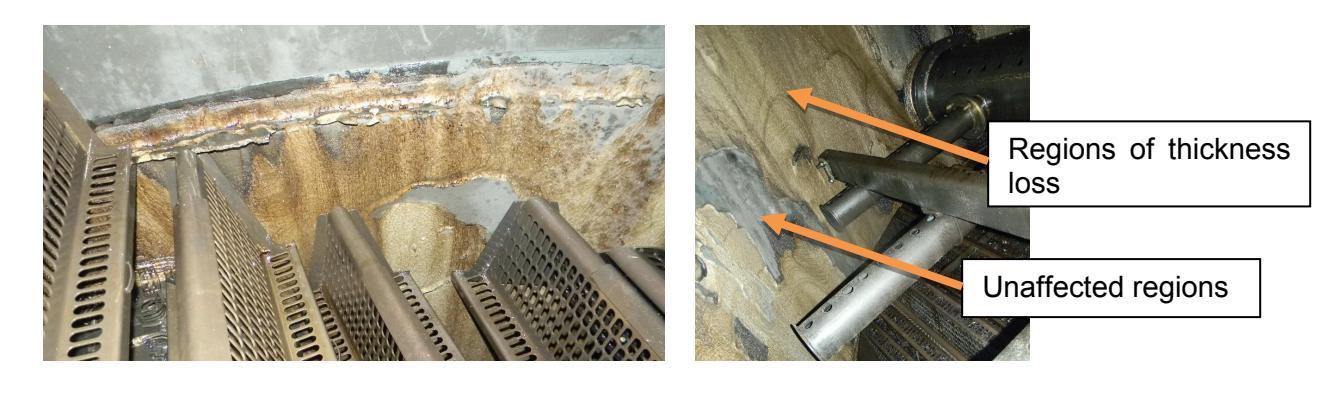
Leakage was reported from bottom of bed 1 of CO<sub>2</sub> absorber section at an Ammonia Plant in Plant 2 and subsequently the plant was taken for a shutdown. The absorber suffered a puncture through which the leakage was observed near the long seam of the first shell located at bottom of bed 1. Profound reduction in wall thickness was observed in the region between longitudinal seam at 315° and 135°. Severe attack on the bed 1 tray supporting ring was also observed. Region where reduction in wall thickness had occurred is observed with groove marks which are typical to erosion-corrosion. Accelerated metal loss led to the failure of absorber in a relatively short time. The photographs of the affected portions of the absorber are shown in Figure 4.

# Figure 4. Plant 2 – CO<sub>2</sub> absorber a) Corroded tray supporting ring b) Affected and unaffected portions of absorber walls

The flow of acid gas loaded GV solution with higher velocity along the walls of shell of the bed-1 region could likely be the reason for the chemical attack and erosion-corrosion. This is possible due to damaged gasket in liquid distributor tray, which might have caused liquid flow along the wall between  $315^{\circ}$  and  $135^{\circ}$ , thereby damaging the passivation layer and eroding/corroding the metal beneath. The solution might have gained velocity while flowing along the shell of bed-1 region and probably exceeded critical velocity at the lowest shell course of the bed-1 region, due to which erosion-corrosion of the shell occurred. It appears that the long seam at  $315^{\circ}$  and  $135^{\circ}$  degree had thwarted the erosive action of the rich solution, due to their slight higher hardness as compared to parent material. At the dummy bed region, entire shell internal diameter was eroded/corroded, which can be probably attributed the turbulence created by  $CO_2$  gas, which is entering at that region. Below the liquid level, it is obvious that no corrosion would occur since passive layer is intact (absence of erosion).

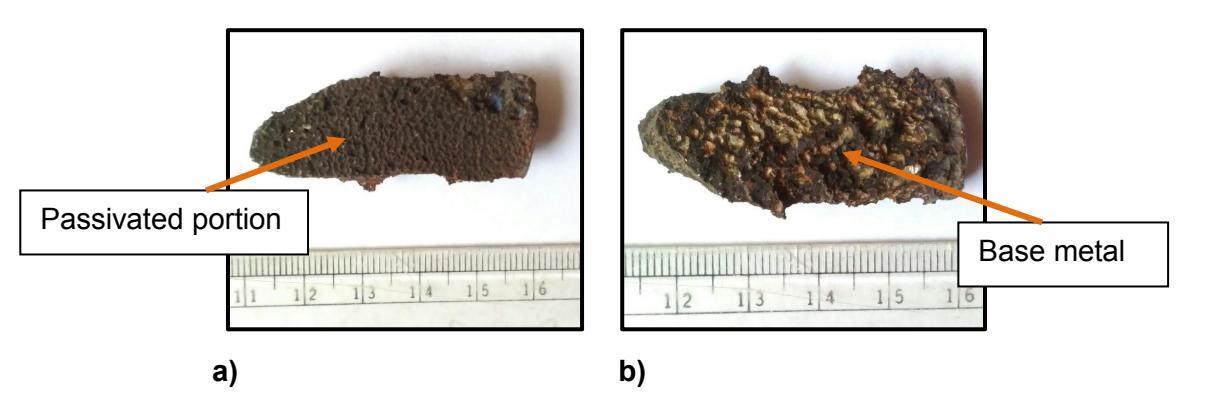
Chipped off samples (Figure 5) from the  $CO_2$  absorber were analyzed by Oxford X-Met 5000 PMI on both passivated and debase metal portion of the chipped sample (Table 2). PMI results show 3 wt% V on the passivated portion and 0.1 wt% V on the carbon steel base metal portion.

Figure 5. Chipped off carbon steel sample from  $CO_2$  absorber a) Passivated portion b) base metal portion

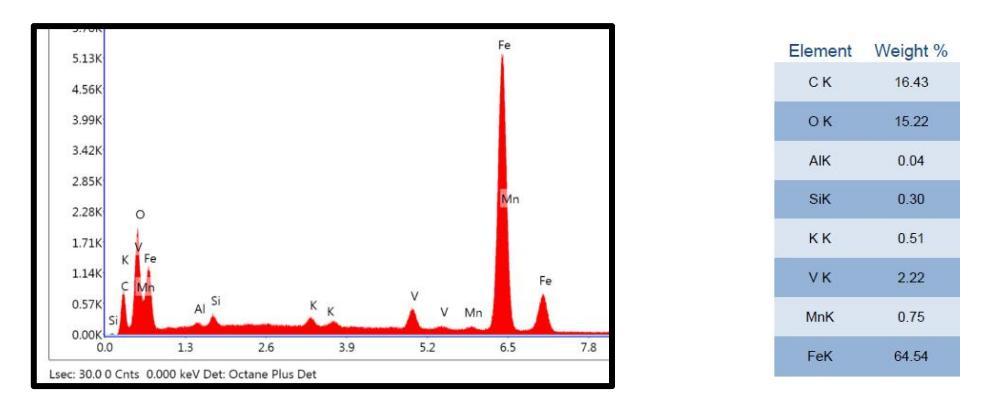
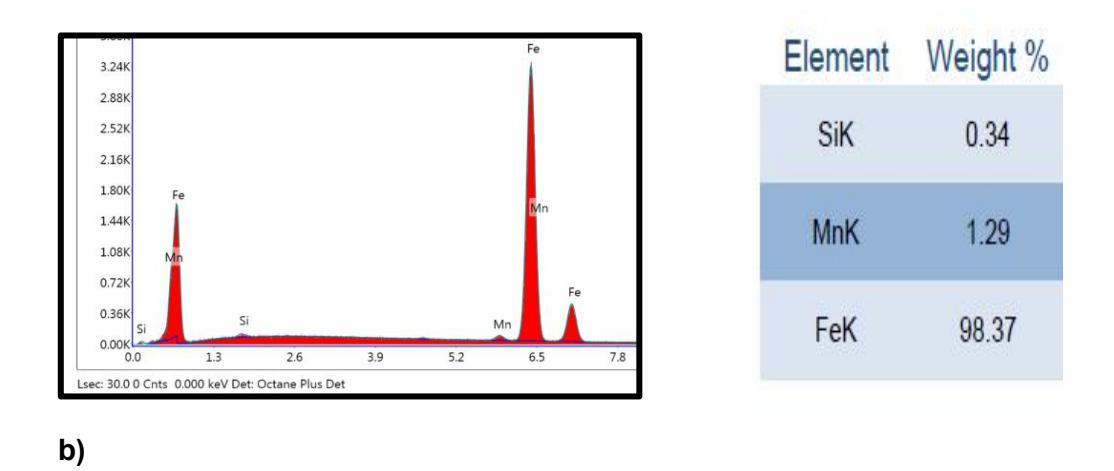
EDS analysis was carried out on both passivated and base metal portions of the chipped off sample (Figure 6). The results shows 2.22 wt% V on the passivated portion in line with PMI results. No significant V peak was observed on the base metal portion of the sample.

#### Figure 6. a) EDS results of passivated portion of the chipped sample. b) EDS results of depassivated portion of the chipped sample

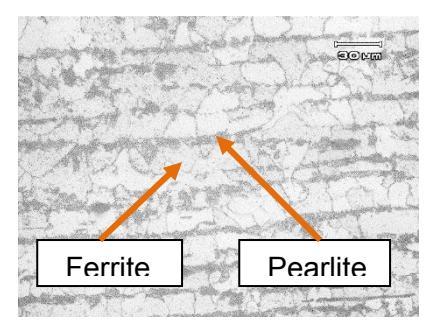
The chipped off sample from the absorber wall was cut along the cross section, polished and etched with 2% nital and examined under metallurgical Olympus FV-700 microscope at 50 to 500x magnification to analyze the microstructure. A banded microstructure consisting of a mixture of ferrite and pearlite was observed (Figure 7) which is typical to a rolled carbon steel plate.

Figure 7. Microstructure of the chipped off specimen at 500x.
