Paper No. CMT12

# Approach towards effective Coating Integrity surveys

Name: 12IN,CH 0.00KM (DT) to CH 176.50KM (IP01) Pipeline Start-Up Year: 2004 Diameter: 12in (323.85mm) Length: 176.5 km Contents: LPG Pipeline Type: Buried, Coated, Cathodically Protected Steel Pipeline. Coating Type : 3-Layer PE Material API : 5L X60 Nominal Wall Thickness : 6.4mm (137.249km) Design Pressure: 98 kg/cm2 (96.11 bar) MAOP: 92 kg/cm2 (90.22 bar) Design Factor: 0.72 (all wall thicknesses)

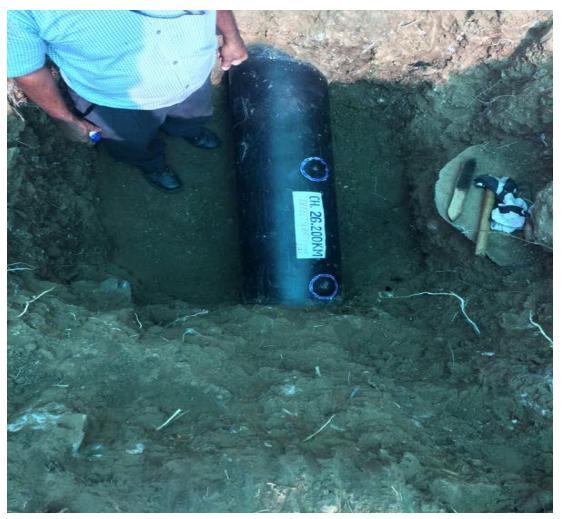
Figure 7 defect at Chainage 26.200Km

At Chainage 26.200 Km two defects have been observed. Figure 7 shows the site photograph of the defect identified after the dig verification. These defects fall under the minor category and were not detected in CIPS survey. The table 1 indicates the DCVG detail report on the defect. The signal strength maintained was 1100mV. Since the location was adjacent to Cathodic protection power station module the defect was not identified in the CIPS as the defect is small and does not vary during the ON-OFF survey of CIPS. But these defects are potential dangerous considering the soil in the area is highly corrosive nature based on the soil resistivity. Such defects could be potential points for AC corrosion. The table 2 show the CIPS survey details indicates no abnormal shift in ON-OFF survey in CIPS at the defect location.

CHAINAGE FROM (KM	CHAINAGE ) TO (KM)	TOTAL LENGTH OF SURVEY (KM	SIGNAL IN mV UPSTREAM Y TLP	SIGNAL IN mV DOWN STREAM TLP	DIFECT LOCATION CHAINAG E	DISTANC E OF UPSTREA M TO DEFECT	DISTANC E OF UPSTREA M TLP TO DOWN STREAM	OLRE AT DEFECT LOCATI ON IN WV	PRE AT DEFECT LOCATION	% OF IR = OLRE X 100 / PLRE	ANALYASI S OF DEFECT	MARKING OF DEFECT LOCATION
26.730	25.750	0.980	1200	1100	26.2	530	1050	20	1149.52381	1.74	Minor	Defect foud at nr. Warning Marker Ch.26.841

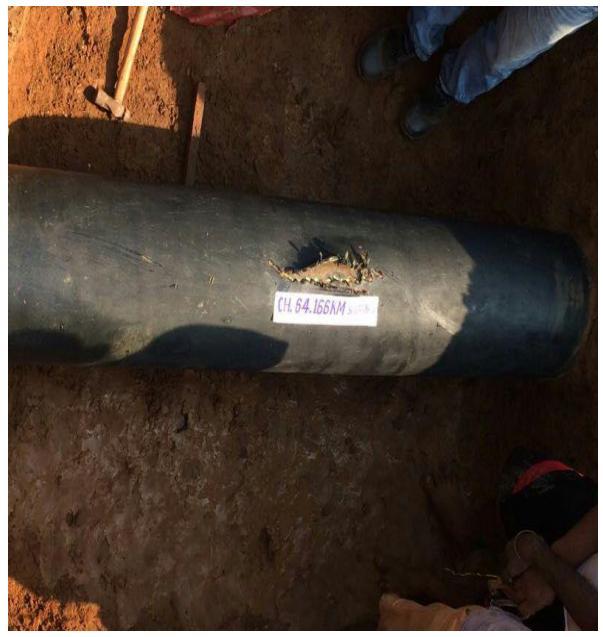
Figure 8 defect at Chainage 64.166Km

While carrying out the DCVG survey it was decided to carry the survey with high signal strength and while the survey was in progress a defect was identified as Minor and was near the High tension tower line. So it was decided to immediately carry out dig verification and ascertain the type of defect due to the small defects causing AC corrosion on the pipeline. But the outer appearance of the defect as displayed in Figure 8 looks major holiday. The DCVG report as per table 7 for Chainage 64.166Km indicate minor holiday defect. The CIPS report refer table 8 also does not show any abnormal dip in the potentials. After carryout the dig verification the defect indicated that the coating was peeled off and the adhesive was intact and hence the bare metal of the pipe was not in contact with the soil. But this was major finding to avoid severe holiday at latter stage and also HT tower near the line. This location was also indicated in the In Line inspection tool report refer table 9. As per the Ili report in table 9 indicates external metal loss of very minor percentage.

CHAINAGE FROM(KM)	CHAINAGE TO (KM)	TOTAL LENGTH OF SURVEY(KM)	SIGNAL IN mV UPSTREAM TLP	SIGNAL IN mV DOWN STREAM TLP	DIFECT LOCATION CHAINAG E	DISTANC E OF UPSTREA M TO DEFECT	DISTANC E OF UPSTREA M TLP TO DOWN	OLRE AT DEFECT ON	PRE AT DEFECT LOCATION	% OF IR = OLRE X 100 / PLRE	ANALYASI S OF DEFECT	MARKING OF DEFECT LOCATION
64.648	64.148	0.500	800	750	64.166	482	500	15	751.8	2.00	MINOR	Defect found in field Nr.TLP NO.85

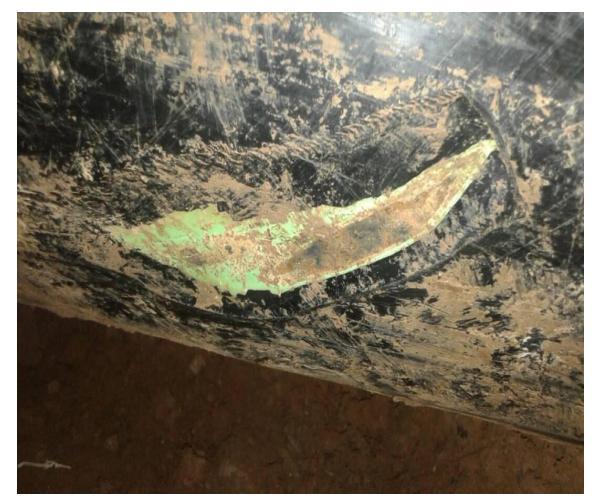
Figure 9 Defect at Chainage 111.121Km

One of the defects observed in the DCVG survey was that moderate fault was observed in the pipeline at Chainage 111.121Km .Upon dig verification (refer Figure 9) the fault was at the 7 O clock position ,The DCVG signal strength was maintained at around 1100mV and the soil at the location was very corrosive . The defect was near to the CPPSM station and as per the report refer table 6 DCVG re[port the defect was moderate. There was no significant dip in potential during the CIPS survey refer Table 8. The reason was due to high polarization of the pipeline which is near to the CPPSM station.

-									
CHAINAGE FROM (KM	CHAINAGE ) TO (KM)	TOTAL LENGTH OF SURVEY (KN	SIGNAL IN mV UPSTREAM I) TLP	SIGNAL IN mV DOWN STREAM TLP	DEFECT LOCATION CHAINAG E (KM)	DISTANC E OF UPSTREA M TO DEFECT	DISTANC E OF UPSTREA M TLP TO DOWN STREAM	OLRE AT DEFECT LOCATI	PRE AT DEFECT LOCATION	% OF IR = OLRE X 100 / PLRE	ANALYASI S OF DEFECT
111.084	111.814	0.730	1300	1200	111.121	37	730	107	1294.930	8.22	Moderate
