Paper No. CPI23

Failure of Kettle Type Condenser in Steam Condensate Service – A Case Study

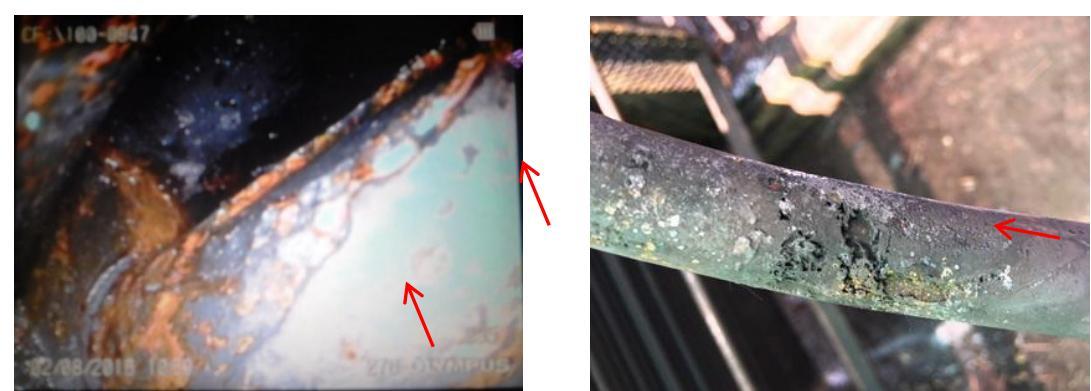
This is a horizontal kettle type exchanger with a removable U-tube bundle. After the tube bundle was pulled out followed by hydro jet cleaning, external pitting / grooving marks were observed on the tubes preferentially adjacent to baffle plate locations (please refer figure 2). External fouling with proprietary online gasket sealing material was observed on the tube surfaces. Grooving was observed in the peripheral tubes at the mid-level near baffle plate locations. Grooving was also observed on the tube external surfaces in the inner tubes. Deposits were observed on the shell internal surface at 6 O' clock location. Similar observations of E-216A was also observed but of

Figure 2: Photographs showing external grooving of the external surface of tube of the HB Condenser

Grooving / Cavitation on the tube external surface confirmed tube leakages due to low flow operation which caused nucleation boiling on tubes external surface at level interface location preferentially at baffle plates locations.

To avoid such failure in future it was suggested to maintain minimum 55% condensate level in the condenser. Proper functioning of LT has to be ensured.

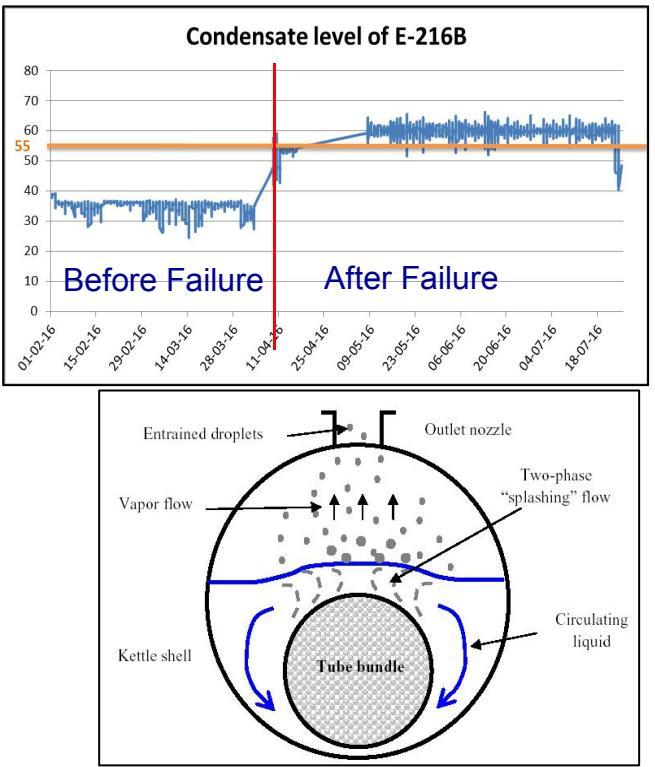
Trends were analyzed for condensate level in condensers 31-E-216A/B as per distributed control system data available for period of 01.02.2016 onwards. A level of 30-35% was being maintained in E-216B and 35-40% in E-216A.

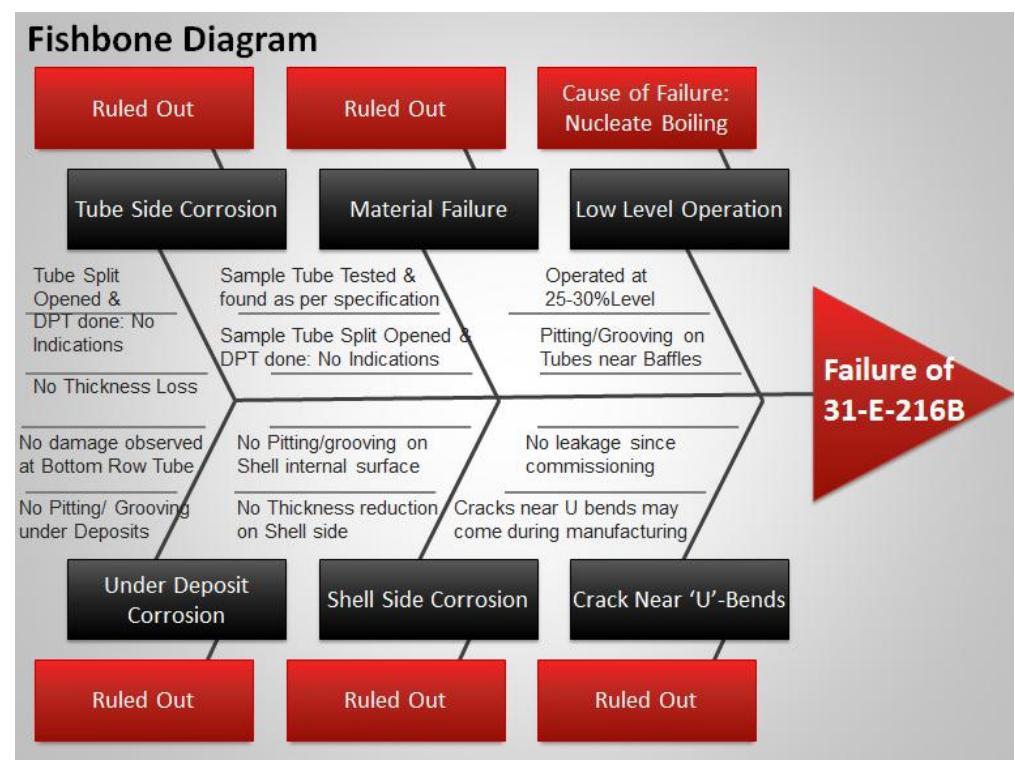
Per calculations made on the basis of LT length and tube-sheet ID, a level of 54.5% is required for complete tube bundle immersion. The condensate level trend was not monitored since commissioning of the unit and condensate level trend was analyzed only after leakage of the tube bundle. Past data of only last three months can be retrieved from the digital control system. The condensate level trend observed in E-216B is in the range of 35-40% as per distributed control system data. After bundle pull-out and inspection, grooving on the tube external surface was observed confirming that the leakage of tubes was due to nucleation boiling at the liquid level interface.

Figure 4: Showing Fishbone Analysis of HB Condenser Tube Failure
