Paper No. CPI24

Corrosion Failure of SS 304L Tubes- A Case Study

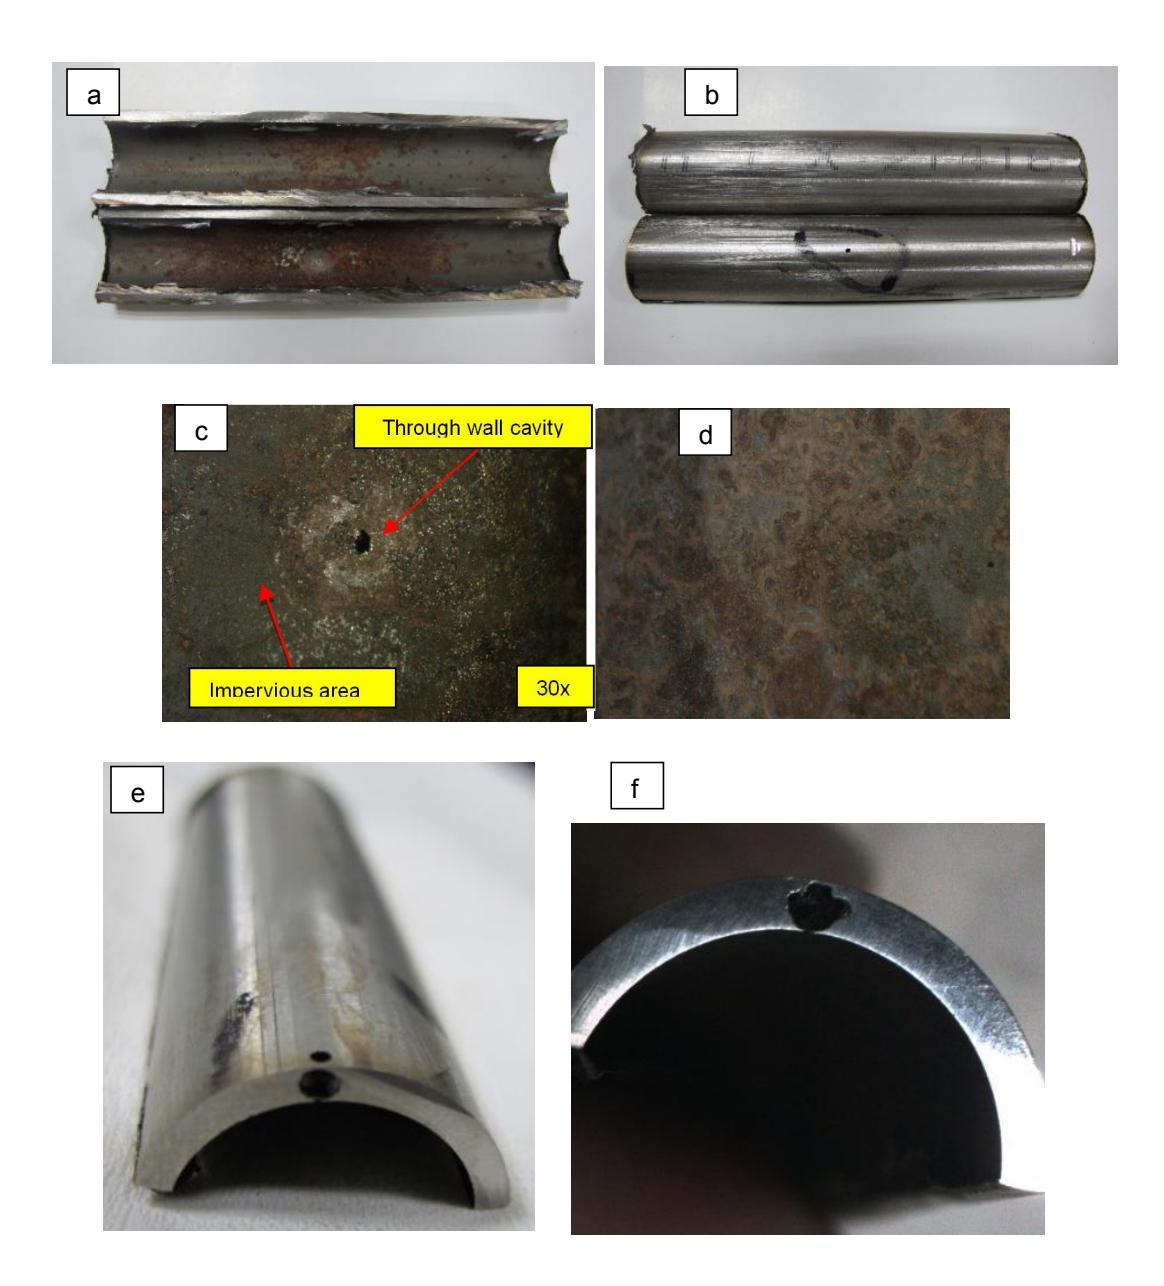
The inside surface of the tube sample showed through wall cavity with irregular profile and impervious area around it. Brown coloration and localized corrosion spots were also observed on the inside surface near this through wall cavity, Figures 1a, 1c and 1d. Examination of the outside surface revealed a round hole at the location of the through wall cavity, Figure 1b.. Specimen was then cut in the transverse direction near the cavity for macro examination, Figures 1e and 1f. The cross section of the specimen was polished and examined under a stereo microscope. It showed narrow opening on ID and oval shape growth in thickness of tube (Figures 1a-f).

Fig. 1: (a) Inside surface (b) Outside surface (c) Cavity on inside surface (d) Corroded area near cavity (e) Cross section at cavity (f) Cross section, magnified view

Visual and macro examination of the inside surface of the tube sample that failed in the air leak test showed the presence of multiple pits along with brownish corrosion marks.

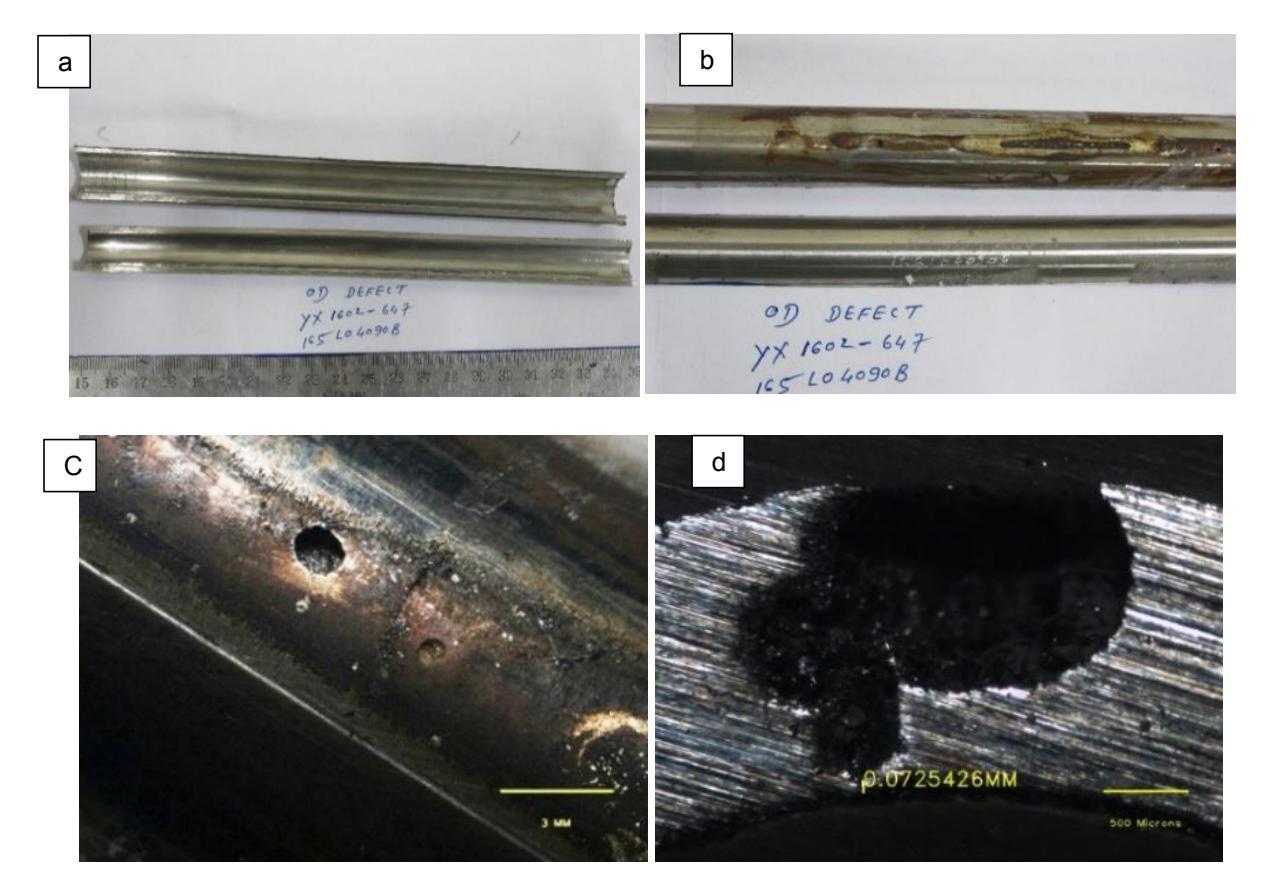
Pits along with brownish colored corrosion products were observed on the OD of the tube sample that were aligned in one orientation. No indications were observed on the ID of the tube sample. Through-wall thickness attack with oval shape growth starting from the OD was observed (Figures 2a-d).

Fig. 2: (a) Inside surface (b) Outside surface (c) OD at 10X (d) cross section at 45X

Visual examination of the tube samples indicated that corrosion marks on the outside surface were aligned along the tube length in one orientation. This implies that the tubes were in contact with an adjacent tube in storage or other surface that was contaminated with stagnant water for long duration, and this stagnant water most likely led to corrosion attack on the tube OD. Macro examination of the cross sections at the location of the pits on the tube OD shows that the pits initiated from the outside surface and propagated to the inside surface with minimum wall thickness remaining of about 0.07 mm. This translates into a very high thickness loss of about 1.5 mm in a few months for SS304L.

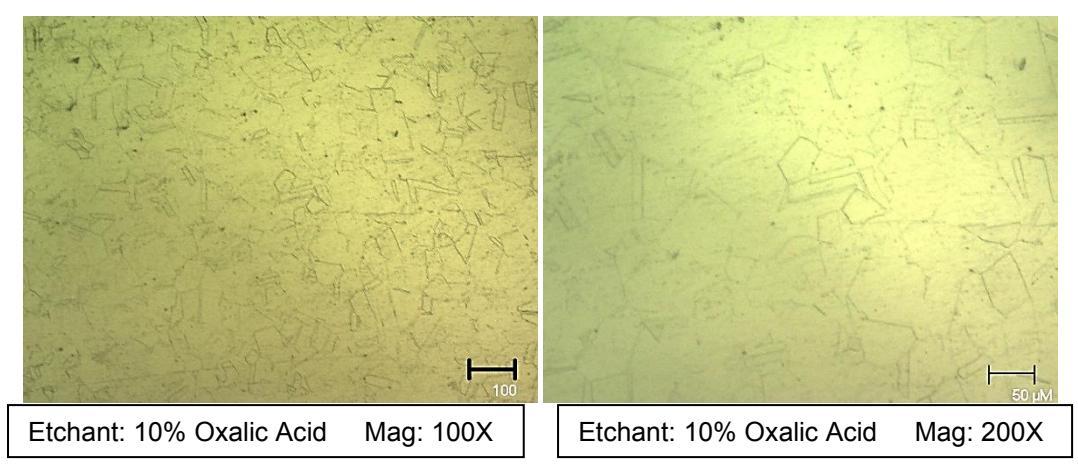
Metallography examination of both the tube samples revealed a normal austenitic step structure without any carbide precipitates at grain boundaries (Figures 3 and 4)

Figure 3: Microstructure at cross section of tube sample 1

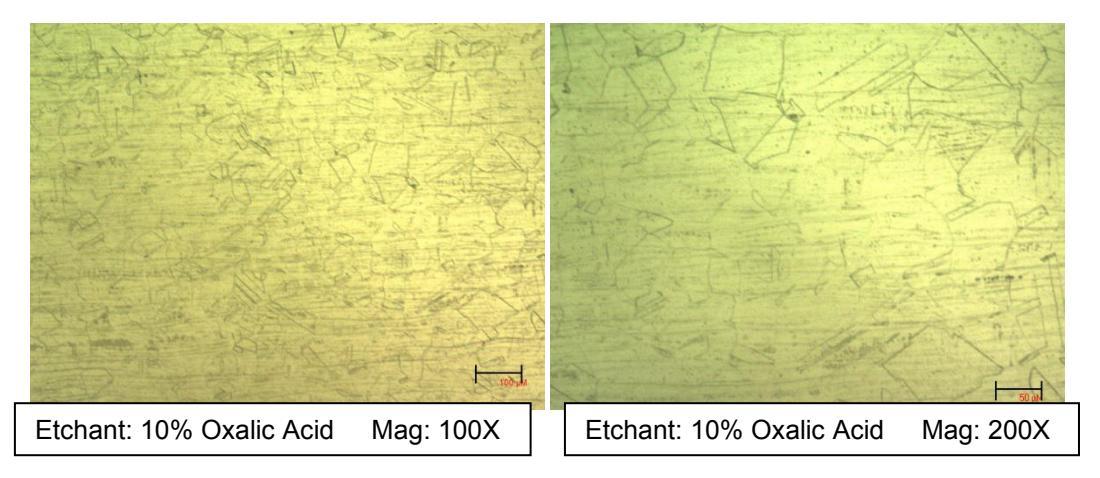
Figure 4: Microstructure at cross section of tube sample 2

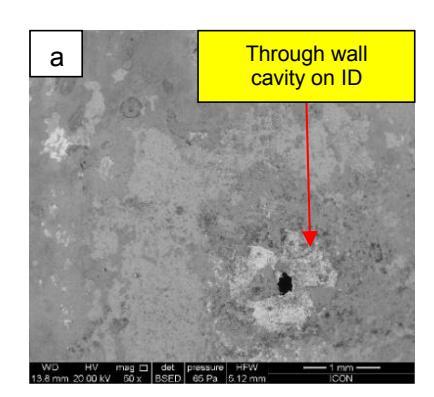
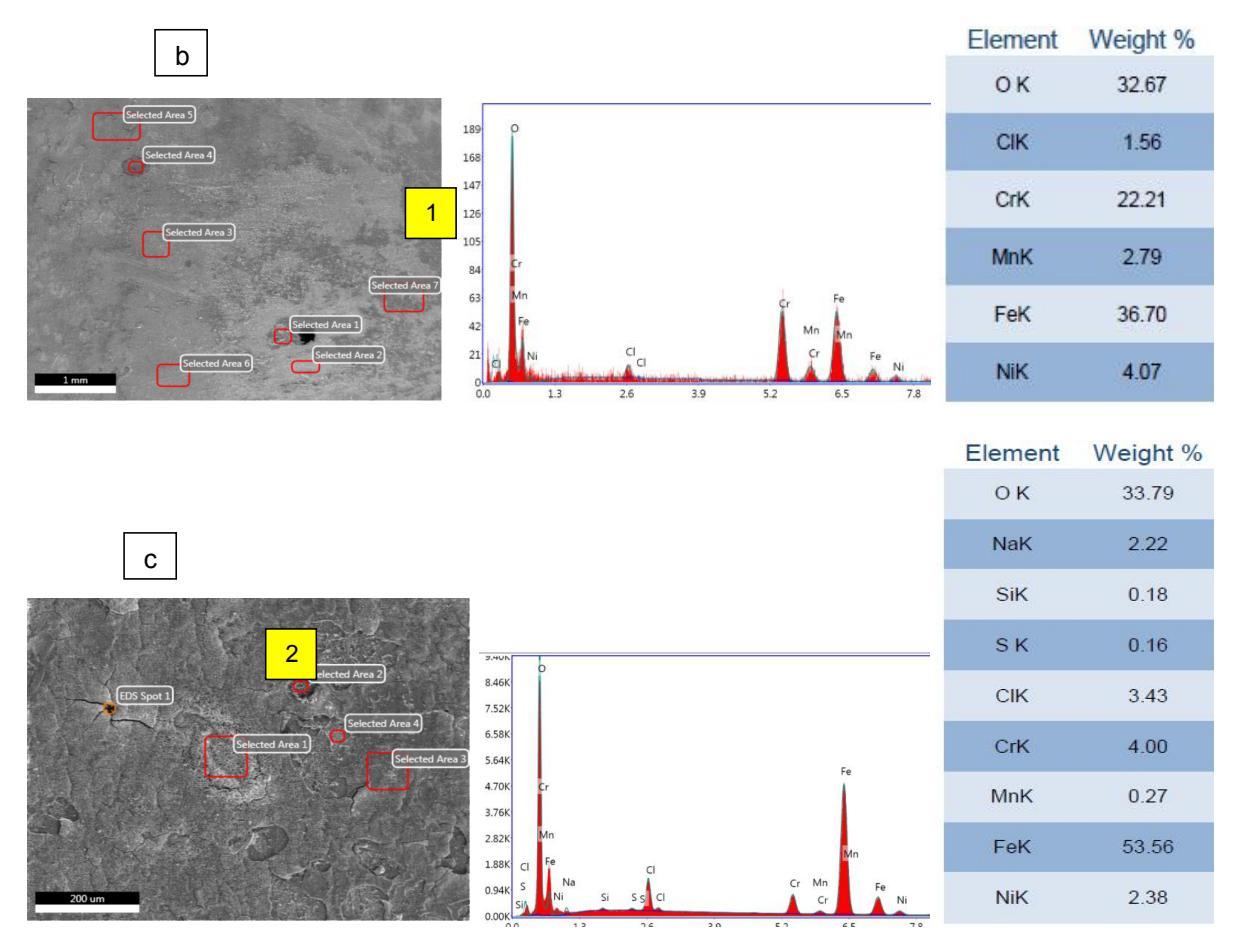
SEM analysis of the affected area showed few shallow cavities in addition to deep cavity observed in visual examination on the inside surface of both the tube samples. All these cavities were located in the rusted areas. EDS showed presence of chloride ions in the range of 0.89 to 3.43% and other elements like O, Ca, Mn and Na (Figures 5a-c).

Fig. 5: Tube sample 1 (a) SEM image (b) EDS at location 1- Near through wall cavity (c) EDS at location 2- Inside shallow cavity

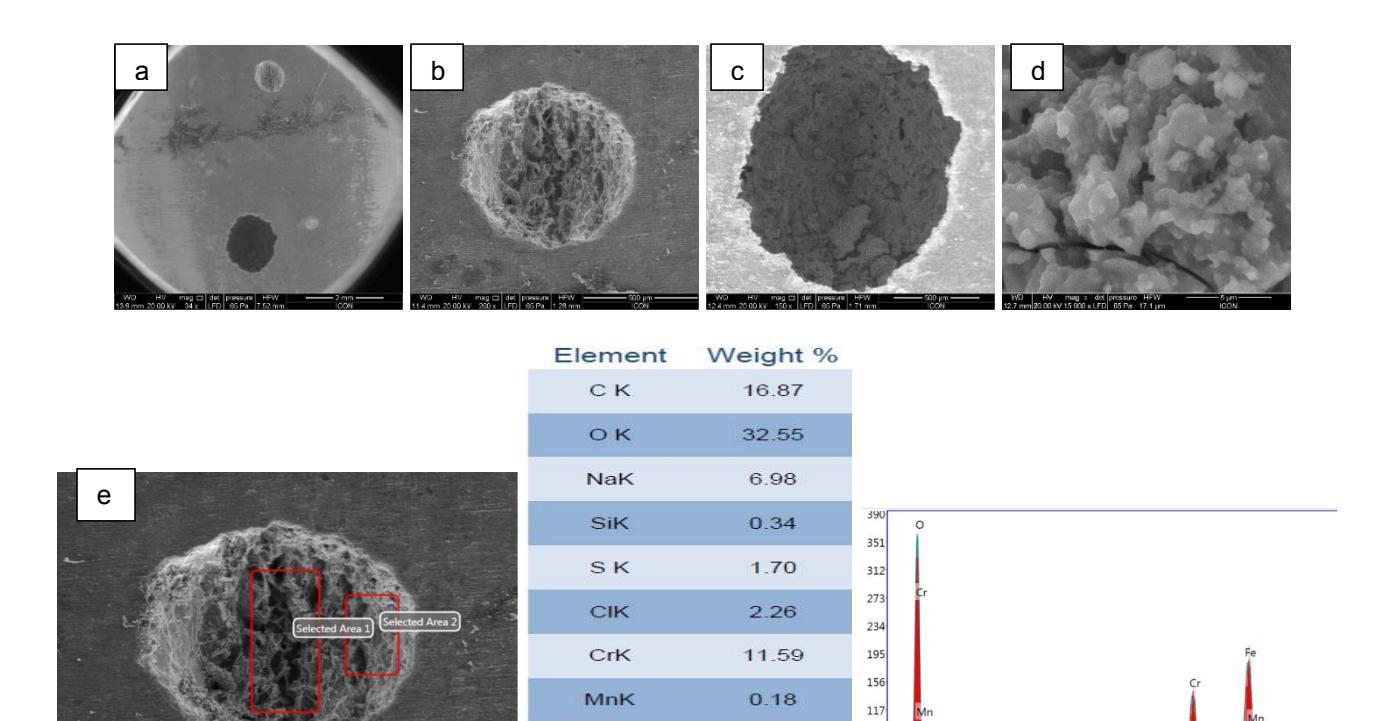
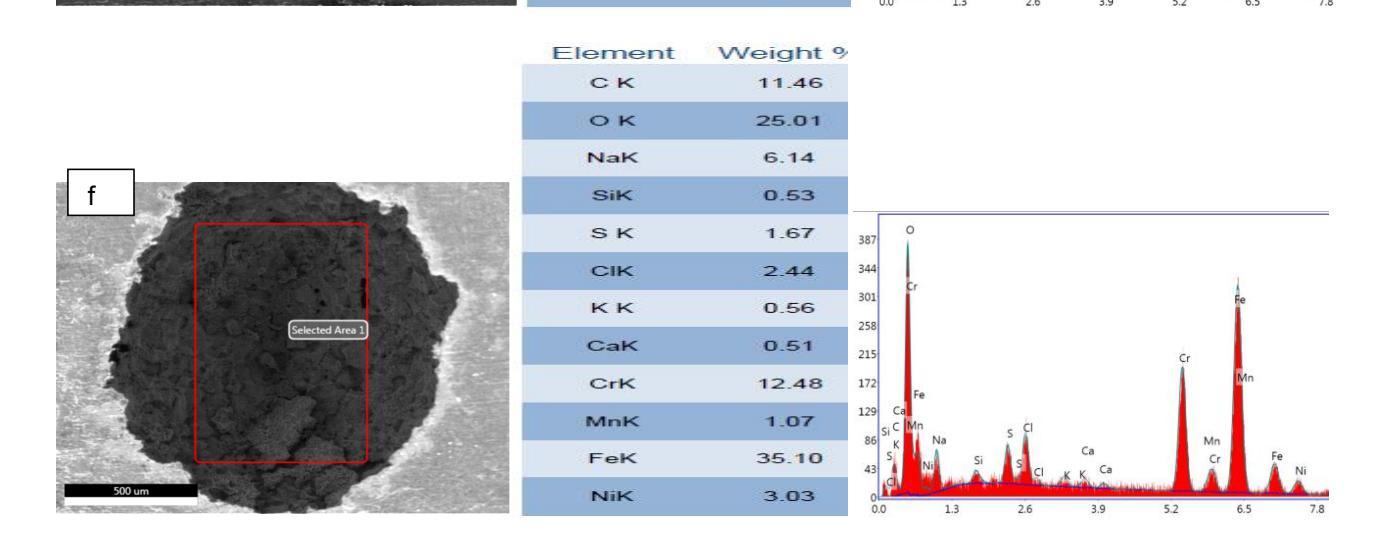
SEM analysis showed pits on the OD in both tube samples. A small cavity on the ID (opposite to one OD pit) was observed in the tube sample R21-T25. EDS on the OD surface showed presence of O, C, Cl, S, Ca and Na in the vicinity of the pit (Figures 6a-g).

Fig. 6: (a-d) SEM Images on outside surface (e) EDS at shallow pit on outside surface (f) EDS at deep pit on outside surface

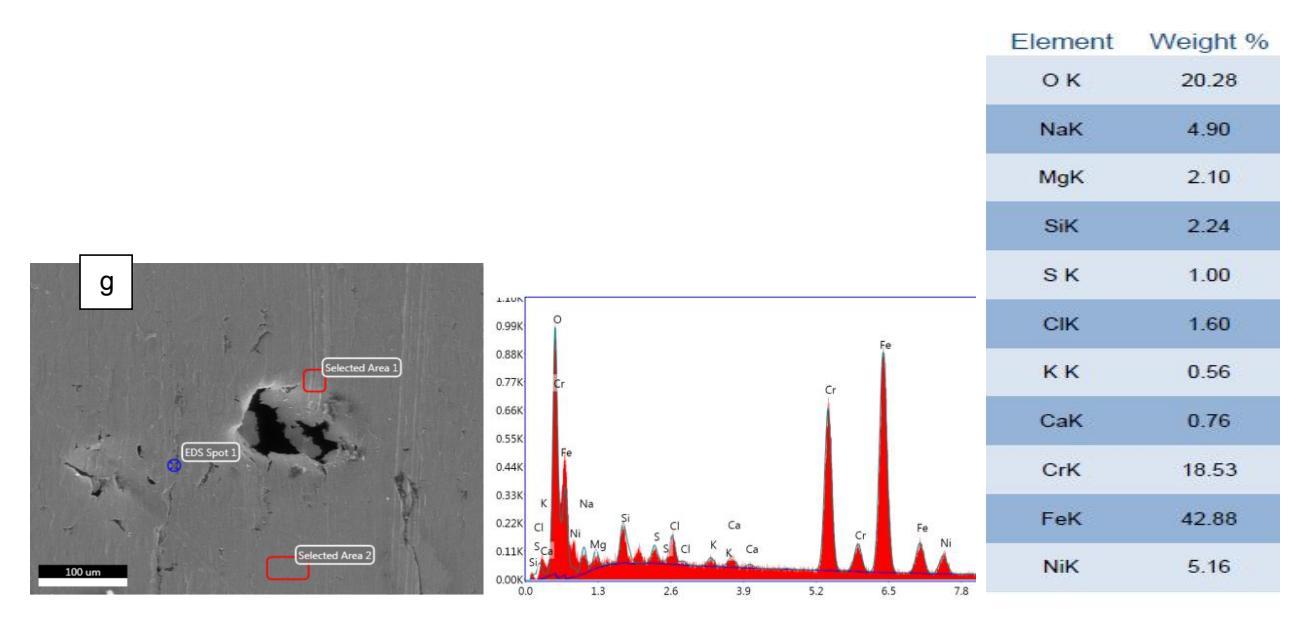
Fig. 6 (g): EDS at small cavity on ID-opposite to OD deep pit

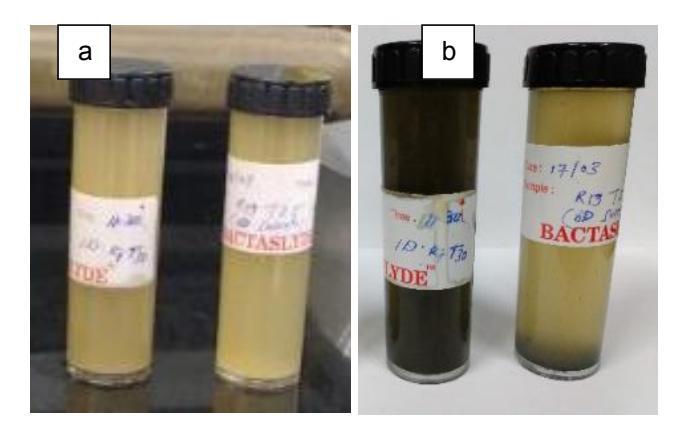
Swab samples were taken from the affected locations and tested using a portable kit (BACTASLYDE BS-115). Test results showed presence of Sulphate Reducing Bacteria which is indicated by blackening of the test solution (Figures 7a-b).

Figure 7: SRB test of tube samples (a) Day 1 (b) Day 6

Testing of tube samples using the SRB portable test kit confirmed presence of SRB, which corroborates with the significant amount of sulfur found in EDS analysis.
