Paper No. CR26

Corrosion of Monel Distributor of Caustic Scrubber In MSQ Unit

NIGIS * CORCON 2017 * 17-20 September * Mumbai, India

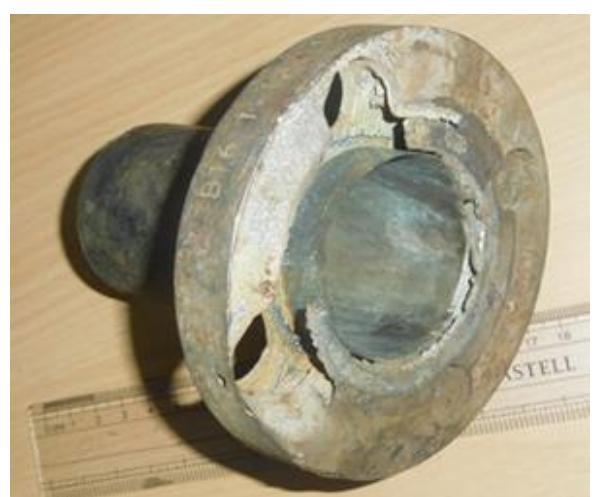
A pinhole leak was found at the toe of the weld joint between WNRF (weld neck raised face) flange and 2" insertion pipe. Following the leakage, the scrubber section was isolated and SS flange with MONEL raised face was found to be severely corroded (Figure 2 & Figure 3). Similar observations were made on another bolting flange (Figure 5). After dismantling the 2" nozzle for maintenance and repair, the internal inspection of the column was carried out.

Figure 2 Severely corroded WNRF Flange

PMI of the flange (SS-304) and MONEL (UNS N04400) weld overlay at raised face was done and the results are as tabulated in Table 1. At the Flange and weld overlay interface, severe corrosion of

the SS flange was observed. The bolting holes were severely corroded and enlarged exposing the Monel piping underneath. However, at the Monel raised face severity of corrosion was less leaving leaf-like structures above the perished SS-304 flange base.

The measured composition of the Monel weld overlay shows values deviating from the actual composition of the metal. Further, a significant proportion of Chromium metal was found in the weld overlaid portion. The Copper content of the Monel-400 alloy was found to have depleted at the interface periphery. Dilution of the Monel weld overlay during welding over the SS-304 flange might have resulted in such compositional variations.

The raised face of the insertion nozzle flange was prepared by weld overlay of Monel-400 alloy over base metal SS-304. Positive material identification shows dilution of the weld overlay by chromium (refer Table-1). The diluted alloy will not have the desired corrosion resistance. Moreover, the weld overlay will leave a high energy area along with chances of inclusions and defects. These areas will act as preferable sites for corrosion in presence of highly acidic environment. Due to absence of electrical tracing at the flanges (inlet nozzle of the scrubber), HCl condensation had started at the flange joint and continued to the distributor. No significant corrosion was found in the electrically traced portion of the piping. The newly formed acid is usually concentrated and highly corrosive. The low pH had resulted in wasting away of the Monel weld overlay and subsequently the SS-304 flange. Further, due to the dissimilar weld between Monel weld neck raised face and SS-304 flange, dilution of the weld overlay occurs. This had resulted in poor corrosion resistance and led to premature failure of the flange.

The original Monel overlaid SS 304 flange has been removed and replaced with Monel Flange to avoid any degradation of the metal. The severely corroded and perforated distributor arms were replaced completely. Replenishment of the caustic has been reviewed and is being done to maintain a minimum of 3% to 4% rather than earlier practice of 2% minimum strength. Close monitoring and maintenance of electrical tracing set point at 5 C above the Off-gas temperature and variation of temperature difference between caustic and Off-gas is being done. After the replacement and corrective measures in March 2015 turnaround of the unit and continuous operational control, no failures have been reported till date.

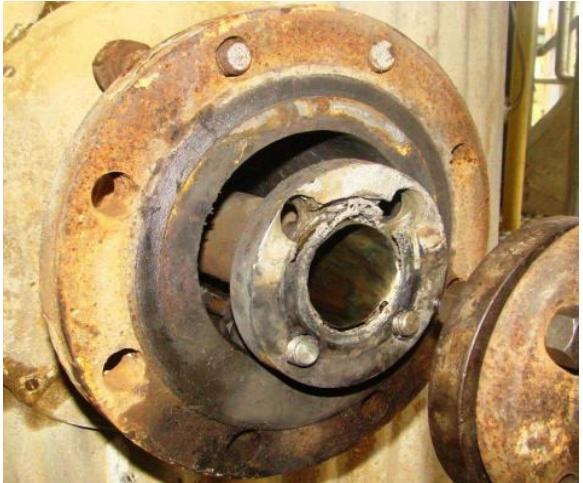
Figure 3 WNRF Flange in As-opened condition

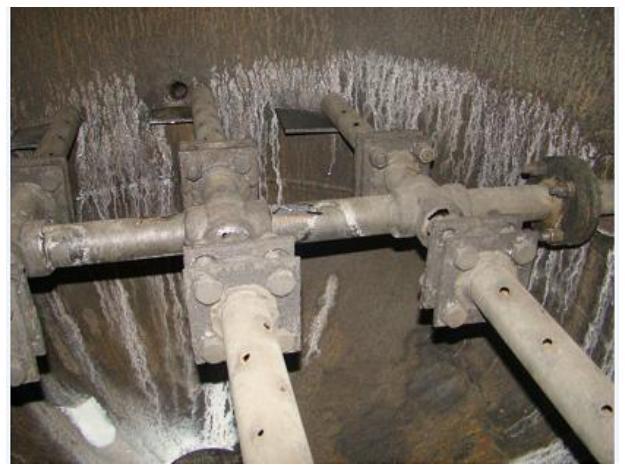
Figure 4 Distributor portion of the Scrubber

Severe perforation at several locations was noticed on the of the distributor arms of the caustic scrubber (Figure 4). The perforations were only on the top portions of the pipe as seen in Figure 6 and Figure 7. The distributor holes on its ribs were found enlarged (approx. 15 mm) from its original size of 6mm due to corrosion. Moderate thickness loss was noted at bottom portion of the distributor. No thickness loss was observed on sides of distributor. UT gauging was carried out on the electrically traced external piping (from NRV to inlet of the Scrubber) of the circuit. No leakage and indication of corrosion in form of thickness loss was observed. Only minor corrosion in the form of pitting was observed in the shell of the caustic scrubber. This shows that the bulk neutralization of HCI is by and large taking place.

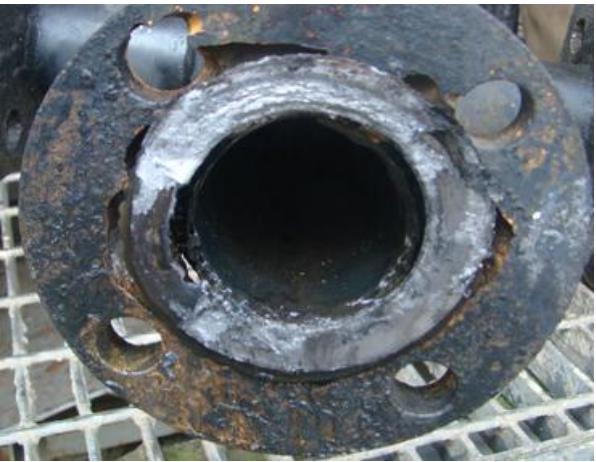
Figure 5 Corroded Bolting Flange

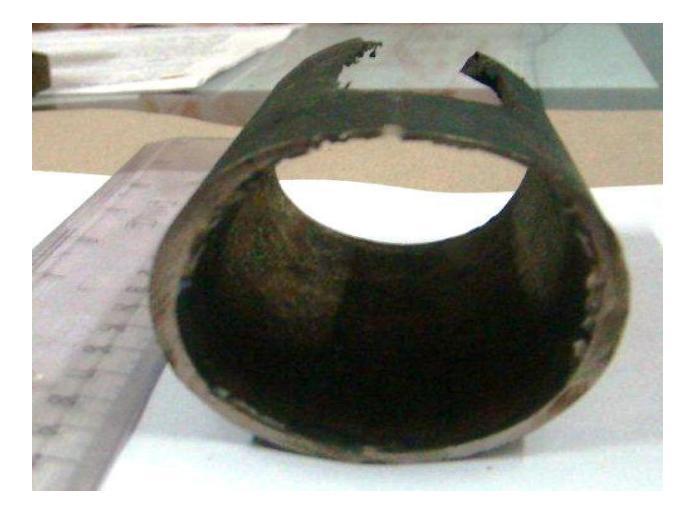
Figure 6 Cut Section of Perforated arm of the Monel Distributor

Uniform thinning and perforations (Figure 6 & 7) were found across the arms and tee-joints of the Monel distributor. The highly corrosive HCl which started condensing at the flange, continued eating away the Monel distributor section. This had preferably been found at the welding joints towards the top potion (12 o'clock). The distributor exit holes had enlarged, which were also positioned at the top. The site of corrosion inside the distributor can be attributed to the flow dynamics of the off-gas. Due to this, condensation had also occurred at the top positions. The low strength of the caustic and its frequent fluctuations in the temperature resulted in inadequate neutralization of the Off-gas near the exit holes. The holes of the distributor provided exit for the off-gas, which are a preferable high energy location for corrosion.

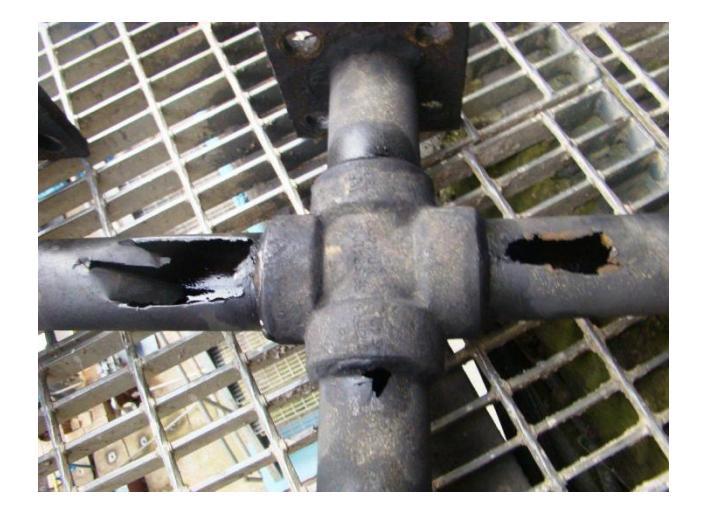
Figure 7 Tee Section of the Distributor
