Paper No. ICP12

Inspection Methodologies and Tradeoffs for Inspection of Unpiggable Pipelines

Christian Openshaw

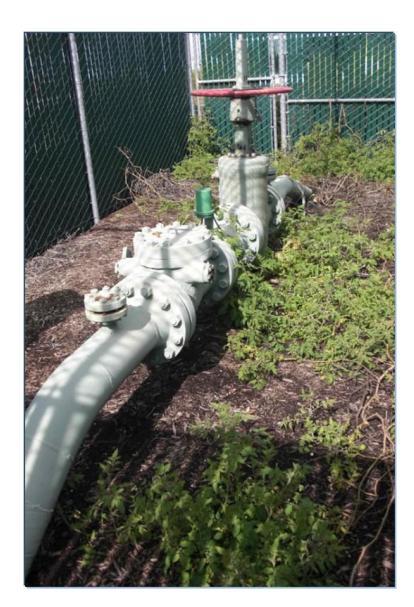
A pipeline operator needed to inspect a pipeline running through a major metropolitan area. The pipeline had been constructed in various phases over time and contained numerous transitions from 6" to 8" and back again (see Figure 1). Several previous attempts at inspection had failed and the operator was left with hydrotesting as their only option for regulatory compliance.

Figure 1. Challenging pipeline containing numerous transitions from 6" to 8".

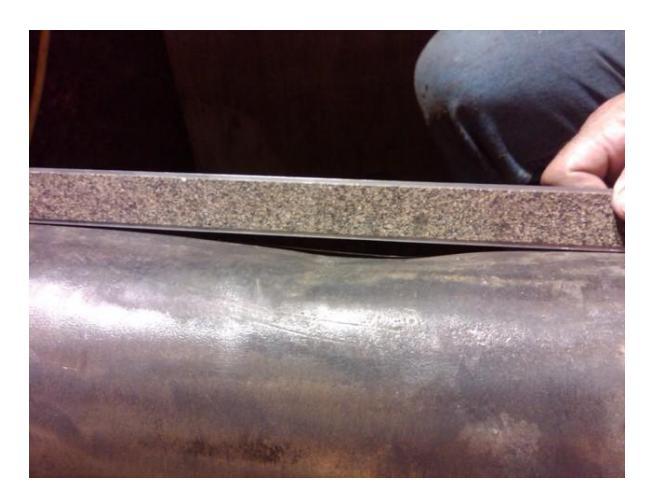
This high-resolution inspection data provided the operator with not only wall thickness data, but also 2D and 3D ultrasonic inner radius (geometry) graphics (see Figure 2), allowing the operator to have a more complete picture of its pipeline which included a number of previously unknown third party damages (see Figure 3). In addition, information about the original construction of the pipeline could also be seen in the data. Previously unknown schedule and weld type changes were observed, creating an as-is pipe book, and all features were then mapped to known above ground locations.

Figure 3. Critical topside dent defect that was detected during the in-line inspection.

A full fitness-for-service engineering assessment was delivered for the entire 51km length of the pipeline and hundreds of individual anomalies were sized and identified. A prove-up program commenced to repair critical anomalies and to develop statistical confidence in the inspection data for this run. Quest Integrity and the operator worked together in locating and investigating critical anomalies in the most cost effective and time efficient manner.

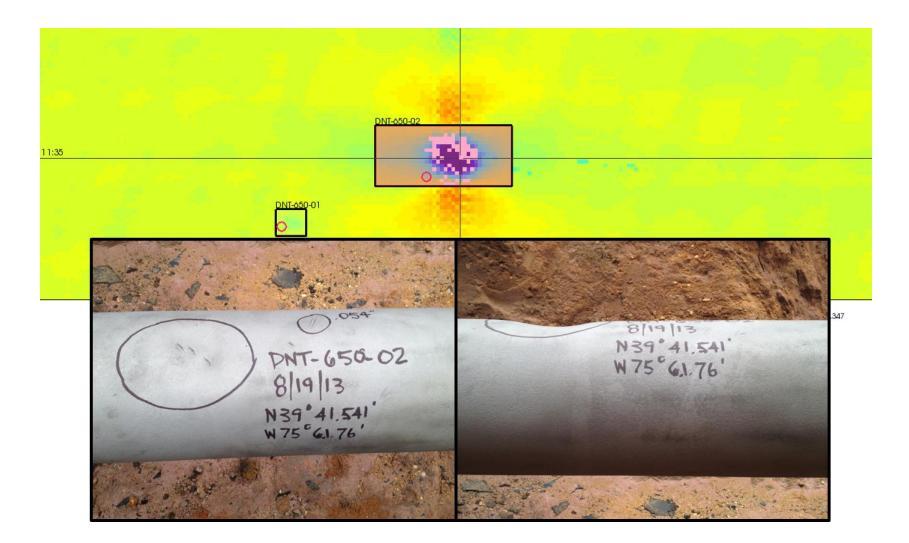
The in-line inspection was successfully completed in one day, and provided the most comprehensive direct measurement data. The results of the advanced data assessment indicated a number of unexpected anomalies that were subsequently excavated and remediated. The entire in-line inspection process was safely completed within one day, and had no impact on the high density population surrounding the pipeline.

Figure 4. Inspection data showing indications of damage on pipeline (top); damaged segment of pipe seen during excavation and remediation (bottom).

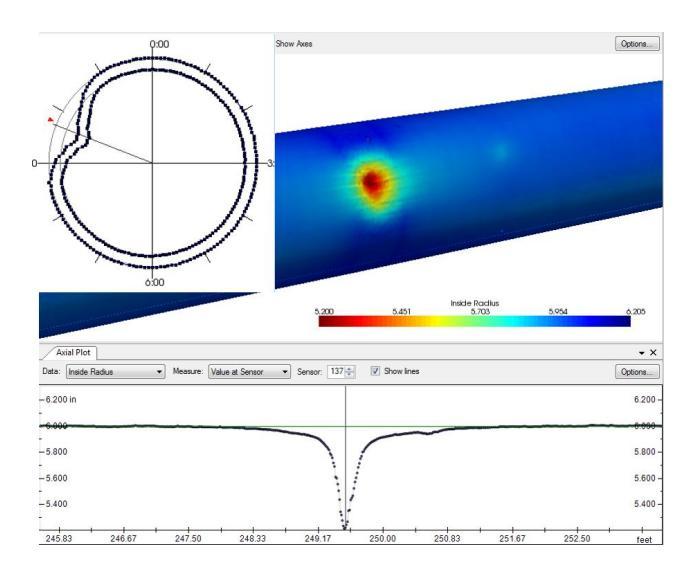
In addition to the operational cost-effectiveness and benefits, high quality data was collected and a full fitness-for- service report was delivered to the operator as part of the standard deliverable. The inspection and assessment reported areas of corrosion and made recommendations about corrective actions in the report. Furthermore, a dent greater than 6% was discovered in the line. Although the dent was difficult to access, further engineering assessment was performed using the detailed inspection data to demonstrate the fitness-for-service of the line inclusive of the dent.

Figure 6. High resolution inspection data revealing a dent greater than 6%.

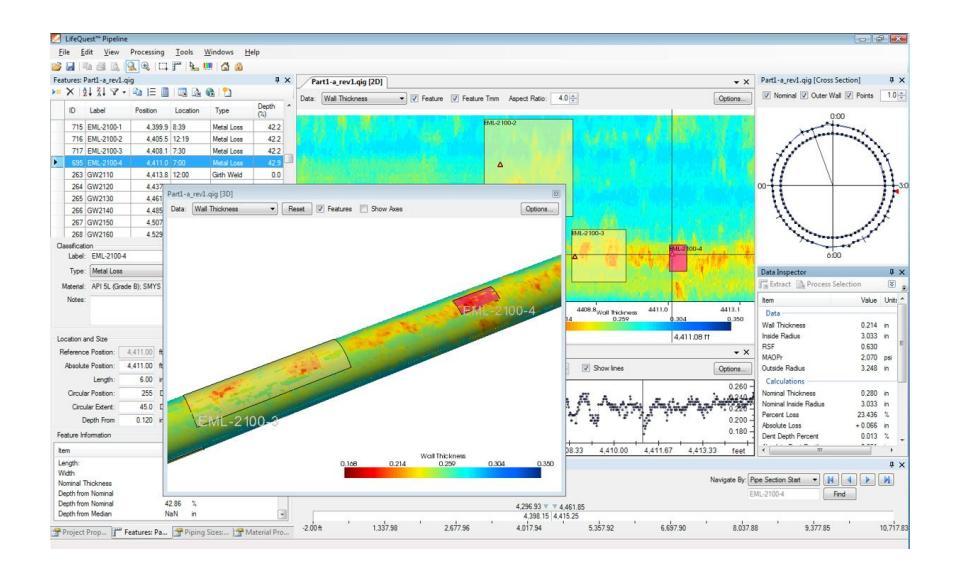
At the completion of the inspection, the data was analyzed and revealed a number of defect indications along the surface of the pipeline, as seen in Figure 8. A full fitness-for-service assessment was then prepared for the entire inspected length of the line. In addition, rapid analysis of the data while the inspection team was onsite allowed the operator to perform additional hand held inspections to verify the signatures seen in the inspection data on key portions of the line while the pipeline was still out of service.

Figure 8. Inspection data revealing areas of damage along length of pipeline.
