Paper No. ICP22

# Learning experience from a case study on failure of a product pipeline due to internal & external corrosion leading to a massive fire

### Rajesh Uprety Indian Oil Corporation Limited (Pipelines Division), Noida, India upretyr@indianoil.in

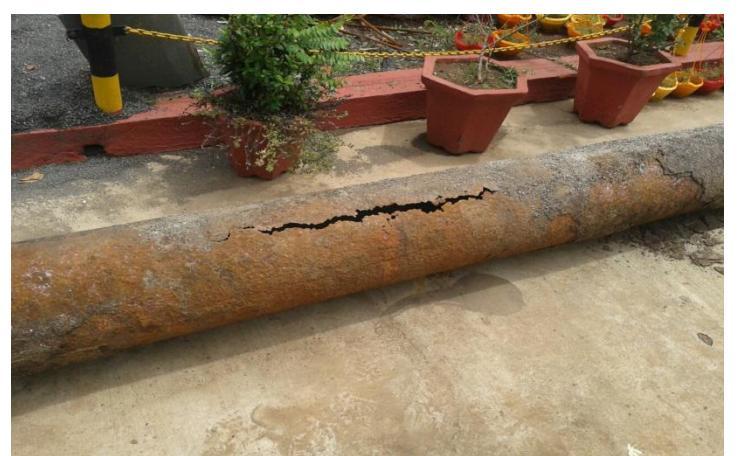
### A VIEW OF SEVERELY CORRODED PIPE

- The uniform thinning of the pipeline, as may be seen from the attached photo indicates uniform external & internal corrosion in the longitudinal section of the pipeline was taking place for prolonged period of time.

- There was no system of monitoring the internal corrosion rate. Corrosion coupons and corrosion probes were not installed in the pipeline and corrosion inhibitor injection was not carried out.
- The internal corrosion in the line is attributed to use of saline (sea) water as flushing media.
- The pipeline was internally coated with cement lining, however, there was no coating on the inner side of the girth weld. Sleeves were provided on the external surface of the pipe in all the girth joints to provide additional protection. The uncoated portion of pipe on the inner pipe surface in all the girth welds acted as anode, consequently, the internal corrosion rate was much faster in these areas. The same was evident after checking the physical condition of the pipe.

- Further, in absence of periodic planned maintenance activity such as direct corrosion assessment tests (hydro test, thickness measurement etc.,) the damage in the line could not be assessed till the same failed.
- It may be pertinent to note that nearer to the sea location indicate that the soil resistivity is low which in turn enhances the rate of external corrosion.
- Since there was no external coating in the underground pipeline and no cathodic protection, it caused severe external corrosion of the pipe.

The uniform paper like thinning of the pipe indicates corrosion for a prolonged period of time. The corrosion in the pipeline is both internal & external in nature; no Cathodic Protection and no external coating of the line made it vulnerable against external environment. This is evident from the physical condition of the pipe. Above photo is the evidence of extensive corrosion (both internal and external). It is a live case study pipe failure has occurred due to extensive corrosion.

- Underground pipes shall be provided with suitable external coating such as 2-ply/ 3-ply cold tape, PU coating, High Build Liquid Epoxy etc.,
- Sleeves shall be provided in all the road crossings after putting a corrosion resistant paint at the outer surface of the pipe, for strengthening the pipe. This would prevent cyclic load on the pipe segment while vehicles pass over the crossings.

- Corrosion probes/ corrosion coupons shall be provided for monitoring the rate of internal corrosion. Corrosion inhibitors may be used in the pipeline, if the internal corrosion rate exceeds 1 mpy.

- Flushing of pipeline with sea water to be dispensed with. In the event line flushing is absolutely necessary, must be done with fresh water or ideally kept with product fill; in the later case, necessary accounting must be done.
