Monitoring and Maintenance of MGL CP system

Pravin Vishvanathe

Mahanagar Gas Ltd, Mumbai, India
pvishvanathe@mahanagargas.com

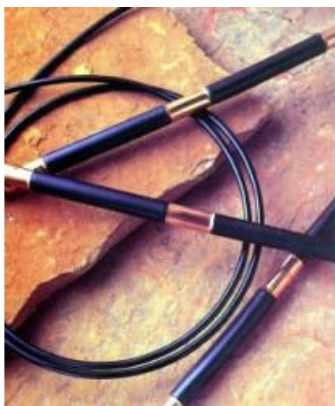
Figure 1: Mixed Metal Oxide (MMO)

- MMO anodes with carbonious back fill is used for vertical type of anodebeds and High-Si-Cr anodes are used for horizontal type of anode beds.
- Number of anodes is then calculated based on anode weight and anode current output.
- PCP system is designed for 30 years.

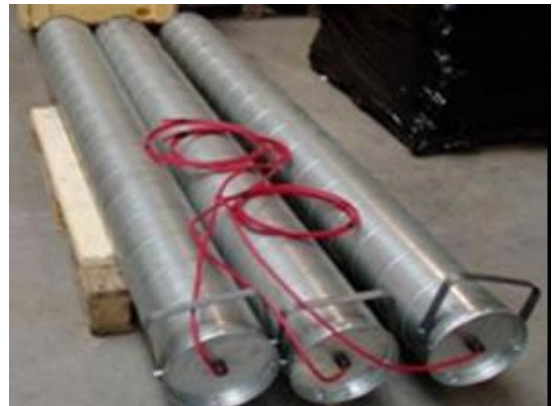
Figure 2: High- Si - Cr anodes

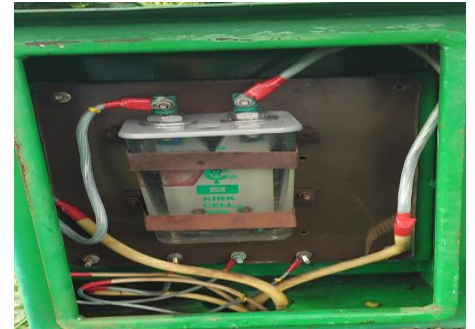
Figure 4:After KOH solution replacement

1. Calibration of TR/ DS – This is done annually. Faulty panel meters and components are replaced as per the reports.
2. TLP maintenance works of TLP straightening, TLP cable cut rectification, TLP door replacement, TLP shifting etc.
3. Patrolling of CP assets on daily basis: Patrolmen who patrol the steel pipeline have also been given the responsibility of carrying out a visual check of CP assets every day. Since Mumbai is a highly congested city, CP assets are prone to third party damage.
4. Whenever we receive any communication of coating damage, the rectification of the same is done using cold wrap. Thickness testing and peel test are also done during this.
5. ALL the CP assets are plotted on GIS.
6. KOH solution is replaced on quarterly basis.
7. History of minor maintenance is maintained in SAP.

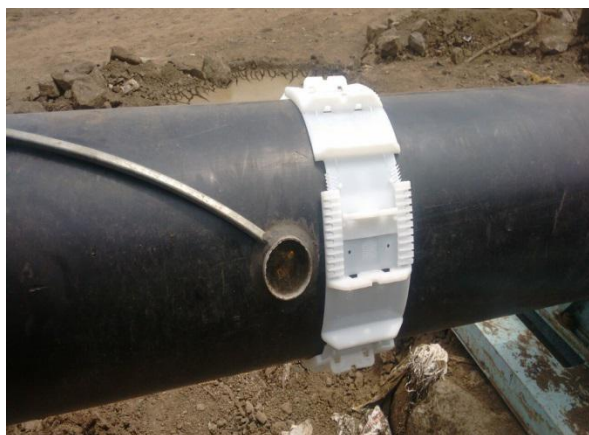
Figure 5: Spacers and Zn ribbon anodes on carrier.

- Top cover of 4.5 m was maintained while crossing of railway track.
- Casing of 24” was inserted initially
- Carrier of 12” with insulating spacers mounted on it was inserted through this 24 ” casing

- Zn ribbon anodes were also installed 4 o'clock to 8 o' clock position at a distance of 1 m on carrier
- Casing and carrier were sealed at both end points to avoid water ingress.
