Improve Equipment Performance against Pitting Corrosion Degradation by Utilizing Corrosion Control Methods at Petrochemical Facilities

Pitting corrosion degradation has been observed on RVCN (Recovered Vinyl Chloride Monomer) tanks at petrochemical facilities. Generally, these pits are repaired by weld build up in order to stop further degradation. However, a more permanent solution is required to resolve these chronic pitting corrosion issues in RVCN tanks. The most efficient method to mitigate the pitting corrosion degradation is application of a protective coating or strip lining as the coating will isolate the material from the environment, and thereby prevent pitting corrosion degradation as well as stop the initiation of SCC (Stress Corrosion Cracking). The type of coating that should be used depends on the temperature, pressure and fluid composition of the system. This paper evaluates the feasibility of providing the strip lining method or coating method to stop the degradation of equipment due to pitting corrosion. Based on a further technical study, successful implementation of the coating application has been carried out on one of the RVCN Tanks, and subsequent inspectio

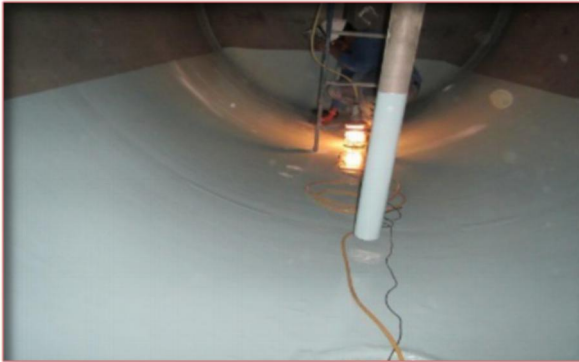
Figures 3 and 4 shows the resultant coating application on the inside bottom section of the tank and on the circumference weld of the dome. Figure 5 provides the measurement of dry film thickness and Figure 6 is a view of holiday test conducted after the coating application.

Figure 3: View of Protective Coating application on the inside of the Tank [5].

Following are the activities carried out for implementation of the new coating method, Table 4. All areas that are not to be coated shall be masked off to terminate on straight edges to ensure an aesthetic finish. Prior to beginning the coating application, environmental conditions must be checked to verify suitability in accordance with NACE guidelines [1]. 100% solids, epoxy coating is applied as a two coat system at a total DFT (Dry Film Thickness) of approximately 800 microns.

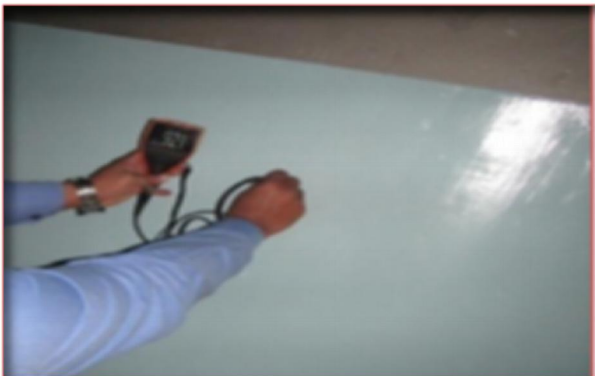
Results of DFT and Holiday Tests are mentioned in Table 5, which shows satisfactory results and within the limits of SSPC PA 2 and NACE SP0188.

Figure 5: View of DFT Test readings taken in accordance with NACE SP 0188 [5]

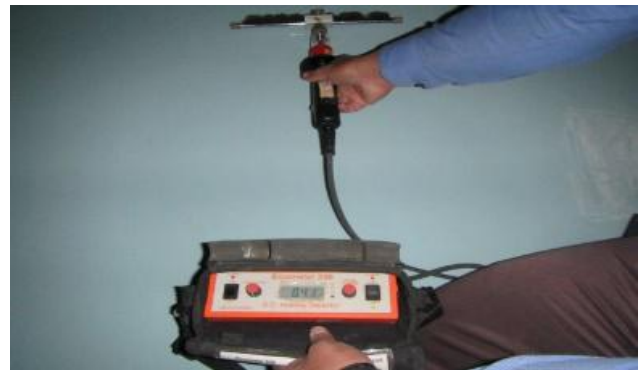
All quality checks were carried out per the approved scope of work. Surface preparation was completed to the desired standard. The specified minimum dry film thickness was achieved and recorded in accordance with SSPC- PA2 [3]. Full coverage and uniformity was achieved on all coats. After holiday testing, corrective action was undertaken for any visual defects that were observed, repaired and re-inspected.

Figure 6: View of Holiday Test in accordance with SSPC PA 2 [5].
