**Paper No.
MC24**

The Cavitation Erosion Behavior of UNS A96061 Alloy in Seawater

NIGIS * CORCON 2017 * 17-20 September * Mumbai, India

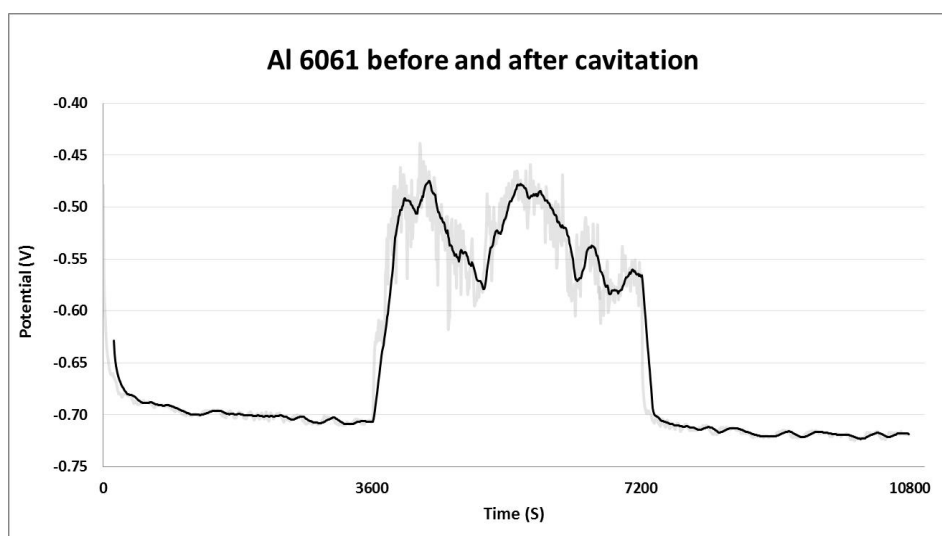
Figure 3 shows the potential-time measurements versus calomel reference electrode (CRE) for UNS A96061 in seawater under stagnant and cavitation conditions. The open circuit (OC) potential of this alloy begins with a more active value under stagnant conditions and then immediately shifts towards more noble direction upon the imposition of cavitation conditions. The value of the negative shift in potential under cavitation conditions is approximately 20 mV. The OC-potential returns to more negative values when cavitation conditions were lifted.

Figure 3: The effect of cavitation conditions on the free-corrosion potential of UNS A96061 in seawater at 25°C.

Results of the corrosion potential versus time tests indicated that cavitation caused a rapid negative shift in the free-corrosion potential for UNS A96061 which increased slightly during the cavitation period. The potential shift for UNS A96061 alloy quickly reversed when cavitation was stopped, suggesting reformation of the protective oxide layer on the surface of this alloy.
