# Integrity Challenges & Control - Tank Bottom Corrosion Shakeel Isak Girkar

This paper focuses on case study of crude oil tank bottom plate failure due to corrosion and discusses its causes, design and installation errors, analysis of CP effectiveness, inspection strategy, interpretation of damage mechanism and recommendations.

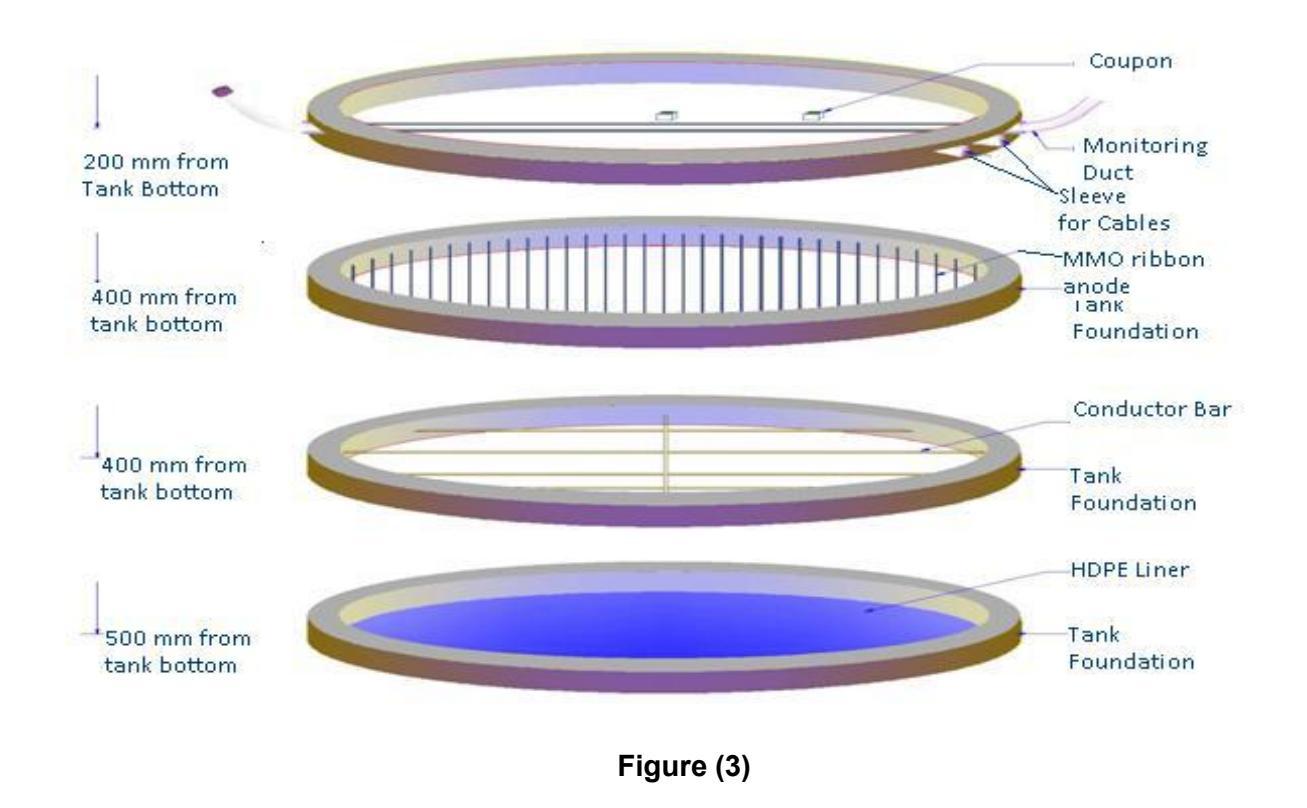
Sequence and cross sectional view of the installed CP system and tank bottom arrangements as illustrated in figure 3 & 4

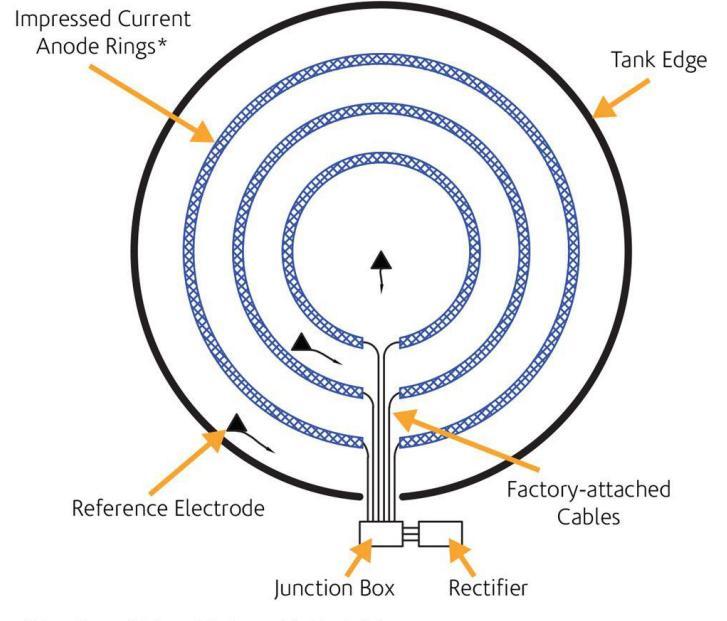
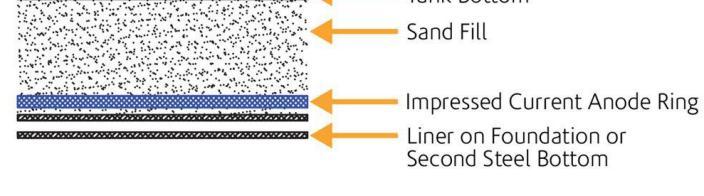
Figure (8)

Typical proposed anode configuration is shown below as Figure 8.
