CAP44

Interference & Corrosion due to HVAC power lines running parallel to cross country pipelines - Challenges in mitigation and way forward

ABSTRACT

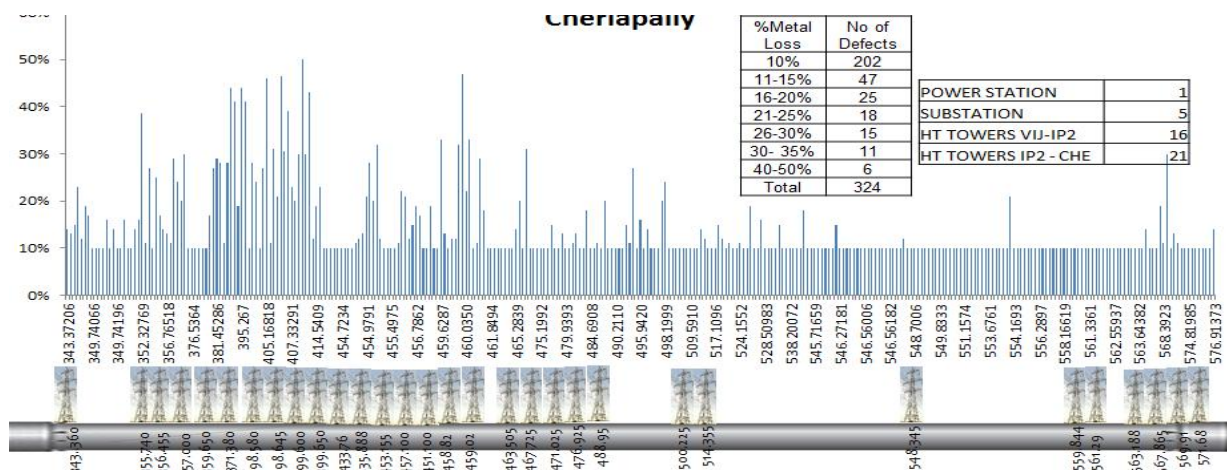
Dig verification was done at external defects sites as per ILI report and coating holidays were found defective at the corrosion locations.

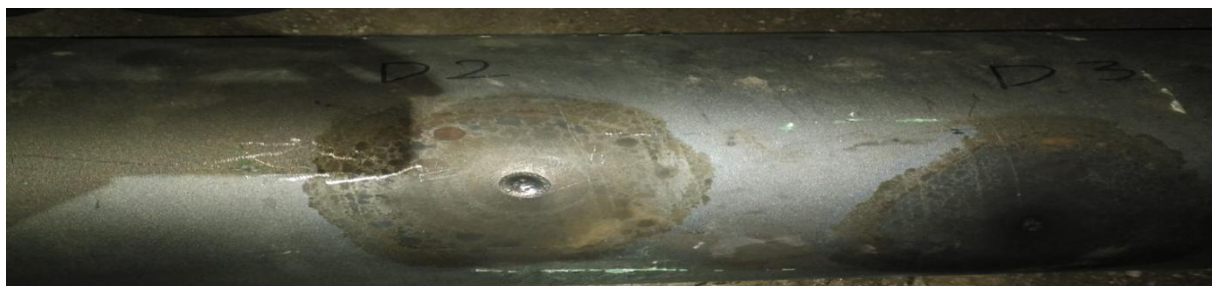
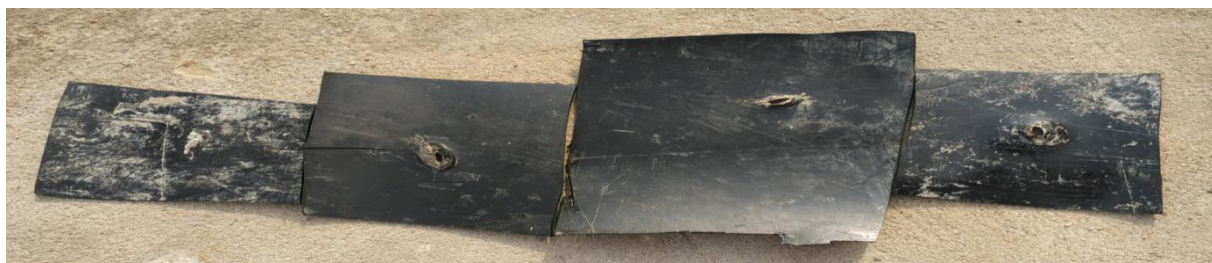
Corroded material analysis & soil sample analysis got done in lab as per recommendation of SME (Subject Matter Expert) during his site visit on 05.06.2015 & analyzed that these coating defects were due to damage during lowering of pipeline in construction period.

Figures shown below for the external defects, coatings

External defect of 52% metal loss

As a precautionary measure installation of composite sleeve for reinforcement and coating repairs for all major external corrosion were carried out, where the metal loss was higher than thirty percent.

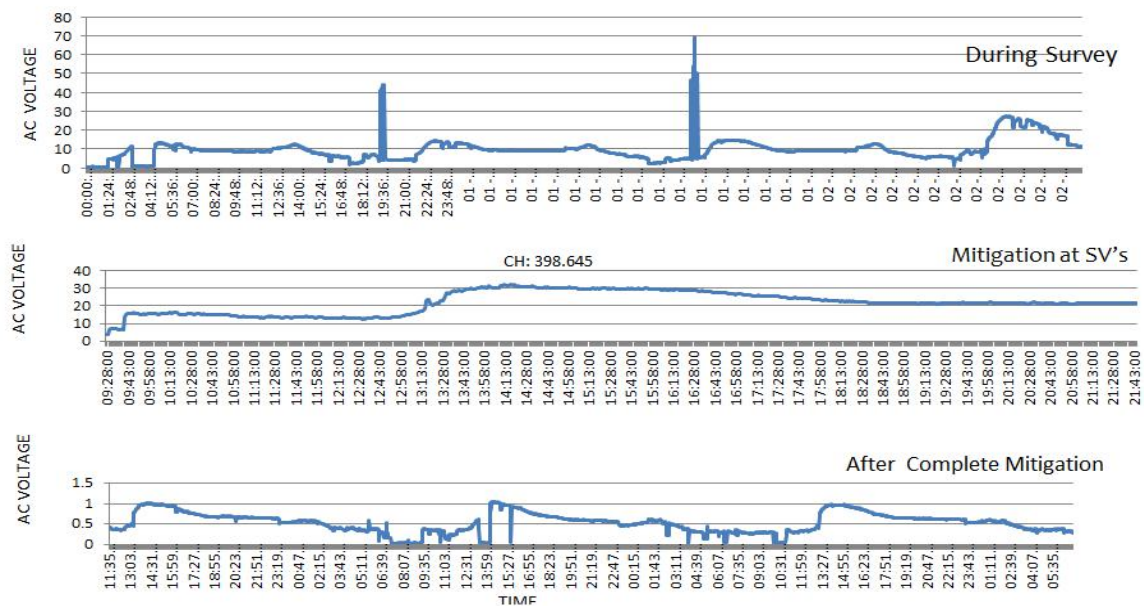
By carrying out aforesaid mitigation activities, we have obtained a positive results by reduction of AC voltages at the points where earlier a significant AC voltages were recorded
