Severe Under-deposit Corrosion Damage in Suction Headers of Compressor House in LPG Recovery Unit

Indian Oil Corporation Ltd, Guwahati Refinery, India
manojk@indianoil.in

Keywords: Sour water, compressor, LRU, Under deposit

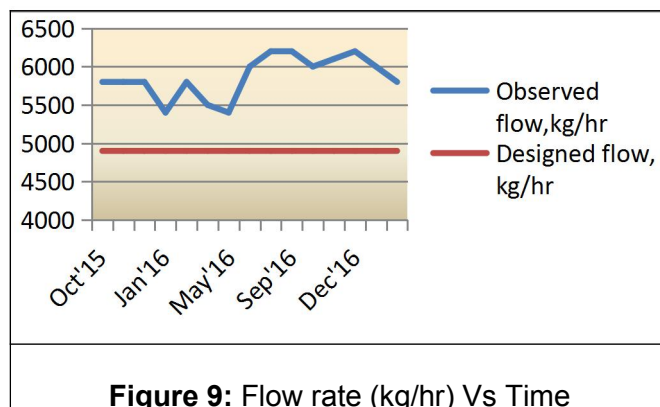
Figure 9 describes that; unit was operated with flow rates up to 6200 kg/hr against the design capacity of 4400 kg/hr. This high flow was favorable for carryover of extra moisture and coke fines.
