**Liquid Metal Embrittlement in Outlet Pigtailed of Reformer of Hydrogen
Generation Unit in Digboi Refinery**

outlet pigtails and caused huge flash of fire. Such failure caused shutdown of the Hydrogen unit for substantial amount of time. This paper describes about the LME (Liquid Metal Embrittlement) in Alloy 800HT reformer outlet pigtail tubes which finally resulted in fire & property loss.

Keywords: HGU; Reformer; Pigtail, Liquid Metal Embrittlement, Alloy 800 HT, Molten Metal Corrosion

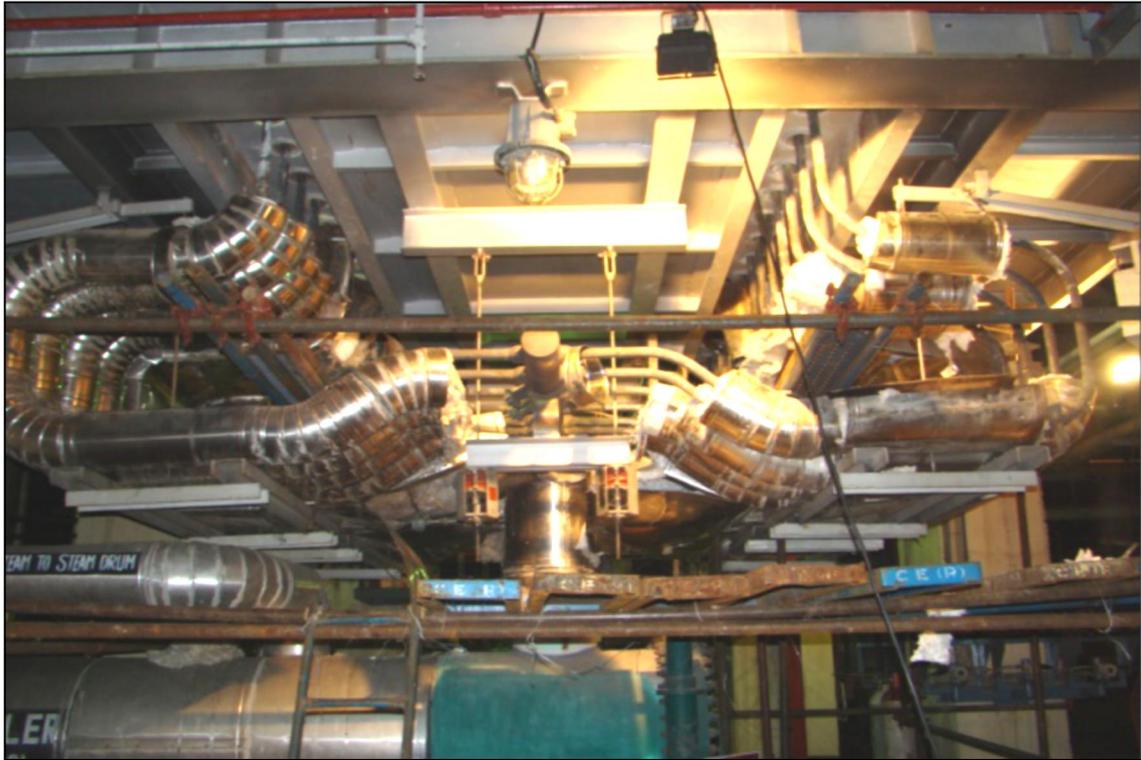
Figure 3 Outlet Pigtail Tube Arrangement (Row-A and Row-B)

Following the unit shutdown, the reformer tubes were pneumatically tested with nitrogen at 5.5 Kg/cm²g. Leaks were detected at six locations in Row-A outlet pigtails. At the outlet pigtail of tube 2, leaks at two locations were found while one leak each at outlet pigtail of tubes 01, 11, 12 and A13 was observed. No leak found in outlet pigtails of Row B tubes.
