Paper No. CR26

Corrosion of Monel Distributor of Caustic Scrubber In MSQ Unit

NIGIS * CORCON 2017 * 17-20 September * Mumbai, India

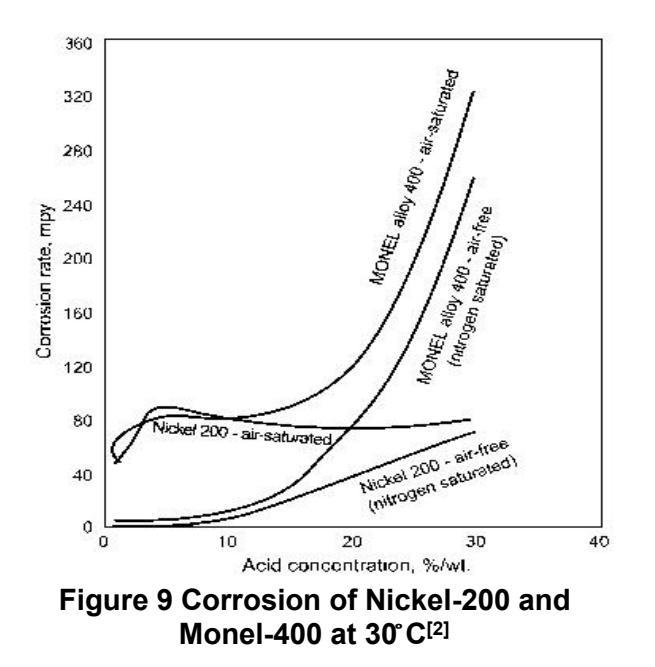
As inferred from the above possible explanations, the most likely reason of failure of the flanges and Monel distributor was due to condensation of highly acidic HCl (low pH). As seen in Figure-9 & Figure-10 Monel 400 shows aggravated corrosion rates as the temperature and acid Concentration increases.
