Paper No. CAP42

# AC Interference, AC Corrosion & AC Mitigation

### Jeffrey L. Didas

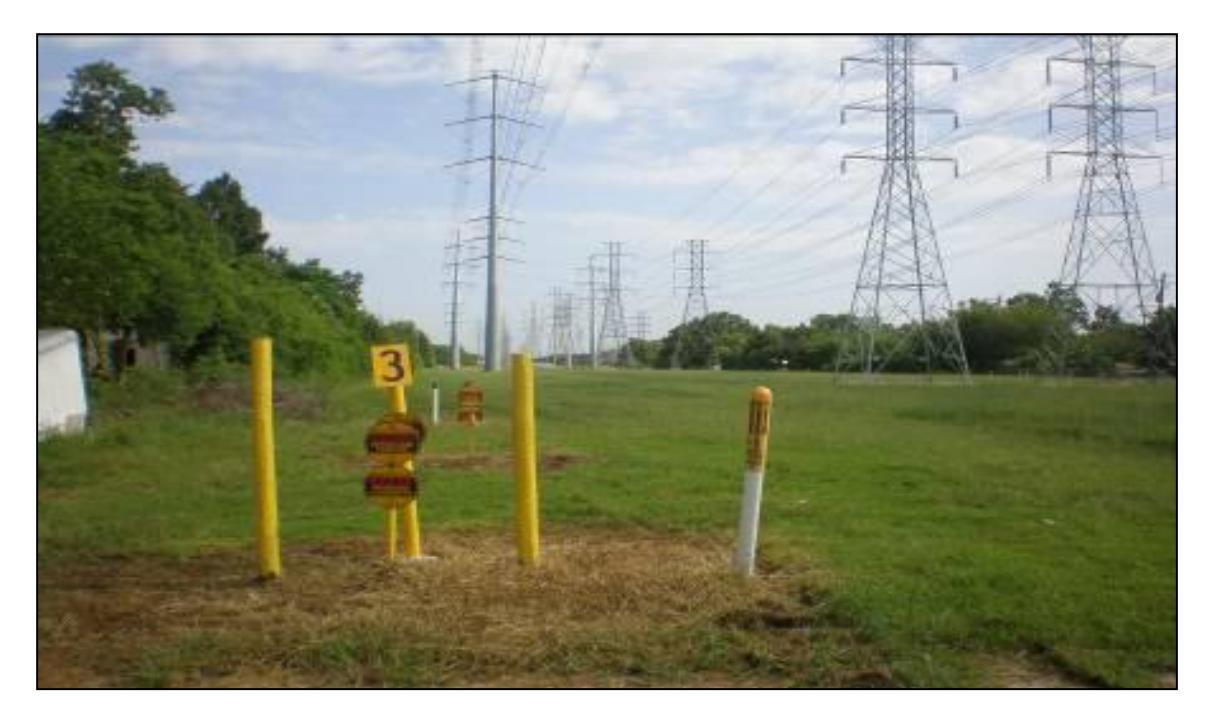
Figure 1: Typical Pipeline ROW with Multiple Powerlines

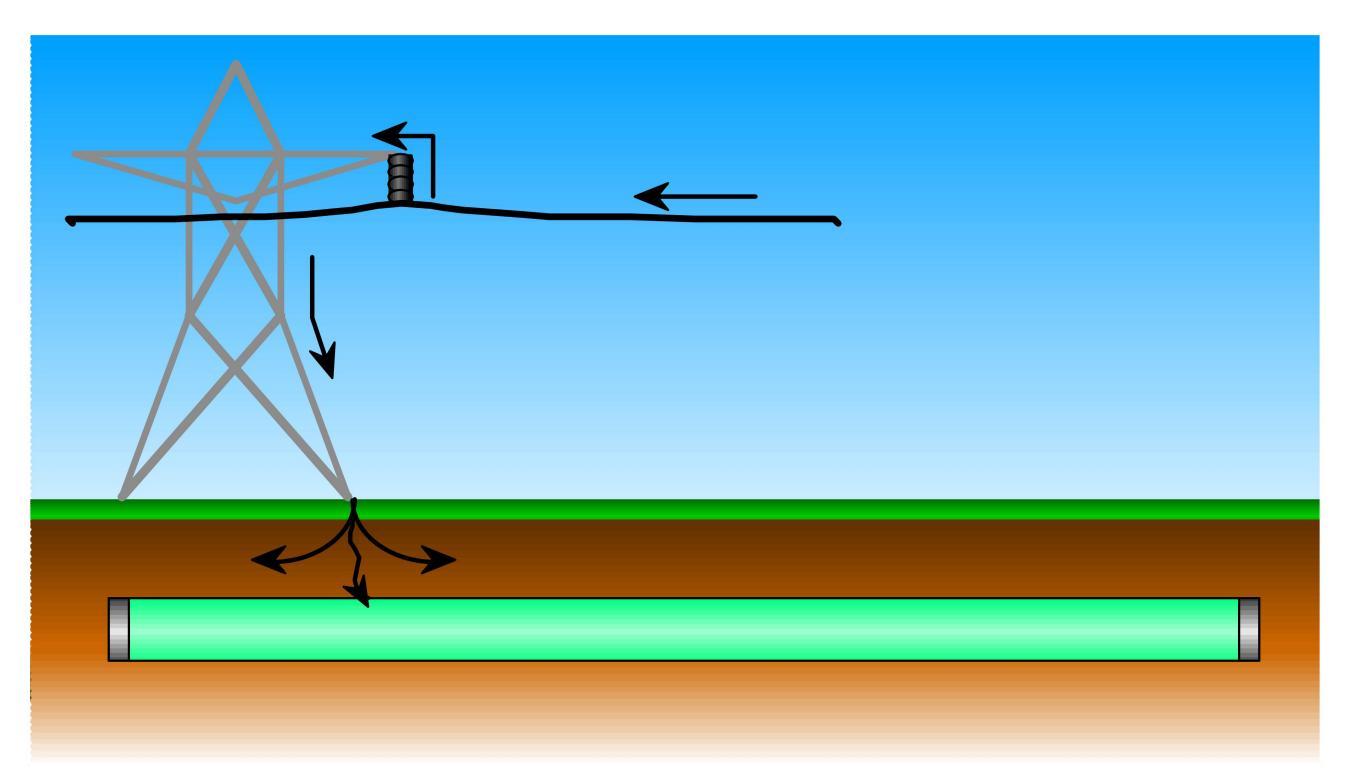
Conductive Coupling -- AC Fault Conditions

Relatively rare Short duration Generally due to weather (lightning and high winds)

Can cause structural failure, CP component damage, causes intense stressing of the pipeline coating and possibly the pipe wall

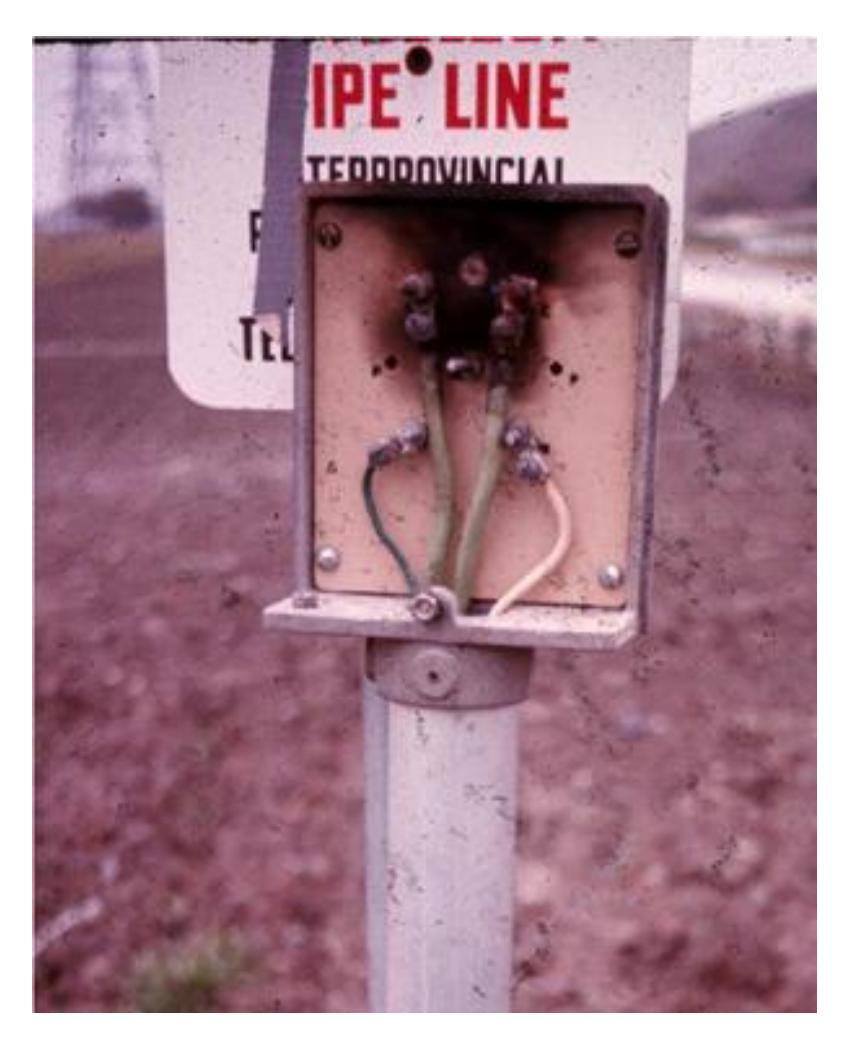
Figure 1B: Lightning/Surge Damage on a Pipeline Test Station

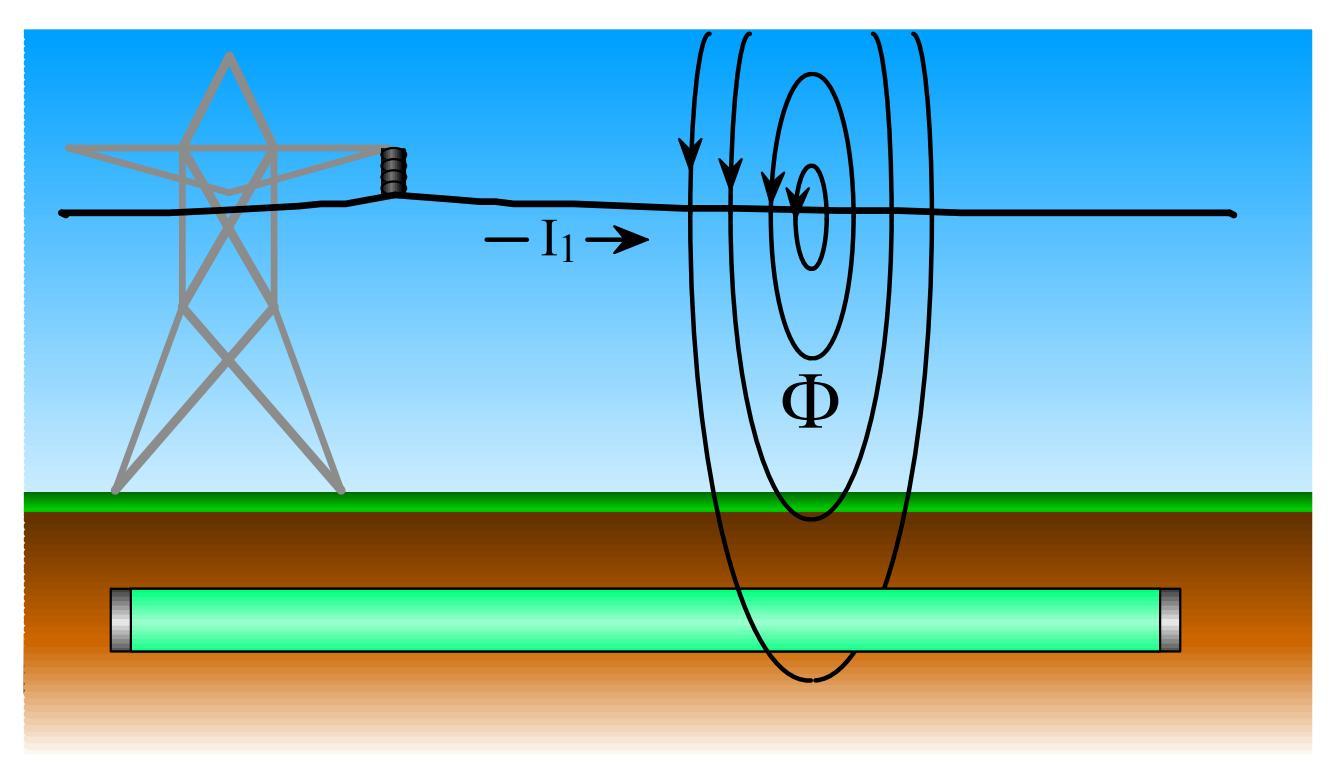
#### Electromagnetic Induction

A function of Line Current not Voltage Power transferred is:

- Proportional to line current \_
- Proportional to parallelism -
- Inversely proportional to separation distance \_

Can result in high voltages on long sections of pipeline even if the pipeline is grounded

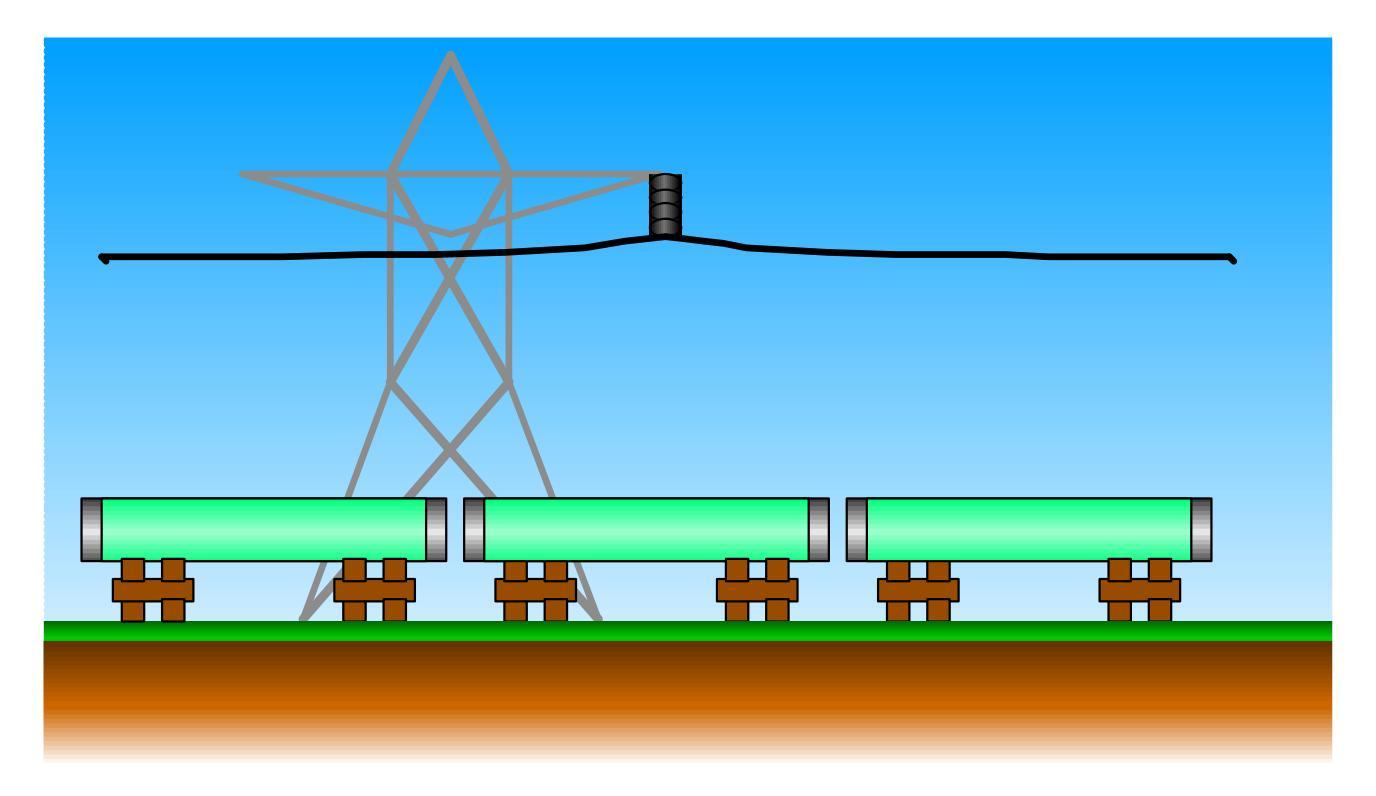
Electrostatic Coupling or Capacitive Coupling

Pipe and Power line create a circuit of two capacitors in series.

A capacitor is a passive electronic component consisting of a pair of conductors separated by an insulator (air).

Can generate very high AC voltage levels – but there is not enough power to do much more than create an electrostatic shock.

Generally a nuisance, however can be an issue and grounding may be required.

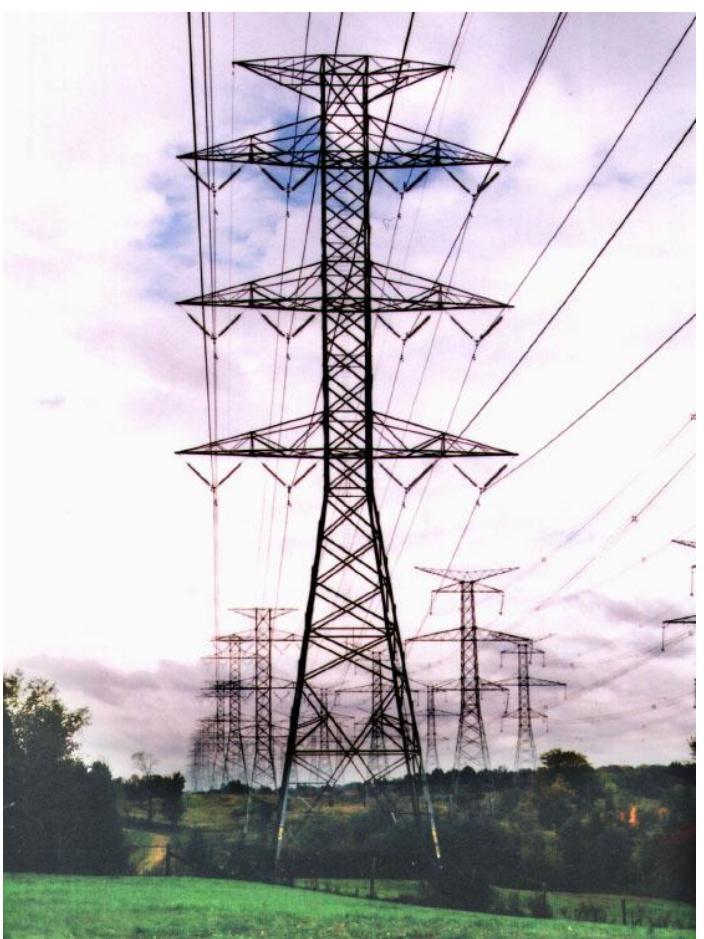
Powerline Geometry Effects the LEF – Powerline - Quadruple Vertical Circuit with Skywires

Current through the HVAC lines generate a Longitudinal Electric Field (LEF) The separation between the phase conductors has a significant effect on the LEF and increases with separation

Bundled buried conductors have no separation and provide only a minimal effect on pipelines The arrangement of phases on multiple circuit HVAC lines can have a large impact on the LEF

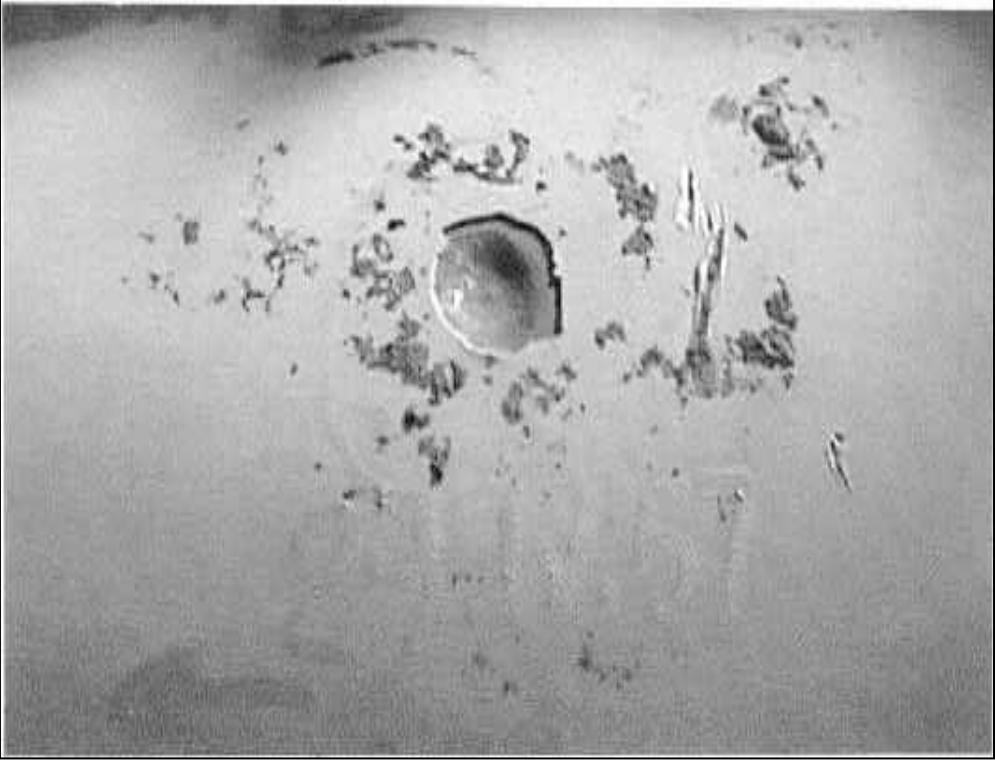
Figure 2A: Typical AC Corrosion Pit

- Ćharacterized by round morphology
  - Unique shapes and colors
  - Almost perfectly round
  - Smooth edges
  - Pimpled Pattern
  - Brown discoloration
  - Corrosion product is not soluble
  - pH Neutral to Elevated
  - AC Current Densities > 100A/meter

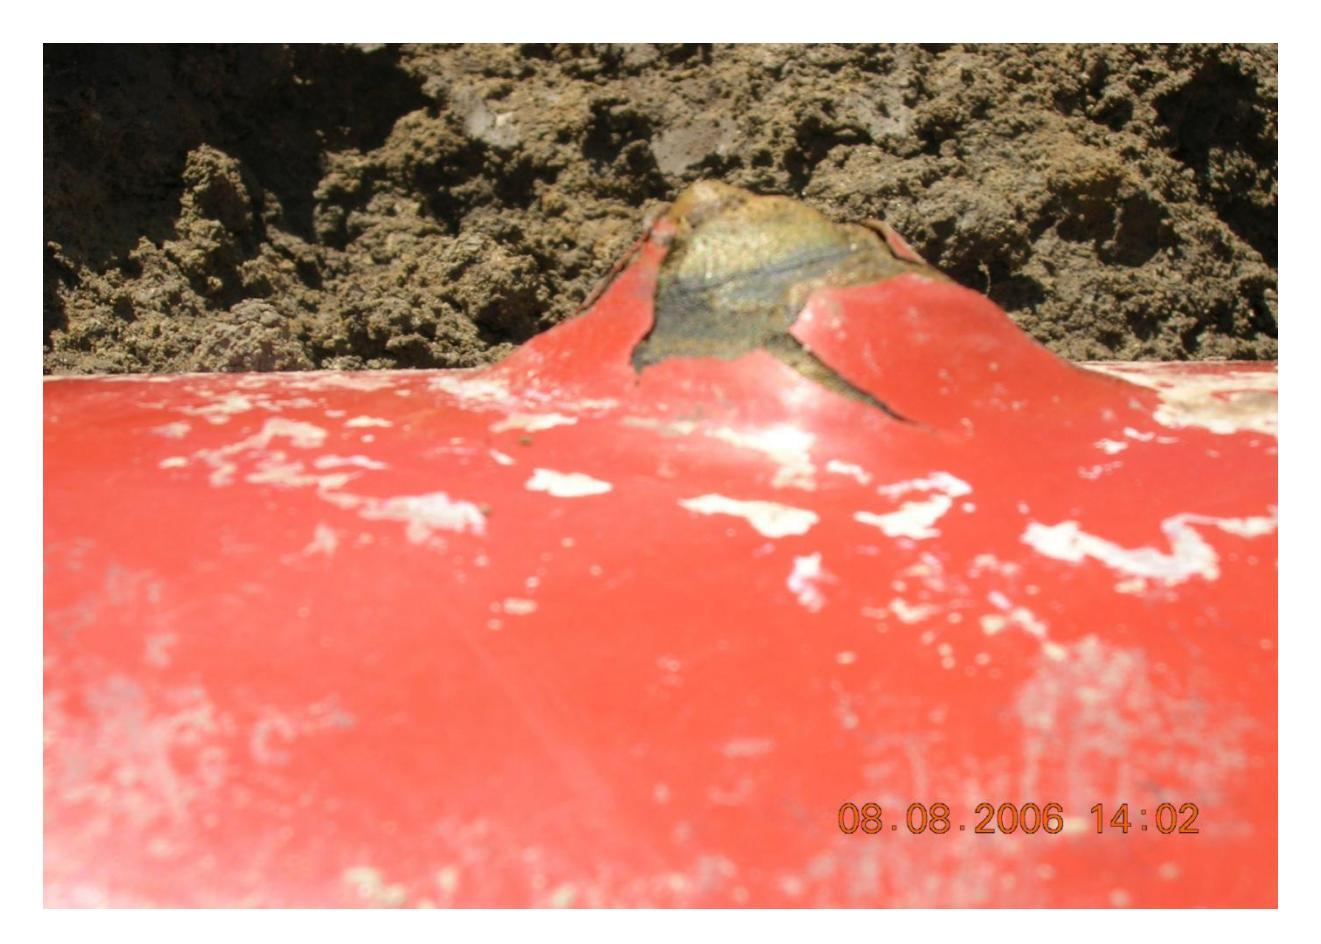
Figure 2B: Typical AC Corrosion Pit with corrosion products

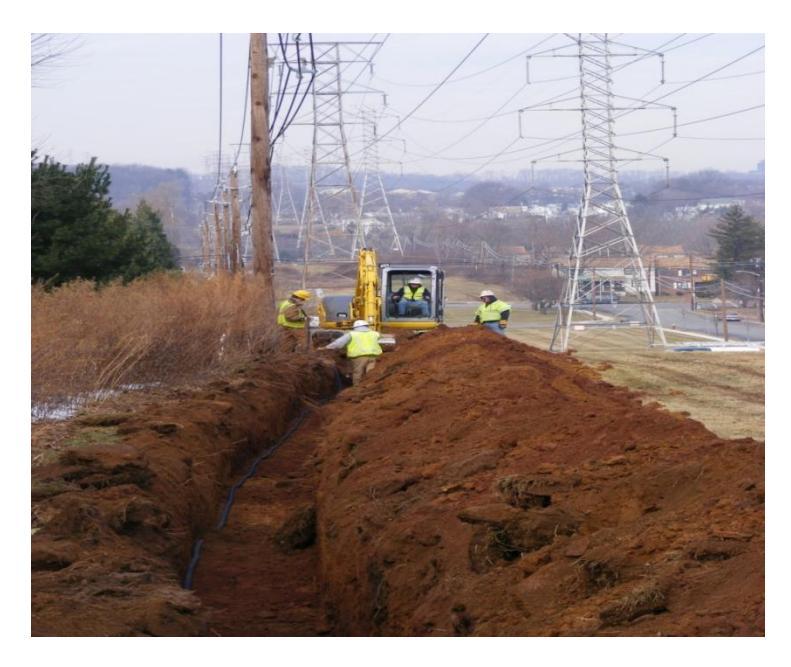
Figure 3: Installing AC Mitigation with Backhoe

The case study is an actual AC Mitigation design based on a model. The 42" pipeline is in a common ROW with other gas transmission pipeline s with coal tar enamel – CTE coating. The 42" line has fusion bonded epoxy – FBE coating. The powerline was a 380 KV line. The model required a single length of AC mitigation parallel to the pipeline, 5' off the pipeline and at pipe depth. The mitigation was installed between the pipeline and the powerline. The mitigation ran the length of the parallelism and was approximately 28,500 feet of #2 AWG copper cable installed inside a prepared backfill. Solid state decouplers were installed at approximately 1000 foot intervals and with an AC coupon test station installed at 2500 foot intervals.
