Paper No. CCFI24

Corrosion studies on coated and bare C-276 material in molten cuprous chloride salt environment

Keywords: Copper-Chlorine, Thermochemical, high temperature, Corrosion resistant coating

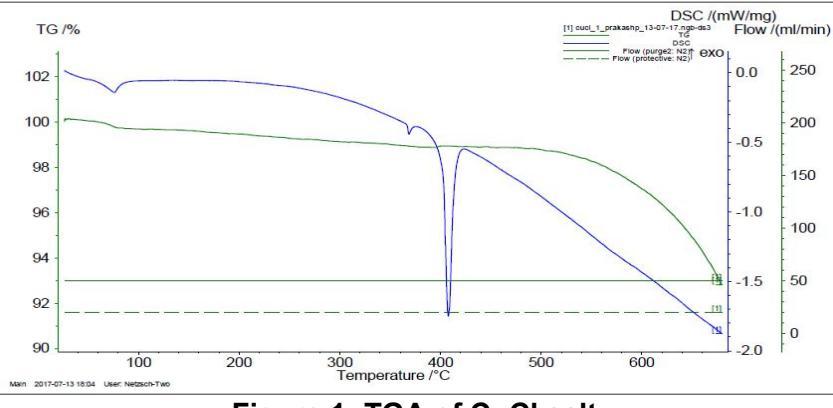
Figure 1: TGA of CuCl salt

Cuprous chloride (CuCl) salt, AR Grade, 96% purity, supplied by M/s. S. D. Fine Chem. Ltd.was used for study. Differential scanning calorimetry (DSC) and Thermogravimetric analysis (TGA) of CuCl was performed with Netzsch STA 449 F3 (Germany). A weight of around 10-12 mg of CuCl was placed in alumina pan and heated in nitrogen atmosphere with 50 ml/min flow from room temperature to 700°C at a heating rate of 10 °C/min.A continuous record of weight loss and heat flow as a function of temperature was obtained (Figure 1).DSC-TGA graph indicates 0.3% weight loss at 100°C, which may be attributed to free moisturecontent.

Initially, CuCl was preheated in a vacuum oven at 150 °C for 6 h to ensure removal of any moisture content taking clue from the TGA study. Then, the preheated salt was immediately charged to quartz reactor and sealed by taking necessary precautions to avoid external contamination. The tests were conducted in the quartz reactor assembly as shown in Figure2. The reactor temperature was increased in a programmed manner from room temperature to 550°C with continuous nitrogen purging at 125 SLPH with the help of the user interface console. After attaining 550°C temperature, the specimensattached to the quartz rod were introduced into the reactor and immersed in molten CuCl mass. Nitrogen purging was continued during the experiment at 25 SLPH to maintain oxygen-free environment. The study was continued for 100 h at 550°C under static condition.

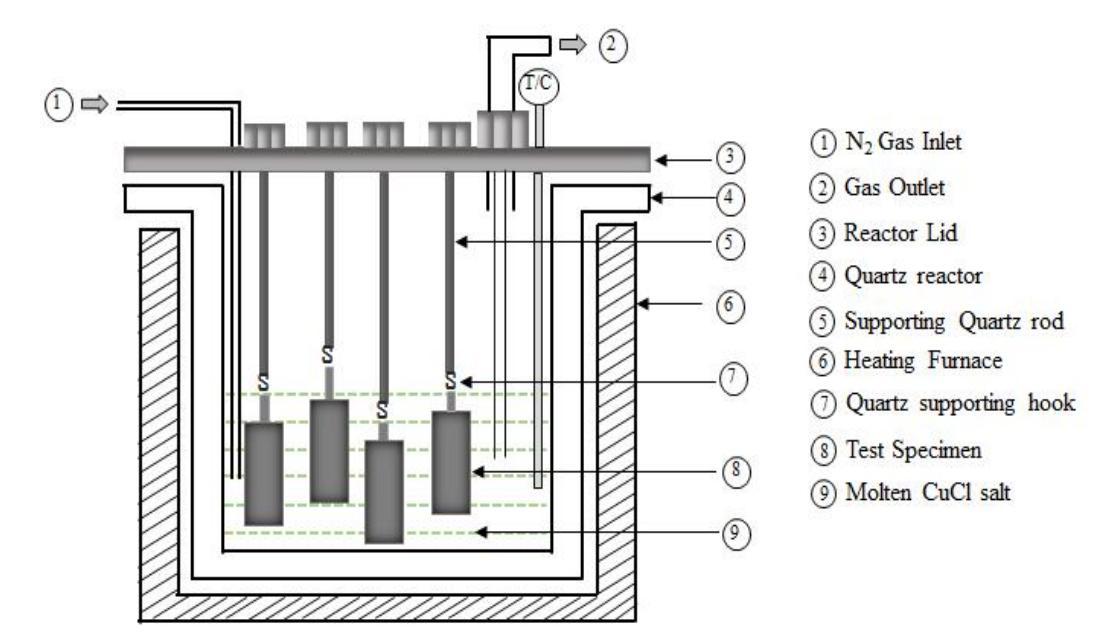
Figure2: Schematic diagram of the quartz reactor assembly

The methodology for immersion test was developed based on ASTM-G-31-72 standards. The experimental apparatus consists of an quartz reactor (immersion vessel, 2 L capacity) enclosed in furnace with inlet and outlet tubes, a gas feed module comprisinggas cylinder and mass flow controller for nitrogen as well as an scrubber system to control the release of noxious fumes. The test experiments was carried out with coated and uncoated specimens and under static condition in molten CuCl media at $550^{\circ}C\pm10^{\circ}C$ for 100 h using quartz reactor systemwith and without nitrogen purging.

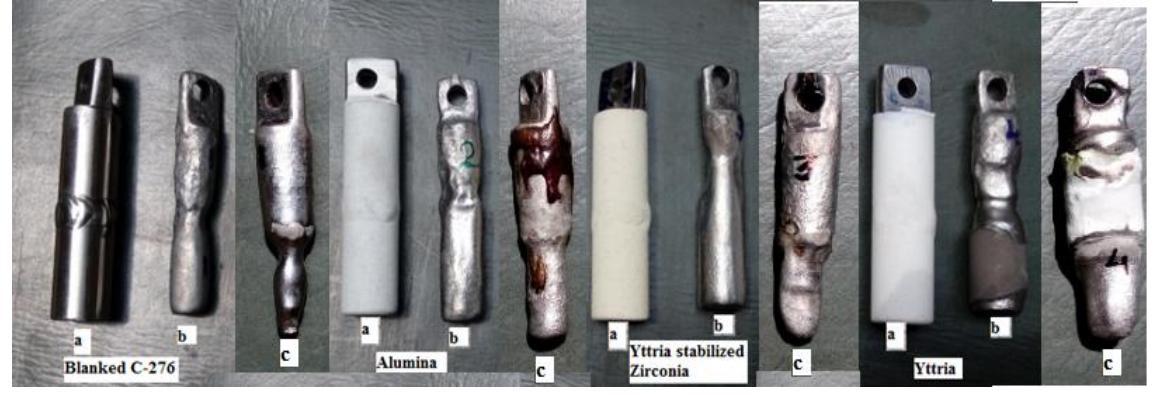
Figure 3:Partially coated specimens in absence of nitrogen (a) Before reaction (b) After reaction without welded joint and (c) After reaction with welded joint

The corrosion test was performed with C-276 specimens (with and without welding) coated with Diamalloy 4006 bond coat followed by alumina, Yttria and YSZtop coatwithout nitrogen purging. Top portion of test specimen near the holewas not coated with base and top coat. The results obtained are shown in Table 3.Figure3 shows the images of specimens before and after reaction. Maximum corrosion was observed on the bottom part of the specimens.

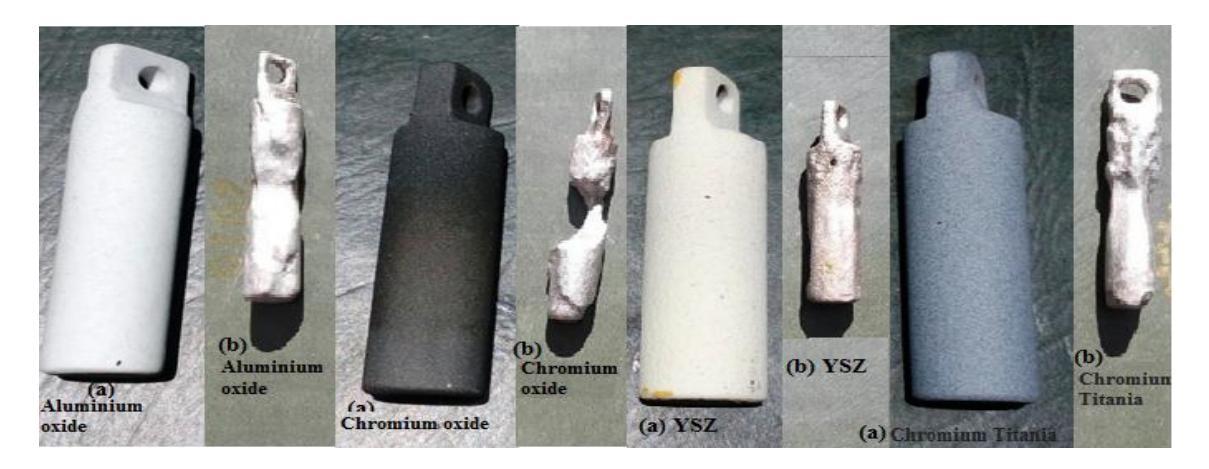
Figure4:Completely coatedspecimensin absence of nitrogen (a) Before reaction (b) After reaction

To verify the possibility of corrosion due to penetration, the next experiment was performed with completely coated specimens (without welding) under the similar conditions for 100 h. The base metal was coated with the bond coat of Diamalloy 4006 and top coat of Aluminum oxide, Chromium oxide, YSZ and Chromium titania. Table 4 shows the weight loss and corrosion rate data.Figure4 shows the images of specimens before and after reaction.

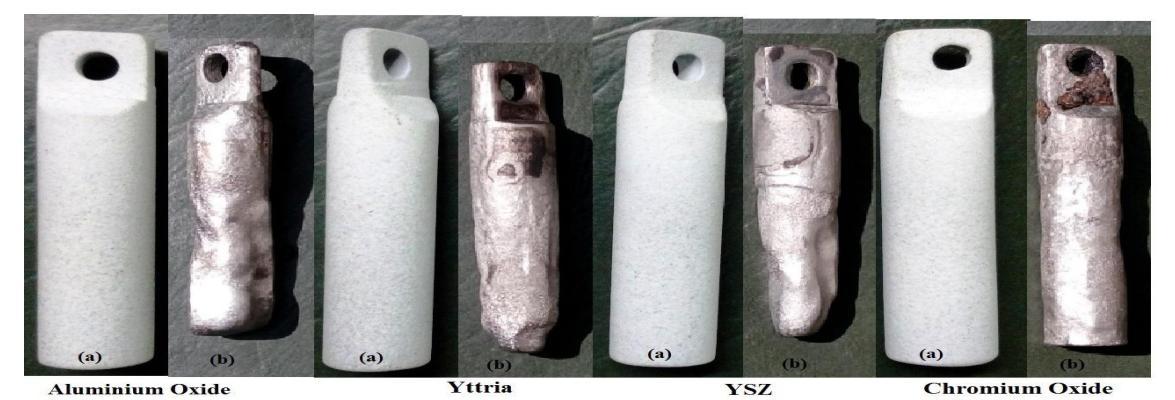
Figure 5:Completely coated specimens in presence of nitrogen (a) Before & (b) After reaction

The experiment was then conducted with C-276 specimens (without welding) completely coated with Diamalloy 4006 bond coat followed by Aluminum oxide, Yttria, YSZ and Chromium oxide coating top coat in presence of continuous nitrogen purging at a rate of 125 SLPH. Table5 shows the corrosion rate of completely coated specimens. Figure 5 shows images of completely coated specimens in presence of nitrogen before and after reaction.

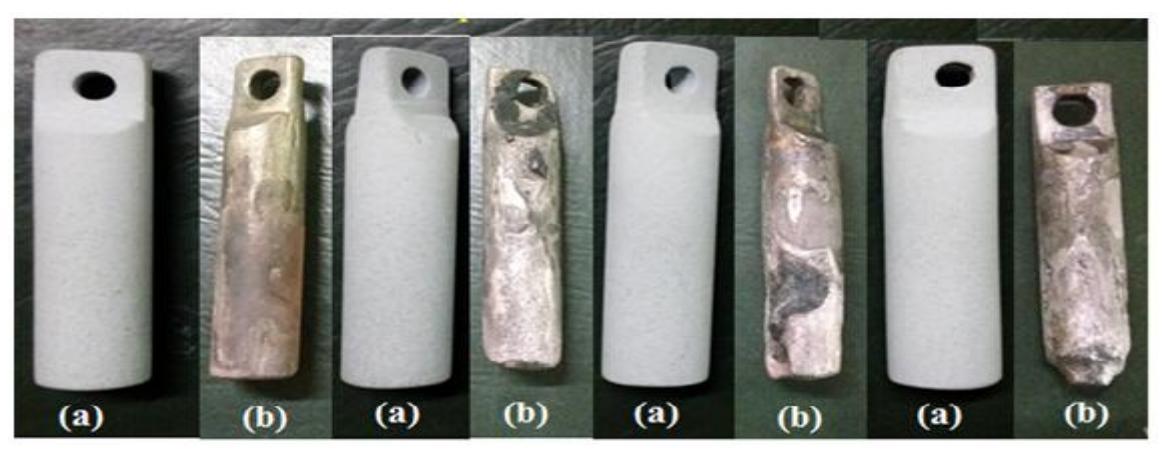
Figure 6:CompletelyYttria coated specimens (a) Before testing (b) After testing

To study the consistency of the coating, four specimens completely coated with Yttria were tested in molten CuCl environment for 100 h in presence of continuous nitrogen purging at a rate of 125 SLPH. The severe attack of CuCl delaminated both of the coating layers of all the specimens as shown in Table 6 and Figure 6

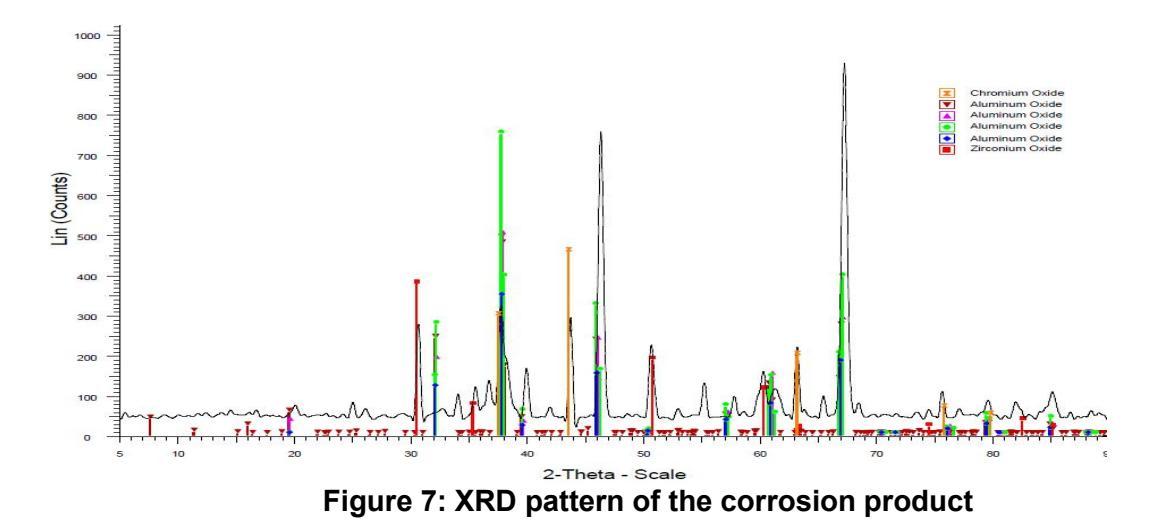
Figure 7 shows the XRD pattern of the solid corrosion products obtained at the bottom of the quartz reactor apparatus at the end of corrosion test at 550°C for 100 h.The element mapping shows the outer scale mainly composed of Cr_2O_3 , Al_2O_3 , and TiO_2 , and an Al_2O_3 scale formed close to the substrate of the coating material.

An EDX analysis was performed to confirm the presence of the coating elements. Table 7 shows the elemental composition of the product. Chromium, Nickel, Manganese, Molybdenum, Zirconia, Copper, Iron and Yttrium were all present. Nickel and chromium are the main constituents of the Diamalloy 4006and C-276. Zirconia was present after the layer of Diamalloy 4006 but its particles were diffused in the bond coat.
