Case studies on corrosion testing in concrete structures

The case studies of non-destructive / semi-destructive investigations carried out on a RCC/PSC bridge and a RCC silo in the state of Kerala, India are presented in this paper. Both the structures were built during 1984-85. The substructure of the 12 span bridge had RCC piers and, its superstructure was built in PSC girders and RCC deck slab. The accessible piers of the bridge were tested non-destructively / semi-destructively using rebound hammer, UPV, concrete resistivity meter and core cutting. In-situ carbonation test was carried out and the chloride content of concrete was determined from powder samples. The RCC silo was in use for storage of water based slurry of thorium hydroxide. The walls of the silo were tested for rebar corrosion using Galvapulse, and concrete carbonation.

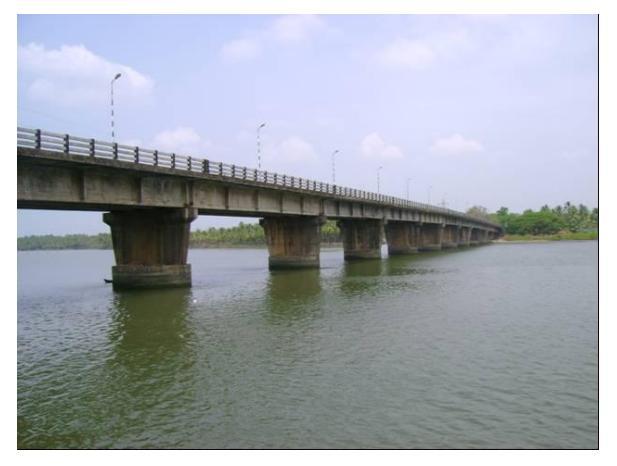
Figure 1: Chetuva Bridge

The salient features of the bridge (Fig. 1), built across the backwaters, are presented in Table 1. The non-destructive testing of the bridge was carried out during July 2011 with an objective to assess the condition of the concrete. As, barring the piers 1, 2 and 11, the other piers were surrounded with water, the testing were carried out on these accessible piers only. The numbering of the piers was reckoned from its Northern side. The design strength of concrete was not known.

1.	Total Length (m)	319.9
2.	No. of spans	12
3.	Type of Foundation	Well
4.	Type of substructure	RCC Piers
5.	Type of super-structure	PSC girders and
		RCC deck slab
6.	Year of construction	Approx. 1985

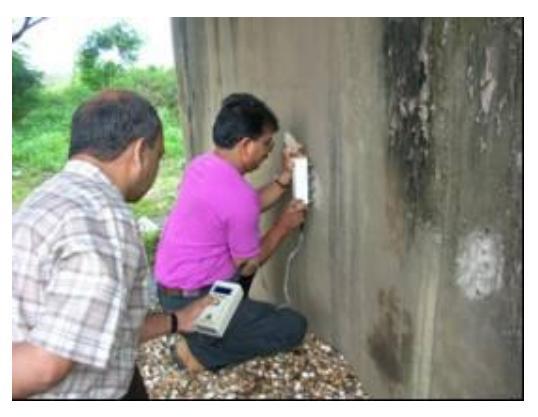
Figure 2: Concrete Resistivity Test

The list of the tests carried out and, method adopted / equipment used for the same are presented in Table 2. Figures 2 and 3, respectively, show the test for resistivity, and concrete core extraction.

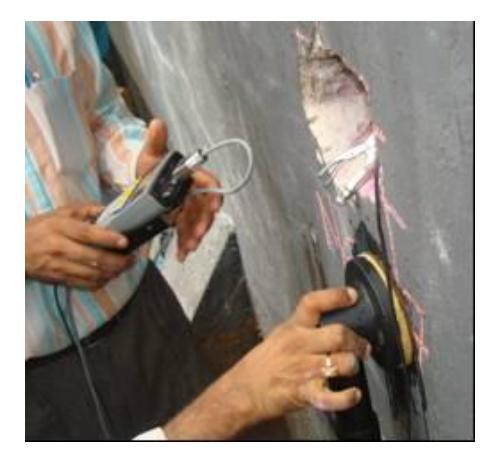
Figure 4: Measurement of corrosion current density of rebar

The testing of the silo was carried out in August 2010. The objective of testing was to assess the condition of reinforcement with respect to corrosion. As there were no visual signs of corrosion (cracks, delamination, spalling etc.), the number of test points were limited to 8; four points on the outer face of the wall and four points on the inner face of the wall. A corrosion measuring equipment, which uses the Galvanostatic principle of corrosion measurement, was used for the above purpose. Figure 4 shows testing for the corrosion current density with the above said equipment. The equipment is provided with a guard ring feature for confining the applied polarization current. A detailed description of the equipment is provided by Peterson⁶. It directly gives the corrosion current density of the steel in terms of μ A/cm², which is interpreted using the criteria presented in Table 3, as suggested by the manufacturer of the equipment. However no standard method exists to assess the corrosion rate of steel reinforcement in concrete through corrosion current density.

The measurement of corrosion current of the reinforcing steel bar was preceded by first locating the same in the concrete wall using a rebar locator, which also gives the diameter of the bar. Access to the rebar was obtained by controlled breaking of the cover concrete using a drill machine, chisel and sickle. The exposed concrete surface was sprayed with phenolphthalein solution for detection of the carbonation of concrete (Fig. 5). The depth of the concrete cover was also measured and the condition of the reinforcement bar was visually inspected after breaking the cover concrete. (Fig. 5).

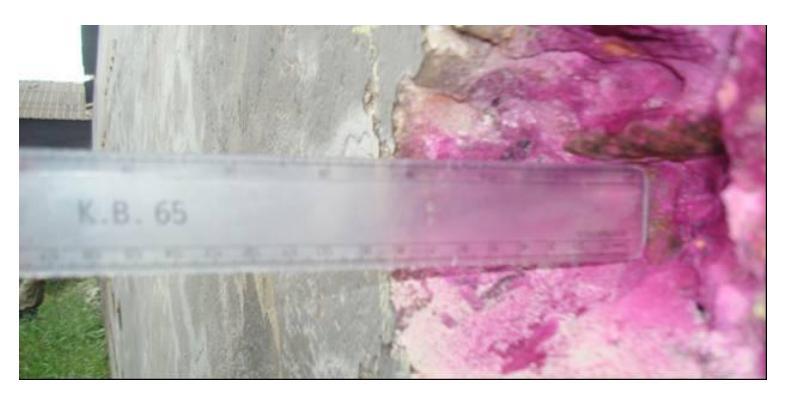
Figure 5: Measuring concrete cover and testing for concrete carbonation

The visual inspection of the RCC wall revealed that the surface of the concrete wall appeared to be in good condition. The concrete cover over the reinforcement as measured was about 60-80 mm. No carbonation of concrete as evidenced from the pink coloration obtained after spraying the phenolphthalein solution on the broken concrete surface (Fig. 5). The reinforcement bar appeared to be in good condition, and the ribs over the reinforcement

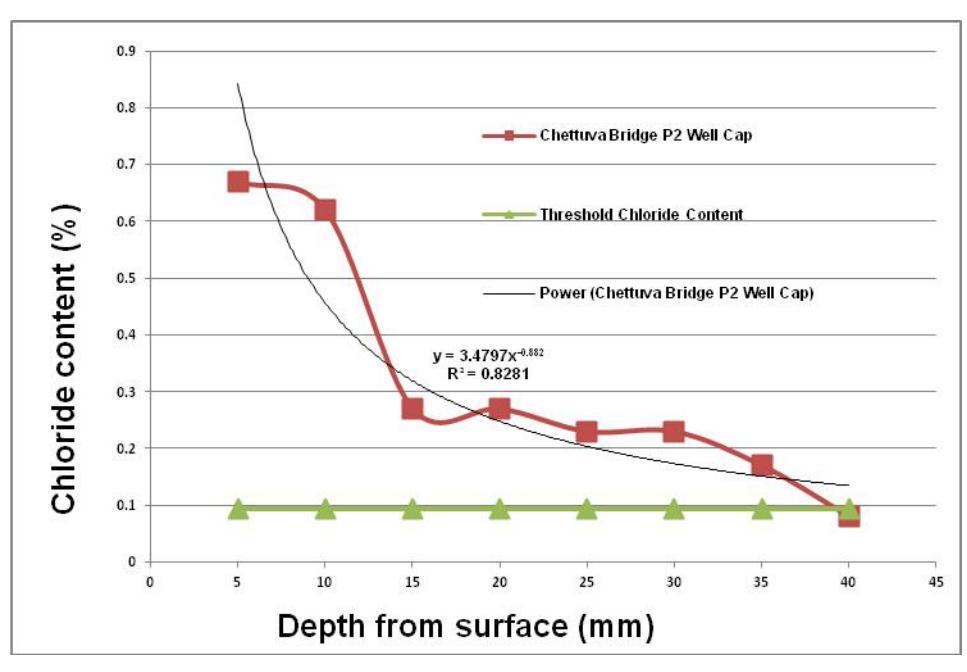
Figure 6: Chloride profile of concrete in Pier cap of Chettuva Bridge

Figure 6 shows a plot of the variation of the chloride contents (chloride profile) with the depth from the surface for the Well cap of Pier 2. The chloride content was found to be higher at the surface, up to about 40 mm, than the threshold chloride level. In other words, the

chloride could penetrate up to about half of the concrete cover in about 27 years. Although it may be concluded that the chloride content at the reinforcement level would be considerably lower than the threshold chloride level for corrosion, however, the results indicate a warning signal in-terms of the impeding chloride attack on the reinforcement of the well cap.

Assuming similar aggressiveness of the exposure conditions, it could take about another 20 years for the chloride content to reach the level of reinforcement (conservative estimate). As the chloride content is less than the threshold value at the level of reinforcement, no corrosion was observed at the location of the testing. The chloride content of the concrete in Pier was found to be less than that of the well cap. The well cap was in contact with water and is subjected to alternate wetting and drying. Hence penetration of chlorides due to diffusion is higher in well cap as compared to the Pier.

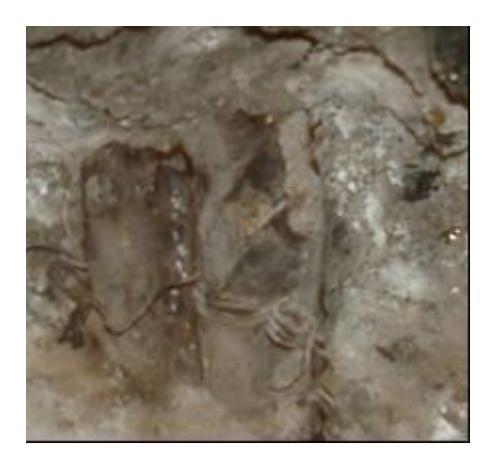
Figure 7: Condition of rebar - binding wire seen intact in the concrete (inside face of the wall)

bar and the binding wire used were intact (Fig. 7). The corrosion current density results and their interpretation are presented in Table 7.

It was concluded from the visual observations, carbonation test and corrosion current density measurements on the walls of the RCC Silo that the corrosion rate of the reinforcement was negligible on the outer surface of the north side wall, and inside surface of the walls and, is slow on the outer surface of the south side wall. The reason for the relatively higher corrosion on the south side wall could be due to its direct exposure to sea face and relatively more humid conditions.
