Paper No. RCC25

### CORROSION CONTROL OF REINFORCED CONCRETE IN CORROSIVE ENVIRONMENT

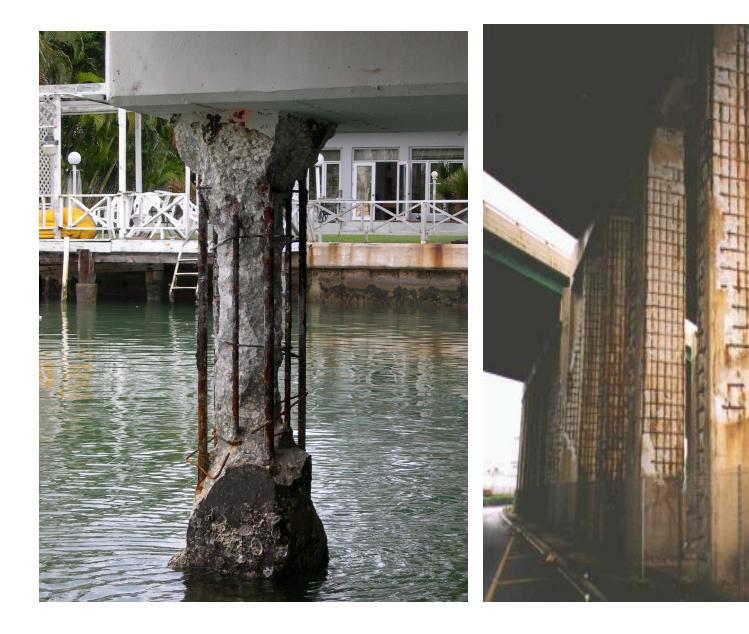
Figure 1. Marine pile corrosion

Figure 2. Concrete column corrosion under a leaking expansion joint

Corrosion of reinforcing steel is recognized as the major cause of the deterioration of reinforced concrete structures. Corrosive environments play significant role in reinforcing concrete corrosion. The corrosive environments include:

- Tidal zone and splash zone of marine structures
- Abutments, beam ends and cross beams at leaking expansion joints
- Concrete structures built with seasands as fine aggregate
- Concrete structures with calcium chloride as set-accelerator
- Exposed concrete structures that are heavily contaminated with di-icing salts

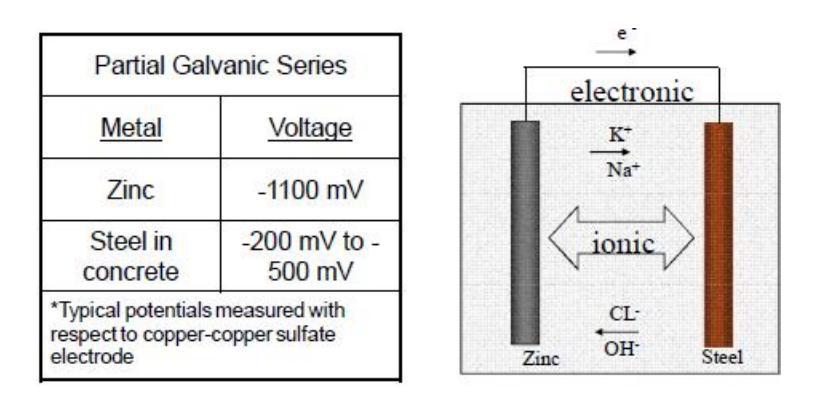
Fig. 3 How galvanic anode works.

Galvanic corrosion protection is a technique to reduce rebar corrosion by making the rebar surface the cathode of an electrochemical cell. The cathode in an electrochemical cell is the electrode where reduction (no corrosion) occurs. In a galvanic anode system, the current is generated by the potential difference between the zinc anode (-1100mV) and the steel reinforcement (typically at 350 to 500mV for corroding steel). There is no monitoring required to keep the sacrificial anodes working.

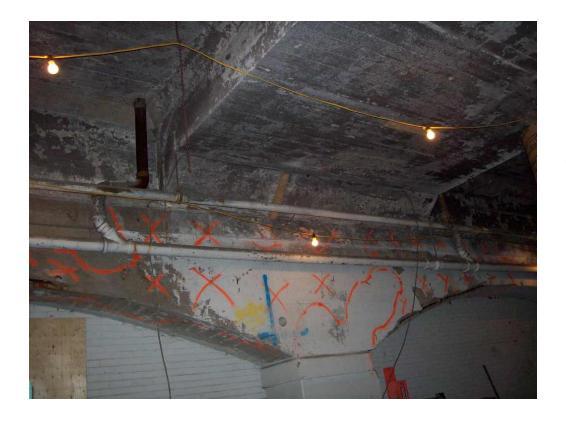
Figure 4. Concrete archway corrosion damages due to joint leaks with de-icing salts.

There was intensive corrosion in the bars due to the leaking expansion joints. A passive corrosion protection system was designed to provide corrosion protection to the main structural bars - the 27mm diameter crank bars on top of the archway.

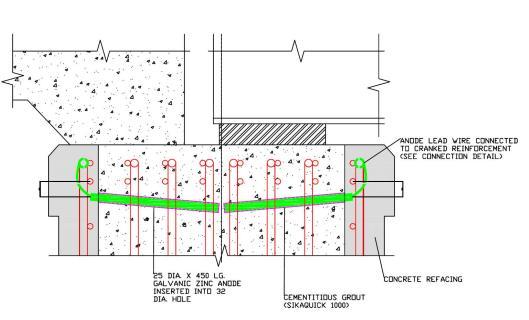
Figure 5. Galvanic anodes were designed to control the on-going corrosion of the top main rebars due to leaking joints.

The selected corrosion protection system consisting of three embedded distributed anodes was designed to provide corrosion control or cathodic protection to the reinforced concrete so as to extend the service life of the structure. Three line anodes (distributed anodes) were installed under the bearings. Each anode is 25mm diameter 450mm (1.5') long and contains 0.34kg (0.75lb) of zinc. 32mm diameter 500mm holes were drilled at downward angle and grouted half-full, then the line anode was inserted into the grouted hole to force the grout out. Finally the line anodes were connected to the rebars. The selected anodes have been monitored and the average current output is about 3mA/m2. The estimated life of the anodes is expected more than 20 years.

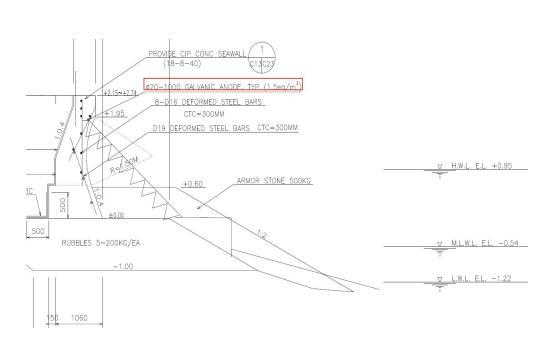
Figure 6. Seawall Sketch.

Galvanic anodes can be used to prevent corrosion from initiating. However, in corrosion environment such as splash zone and tidal zone, corrosion control current density of average 3mA/m2 is used as design current density.

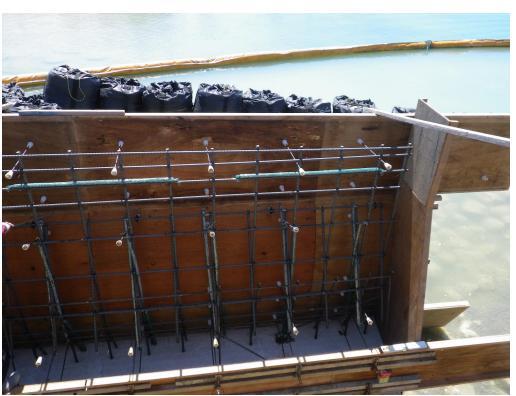
Figure 7. Seawall under construction.

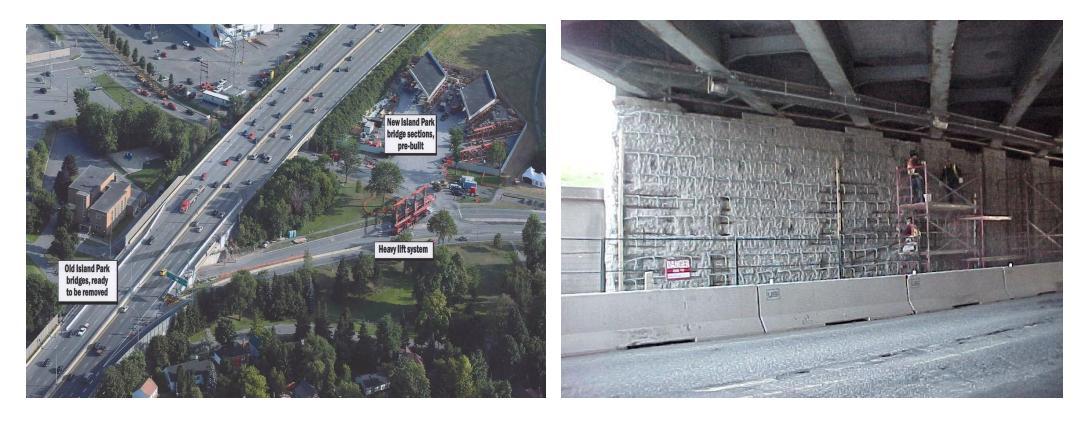
Figure 8. Highway 417 Island Park	Figure	9.	Abutment	t corr	osion
Drive Overpass, Ottawa, Canada	control	and	re-facing	before	rapid
	structural replacement

Since the superstructure is new, the corrosion of the abutments and wingwalls have to be arrested such that the substructures would have the same service life as the superstructures. Corrosion control with galvanic DAS anodes was designed. The anodes were spaced typically at 500mm on centers, the exception was at top of the abutments where heavy reinforcing was present and anodes are spaced at 250mm on centers. The galvanic anodes were embedded in 225mm refacing. The galvanic corrosion control system was installed in May 2007, and the superstructure was replaced in 2007 during Civic Holiday traffic closure at that Saturday night.

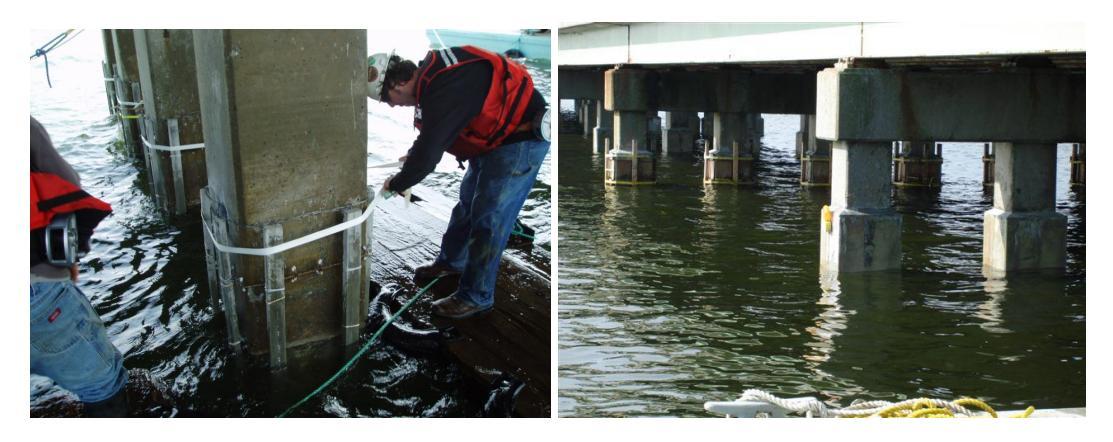
Figure 10. Galvanic	anodes	Figure 11. Marine pile jackets with			
installation for Robert	Moses	DAS galvanic anodes inside for			
Causesway, Long Island, New	w York.	corrosion control at tidal zone and			
		splash zone.

The scope of work for the pile protection included the removal of existing steel jackets and the installation of a galvanic pile protection system. NYSDOT specified activated distributed anode strips in conjunction with stay-in-place fiberglass reinforced polymer (FRP) jackets filled with a standard flowable concrete mix.

The galvanic jacket consisted of a 6 ft. high FRP shell, FRP bottom form and 8 Galvanode DAS anode strips (two per face). Each Galvanode DAS had nominal dimensions of 1 3/8 in. x 3 in. x 5  $\frac{1}{2}$  ft in length.
